MDOT State Study 316 – Development of Advanced Landslide Investigation Protocol Using Geophysical Methods for Mississippi

FINAL REPORT

June 30, 2023

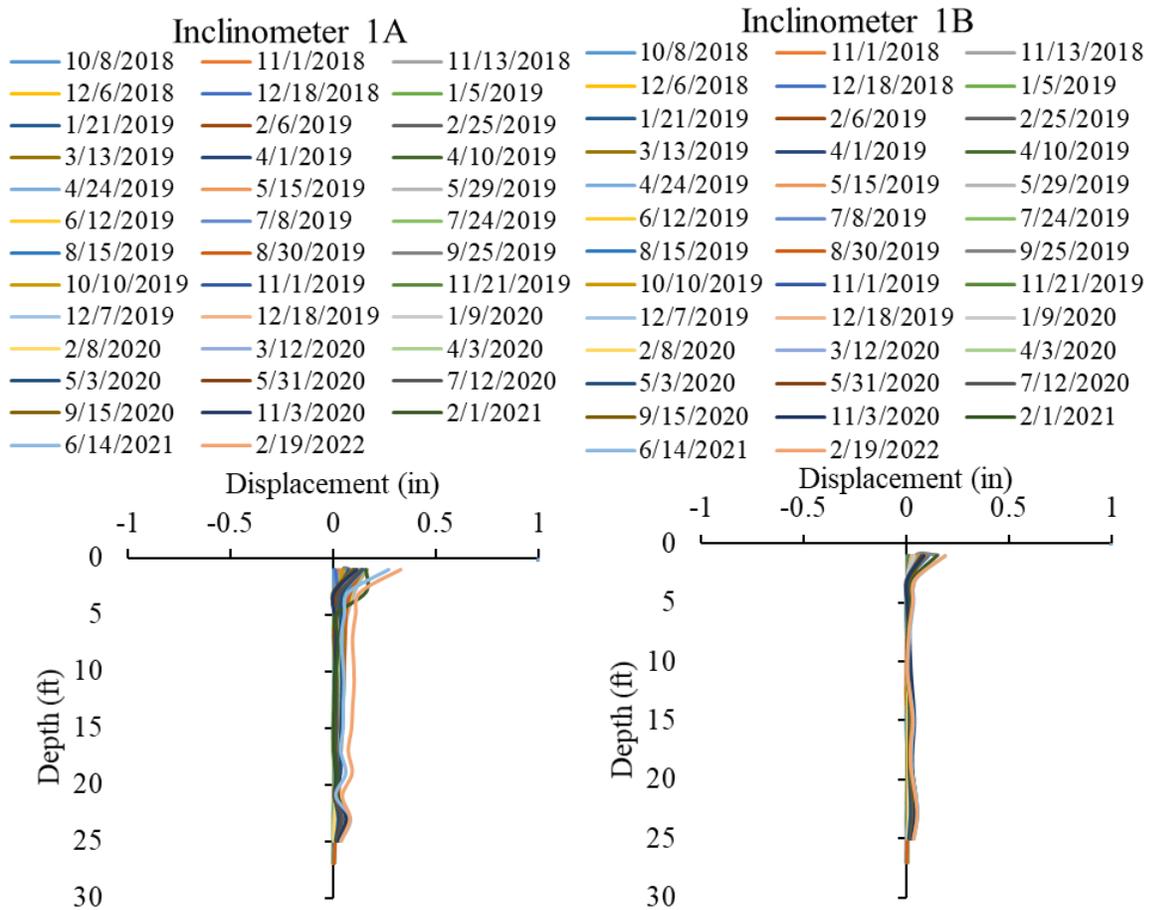
Figure 3.5 Displacements at Inclinator 1 at I-Slope 1

The slope inclinometer measurements were collected at 2 ft. intervals along the inclinometer pipe to observe the horizontal movement of the slope. The inclinometer data was then analyzed to determine the slope's movement. Figure 3.5 and Figure 3.6 display the horizontal movement data from Inclinometer 1 at the as-built section and the time-dependent movement along the crest of the slope, respectively. Similarly, Figure 3.7 and Figure 3.8 show the horizontal movement data from Inclinometer 2 at the repaired section and the time-dependent movement along the crest of the slope. The figures indicate that no significant movement was observed in either section, or the performance of both slope sections was satisfactory.

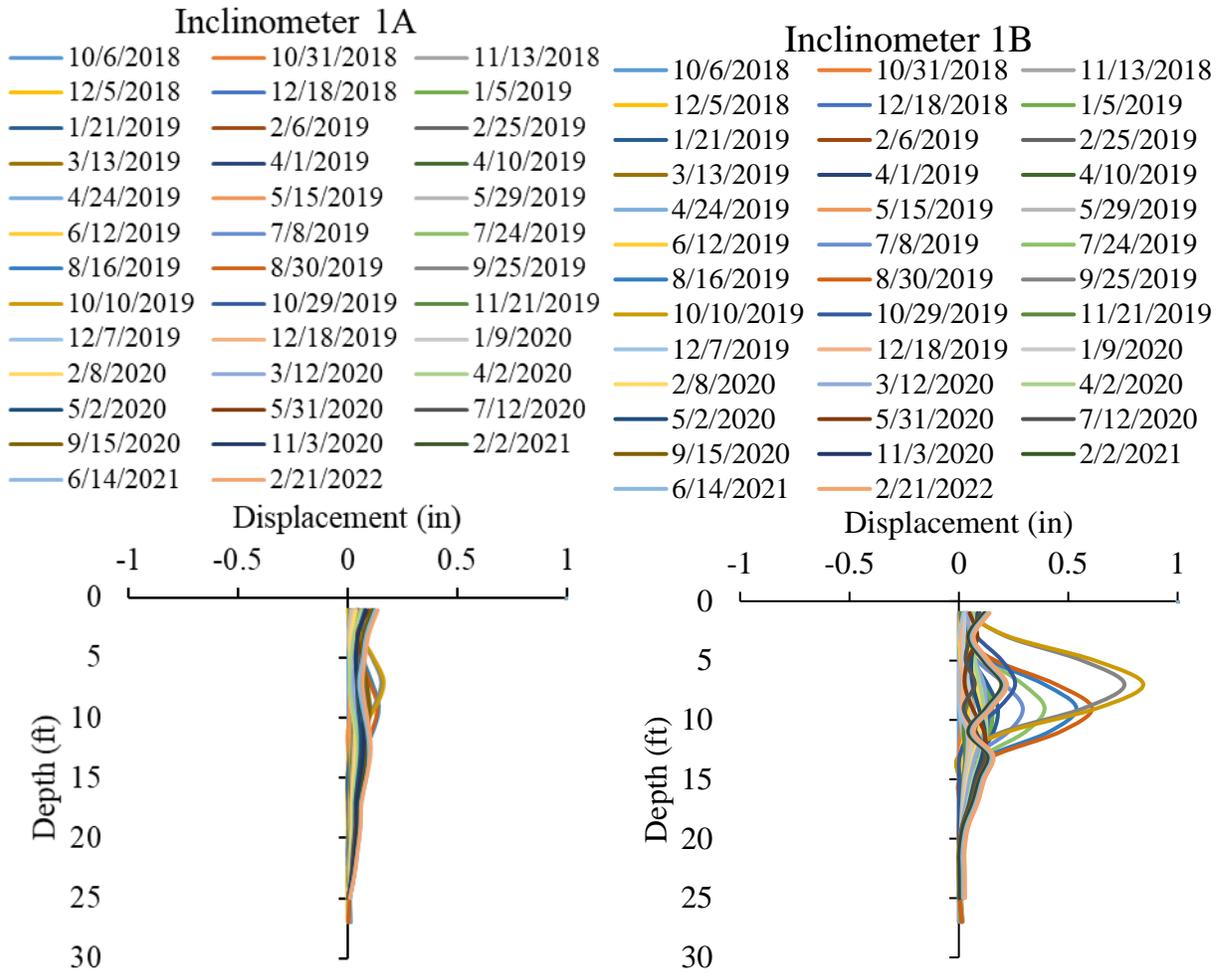
Figure 3.35 Displacements at Inclinator 1 at I-Slope 4

Inclinometer measurements were conducted along the slope inclinometer pipe at 2 ft. intervals to gather data on the horizontal movement of the slope. The collected data were then analyzed to assess the slope's movement. Figure 3.35 displays the horizontal movement data from Inclinometer 1, while Figure 3.36 illustrates the time-dependent movement at the surface of the slope. The data reveals that no significant movement was observed; however, some movement was detected at depths ranging from 5 ft. to 10 ft. During the field inspection, it was noted that a void had formed near Inclinometer 1, as depicted in Figure 3.36, due to erosion of the slope surface. To address this issue, it is recommended to backfill the void with lean clay fill materials.

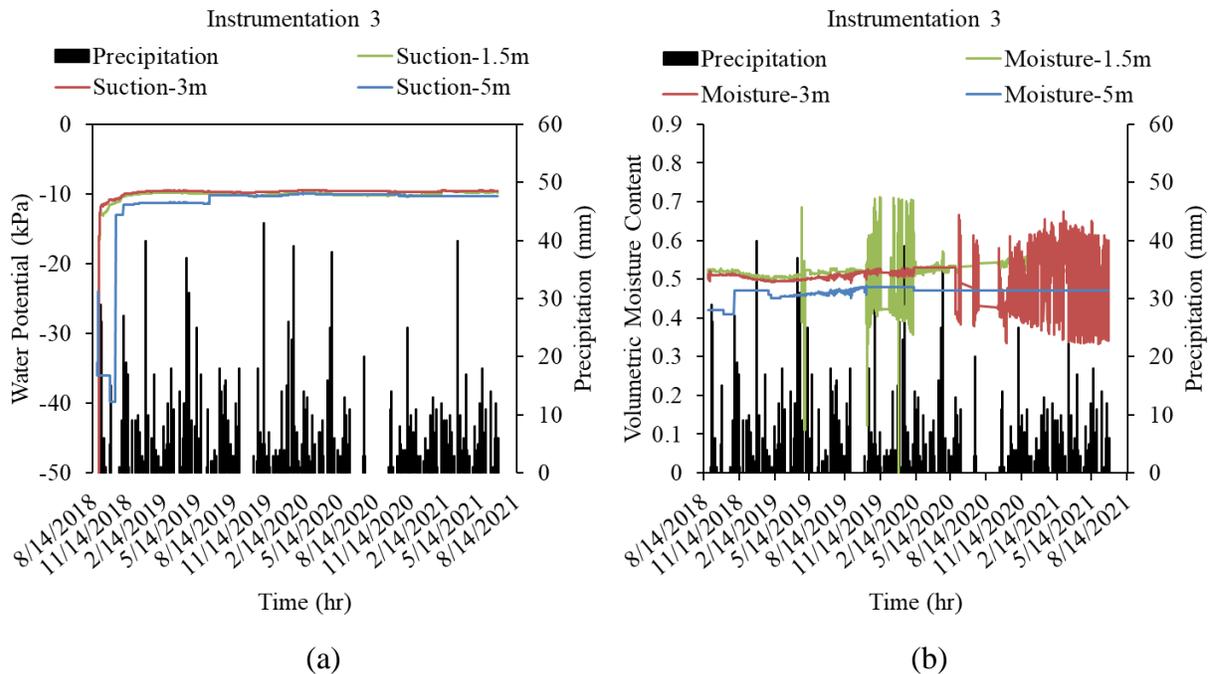
Figure 3.39 Variation of parameters at I-Slope 4 (a) Matric Suction, (b) Moisture Content and Rainfall data from Instrumentation 3

Figure 3.39 reveals significant fluctuations in moisture content at all depths in the middle of the slope, accompanied by lower matric suction values at 5 ft. (1.5 m) and 10 ft. (3 m) depths compared to the value at 15 ft. (5 m) depth. This indicates the infiltration of rainwater into the slope. Similar moisture and matric suction variations were observed at the toe of the slope. Notably, the fill material used in the slope reconstruction has high permeability, allowing consistent rainwater infiltration. However, this fill material is underlain by Yazoo Clay, which has very low permeability. As a result, rainwater infiltrates the fill material and creates a perched water condition, leading to a ponding effect within the fill soil's pore space. The movement observed in Inclinomometer 1 at depths of 5 ft. (1.5 m) to 10 ft. (3 m) is attributed to this perched water condition and the void formation resulting from soil erosion at the slope's surface.

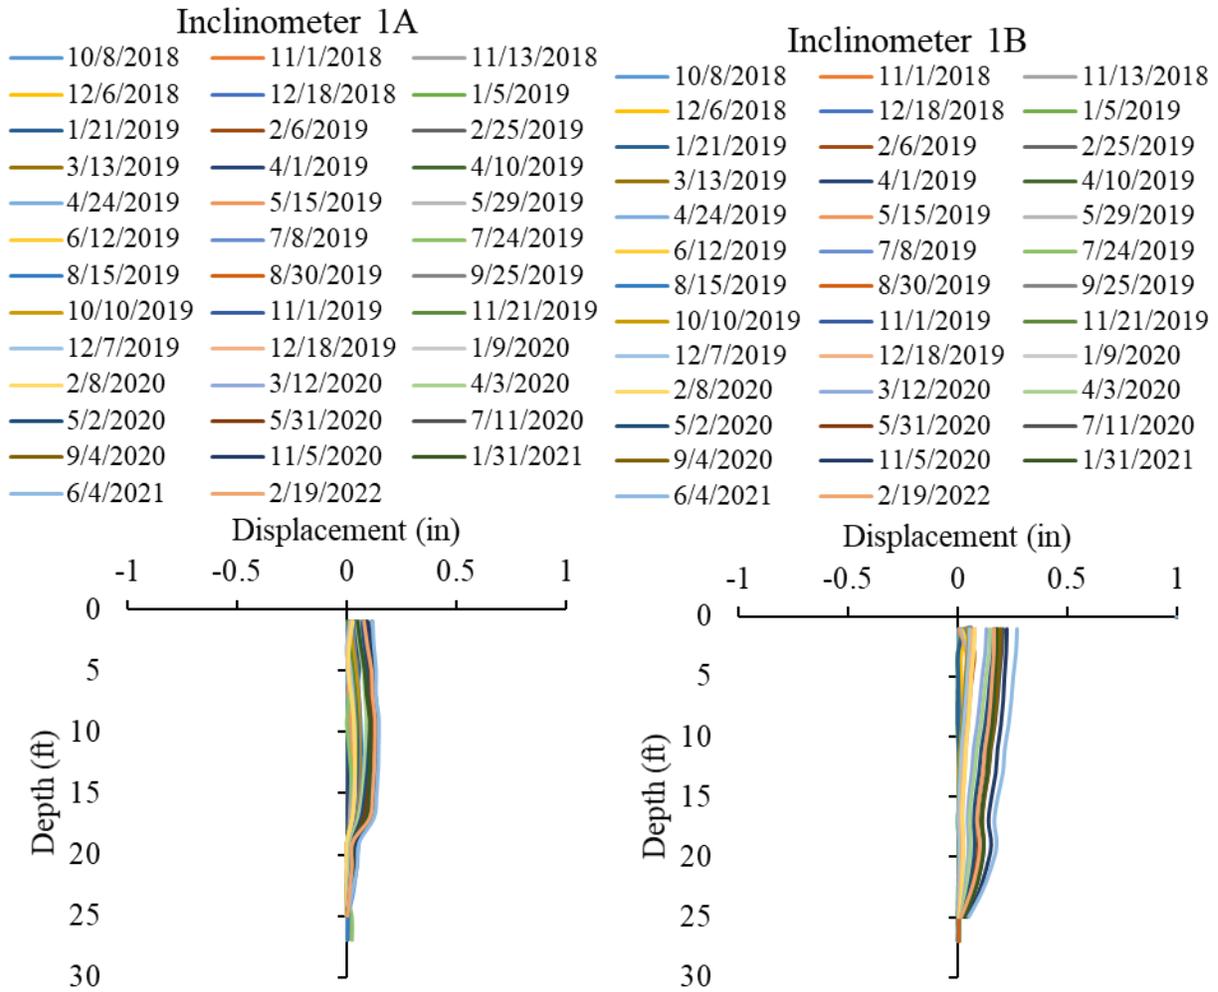
Figure 3.43 Displacements at Inclinator 1 at I-Slope 5

Data on the horizontal movement of the slope was obtained through inclinometer measurements taken at 2 ft. intervals along the slope. The collected data was then analyzed to determine the slope's movement. Figure 3.43 presents the horizontal movement data from Inclinometer 1 at the reinforced section, while Figure 3.44 displays the time-dependent movement at the slope's surface. Notably, no significant movement was observed in the as-built section of the slope, indicating a stable and satisfactory performance.
