MDOT State Study 316 – Development of Advanced Landslide Investigation Protocol Using Geophysical Methods for Mississippi

FINAL REPORT

June 30, 2023

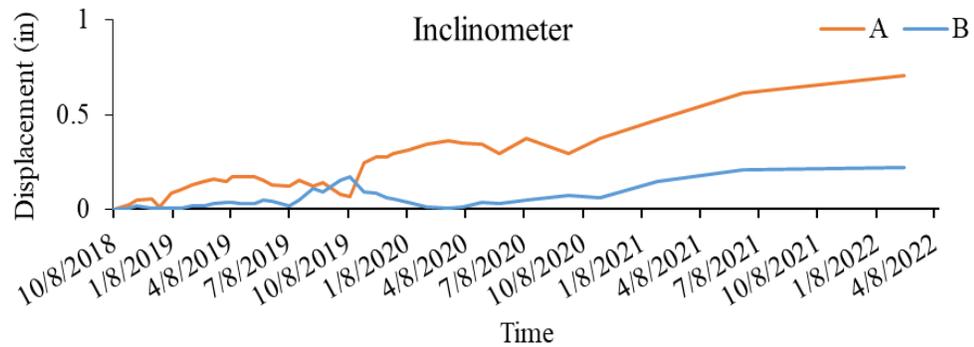
The slope inclinometer measurements were collected at 2 ft. intervals along the inclinometer pipe to observe the horizontal movement of the slope. The inclinometer data was then analyzed to determine the slope's movement. Figure 3.5 and Figure 3.6 display the horizontal movement data from Inclinometer 1 at the as-built section and the time-dependent movement along the crest of the slope, respectively. Similarly, Figure 3.7 and Figure 3.8 show the horizontal movement data from Inclinometer 2 at the repaired section and the time-dependent movement along the crest of the slope. The figures indicate that no significant movement was observed in either section, or the performance of both slope sections was satisfactory.

Figure 3.6 Deformations in the As-Built Section from surficial levels of Inclinator 1 at I-Slope 1

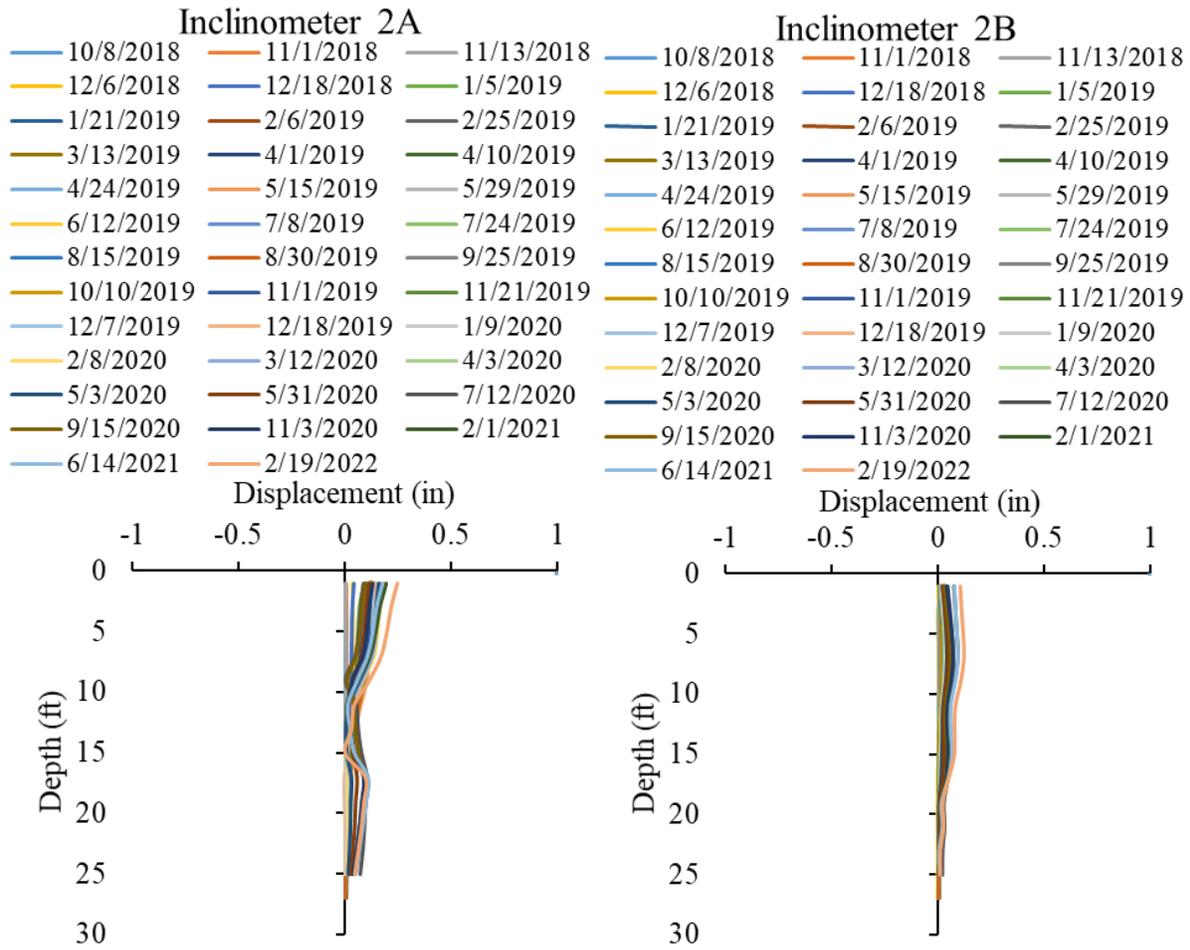
Figure 3.7 Horizontal Displacements of the Inclinator 2 at I-Slope 1

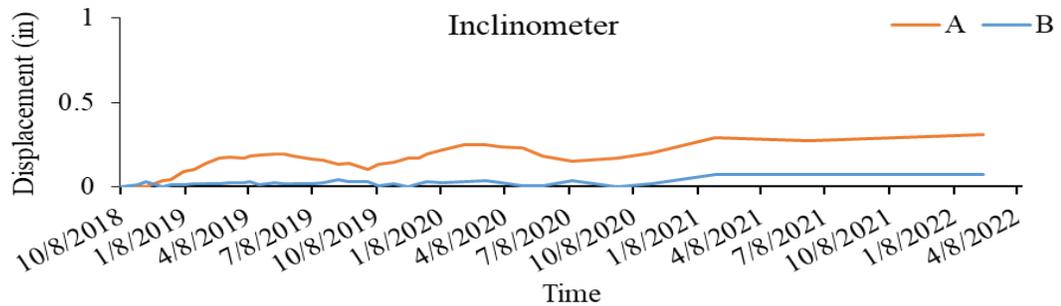
Figure 3.8 Variations of Lateral deformation at I-Slope 1's Repaired Section

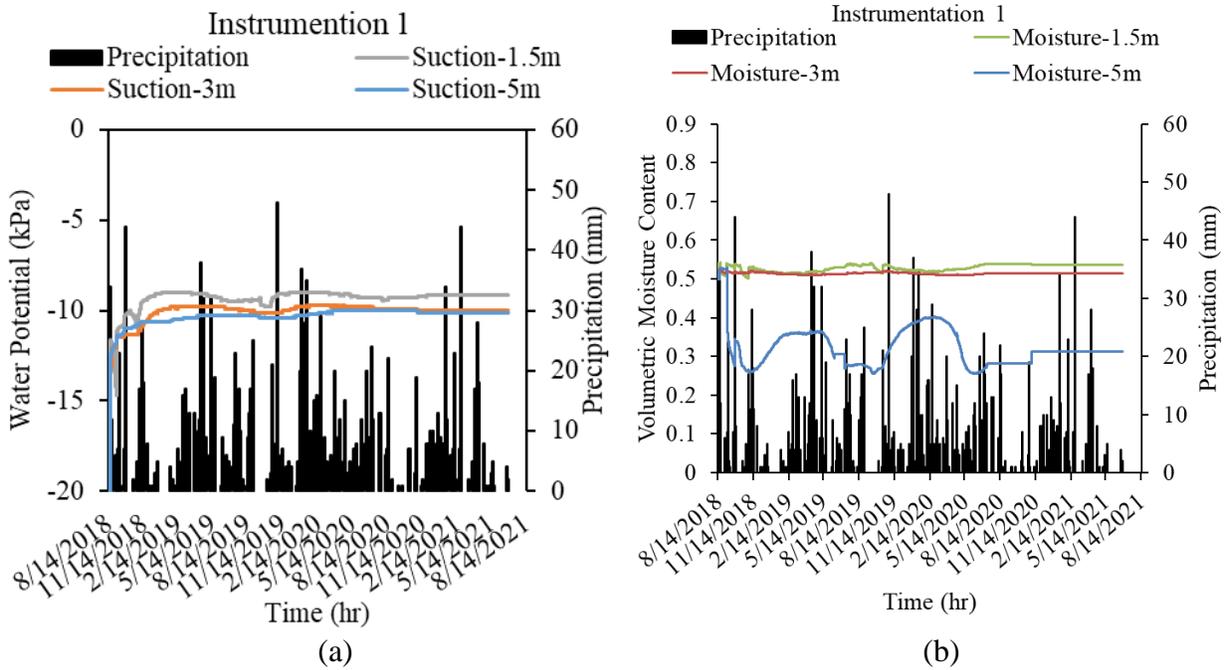
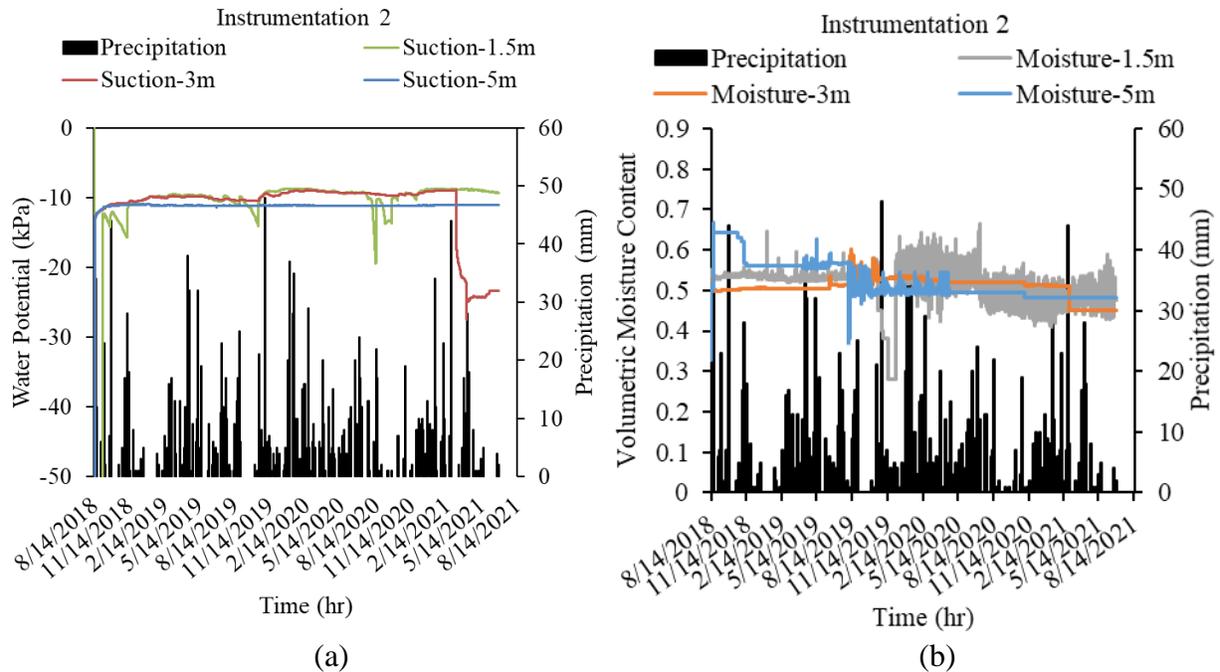
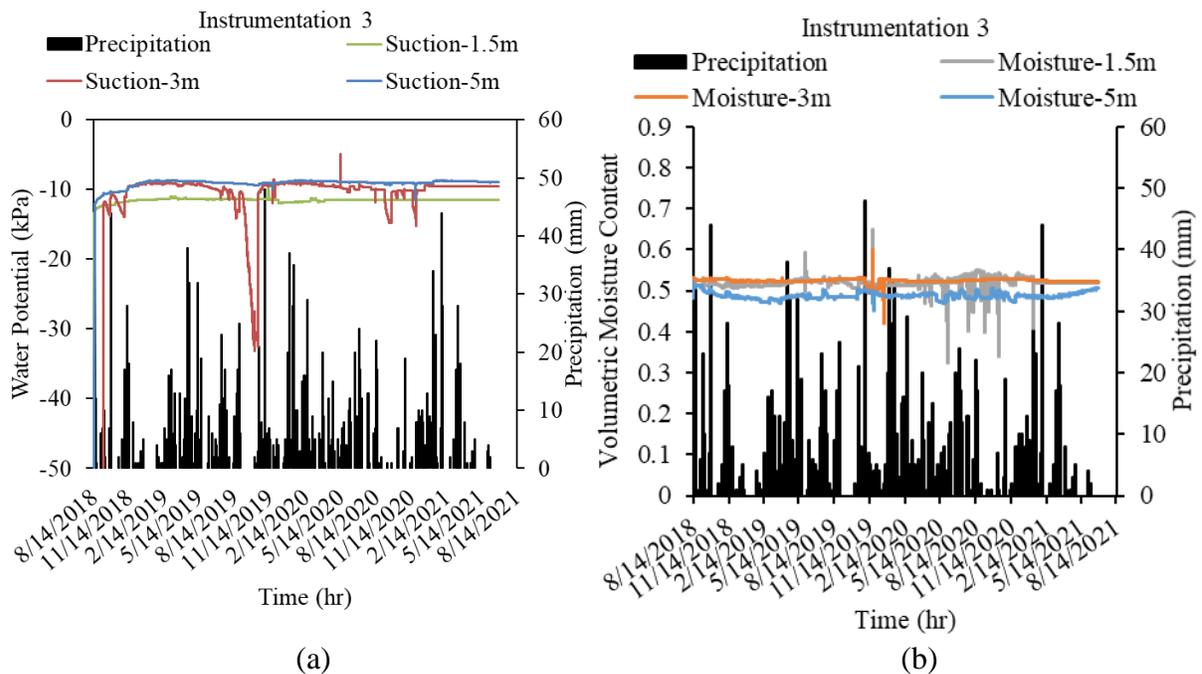
The sensors collected data at the crest, middle, and toe of the slope, and variations in the in situ matric suction profile and moisture content at 5 ft. (1.5 m), 10 ft. (3 m), and 15 ft. (5 m) depths with rainfall are presented in Figures 3.9 to Figure 3.11. The moisture content and matric suction variations at Instrumentation 1, Instrumentation 2, and Instrumentation 3 are presented in Figure 3.9, Figure 3.10 and Figure 3.11, respectively. The highest rainfall occurred in late December 2018, but few variations in moisture content were observed at any of the three depths within the 2-year monitoring period; the matric suction showed no variations.

Figure 3.9 Variation of parameters at I-Slope 1 (a) Matric Suction, (b) Moisture Content and Rainfall data from Instrumentation 1

Figure 3.10 Variation of parameters at I-Slope 1 (a) Matric Suction, (b) Moisture Content and Rainfall data from Instrumentation 2

Figure 3.11 Variation of parameters at I-Slope 1 (a) Matric Suction, (b) Moisture Content and Rainfall data from Instrumentation 3

Figures 3.9 to 3.11 present variations in the moisture content(volumetric) with time. The moisture content changes at the site slopes' soil layers are influenced by the water infiltration after rainfall events. Typically, variations in moisture content are inversely related to variations in the

matric suction profile. This means that the soil moisture content increases during and immediately after rainfall while the matric suction decreases (Hossain et al., 2013). Yazoo Clay exhibits minimal changes in soil water content at deeper depths and a steady matric suction profile. The soil was saturated at all depths during rainfall, and the volumetric moisture content was between 0.5 to 0.7. Figures 3.9 to 3.11 illustrate the consistent and minimal variations in matric suction with rainfall at different depths in both the crest and middle of the slope. The soil below approximately 5 ft. (1.5 m) depth was fully saturated, despite the low permeability of Yazoo Clay hindering the downward movement of rainwater. The suction values increased with depth at the slope crest, but this trend differed at Instrumentation 2 and Instrumentation 3 in the middle of the slope.

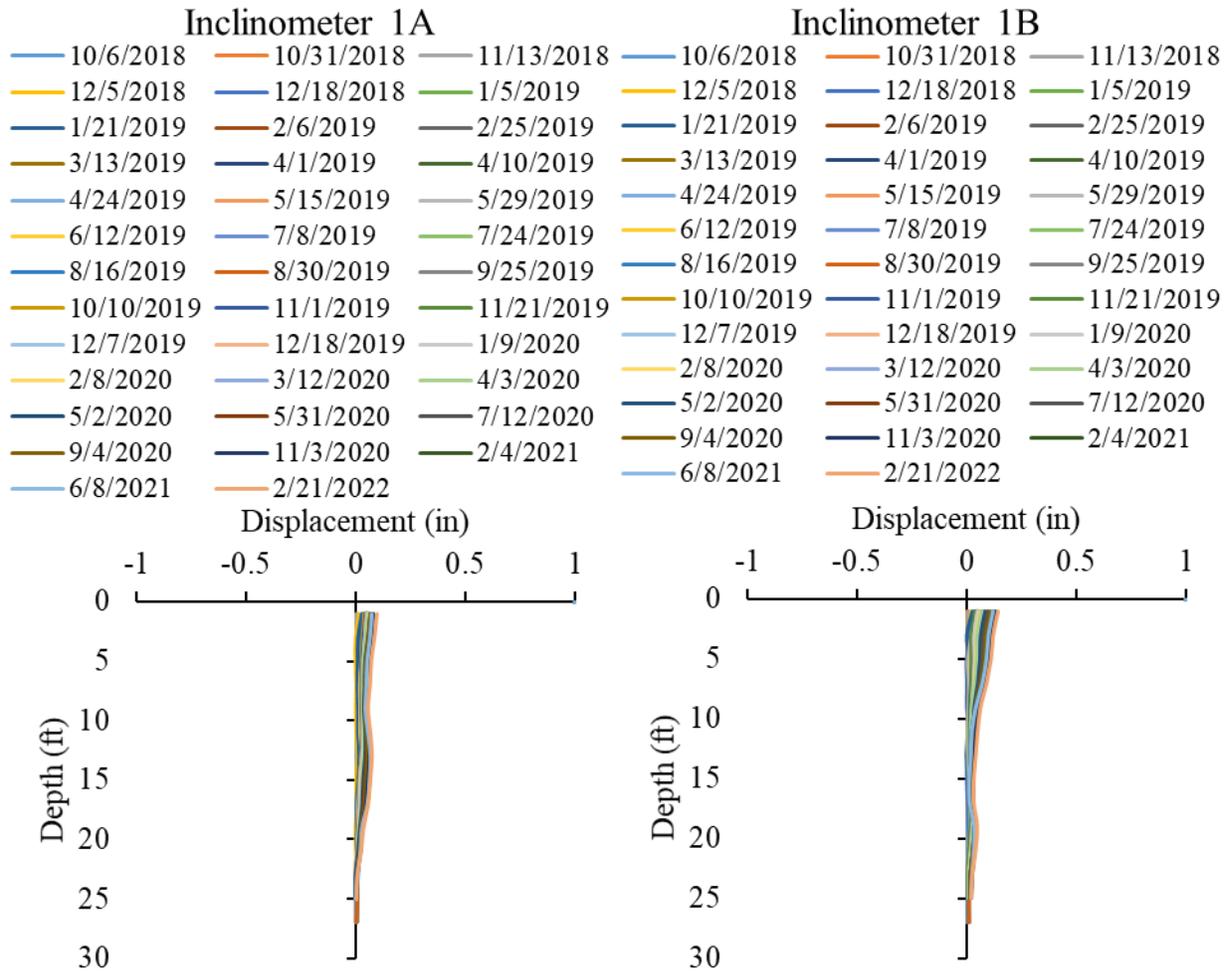
The slope's horizontal movement data was obtained by collecting measurements at 2 ft. intervals along the slope inclinometer pipe. These measurements were then analyzed to determine the movement of the slope. Figure 3.15 presents the data from Inclinometer 1 at the reinforced section, while Figure 3.18 shows the time-dependent movement at the slope's surface. Similarly, Figure 3.15 displays the horizontal movement data from Inclinometer 2 at the as-built section, and Figure 3.18 represents the time-dependent movement at the slope's surface. The figures indicate no significant movement in either section, demonstrating satisfactory slope performance. It should be noted that the inclinometer was struck by an external object at the surface in late 2021, rendering the results from late 2021 inconsistent with the previously observed trend shown in Figure 3.17.

Figure 3.15 Displacements at Inclinator 1 at I-Slope 2

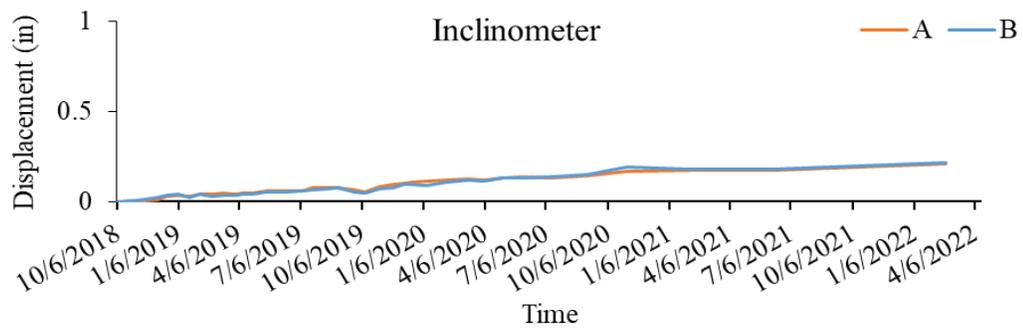
Figure 3.16 Overtime Lateral Deformation at the Top of Inclinator 1 at I-Slope 2.

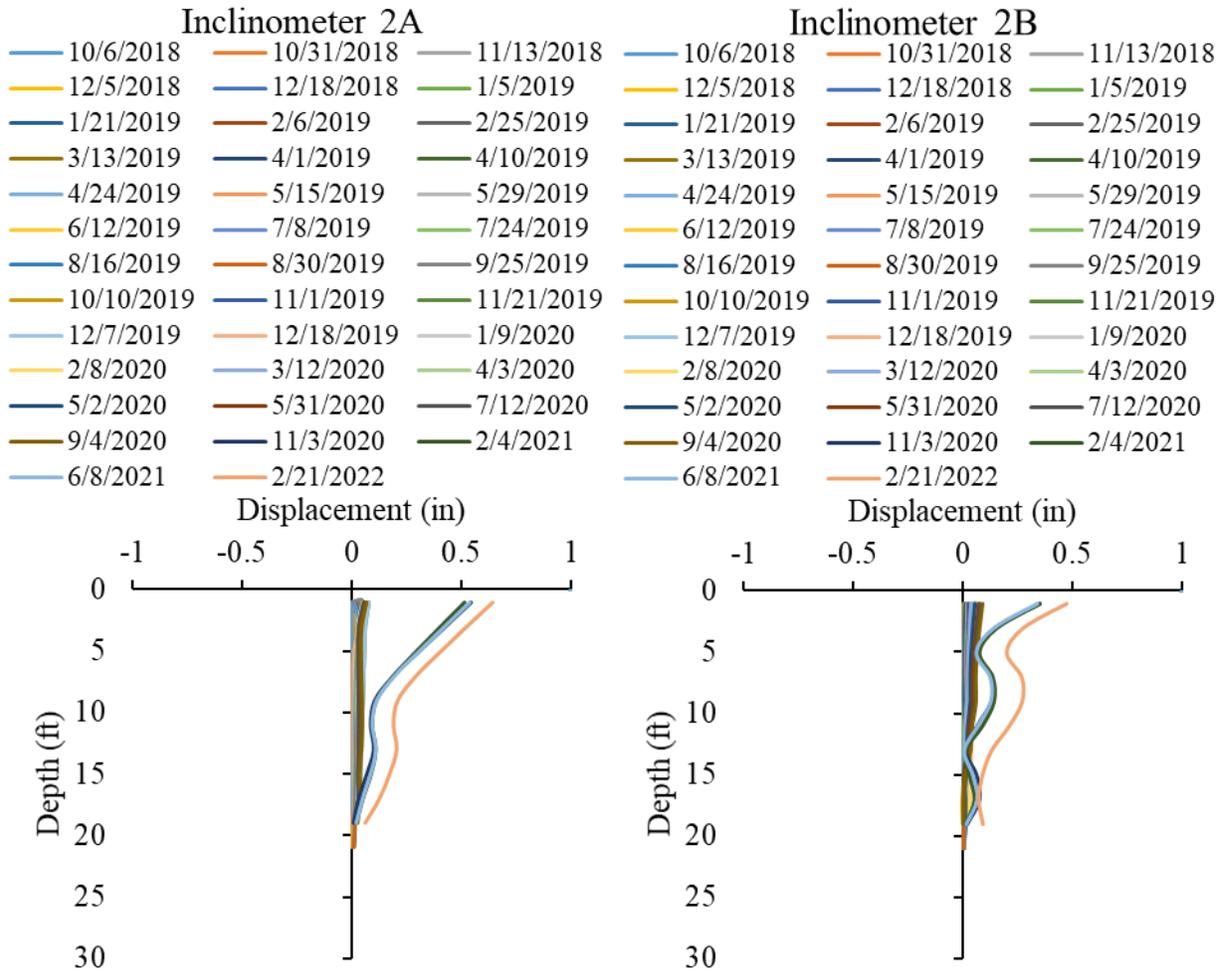
Figure 3.17 Displacements at Inclinerometer 2 at I-Slope 2

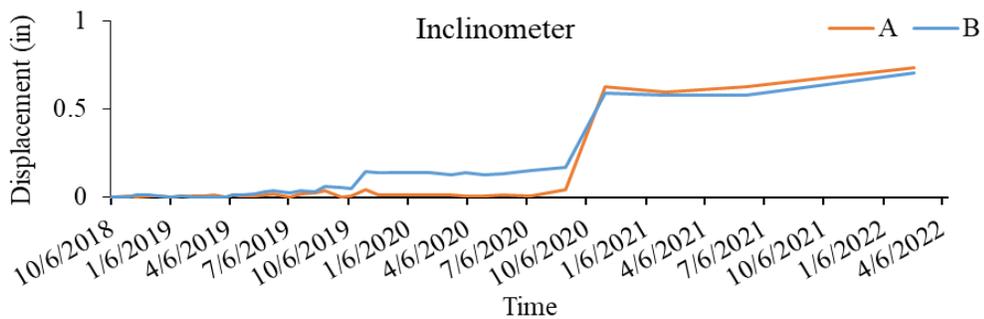
Figure 3.18 Overtime Lateral Deformation at the Top of Inclinerometer 2 at I-Slope 2.

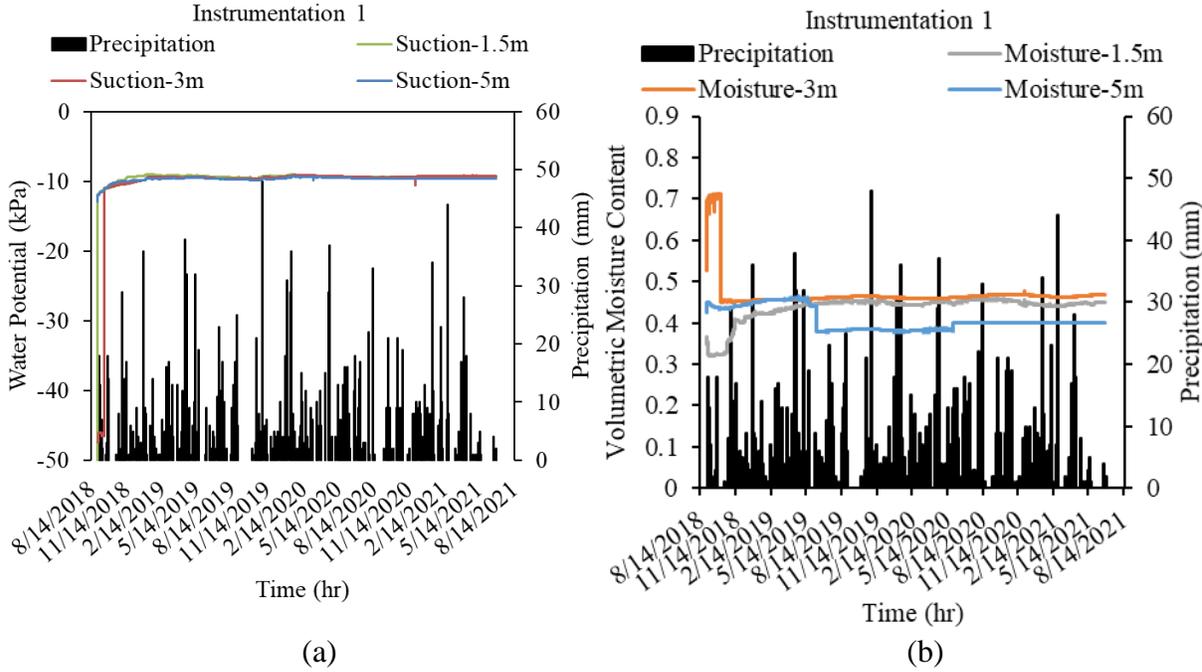
Figures 3.19, 3.20, and 3.21 display the variations in the in situ matric suction profile and moisture content at depths of 5 ft. (1.5 m), 10 ft. (3 m), and 15 ft. (5 m) with rainfall. During the initial three months after Instrumentation 1 and Instrumentation 2 installation, an initial variation in moisture was observed, indicating an adjustment period for moisture distribution. However, no

changes were observed in the matric suction at these locations. Minimal moisture variations were observed at the crest of the slope (Instrumentation 1) over the two-year monitoring period. In contrast, variations were observed at the middle of the slope (Instrumentation 2) during the summer and late December of 2019, indicating rainwater infiltration. Surface cracks near the slope's toe were observed, and a significant moisture variation was detected, suggesting rainwater infiltration through the cracks.

Figure 3.19 Variation of parameters at I-Slope 2 (a) Matric Suction, (b) Moisture Content and Rainfall data from Instrumentation 1

Figure 3.19 to Figure 3.21 display the variations of in situ matric suction with daily rainfall data at different depths (5 ft., 10 ft., and 15 ft.) in the slope's crest, middle, and toe. The matric suction exhibited a low and steady change at the middle and toe of the slope.

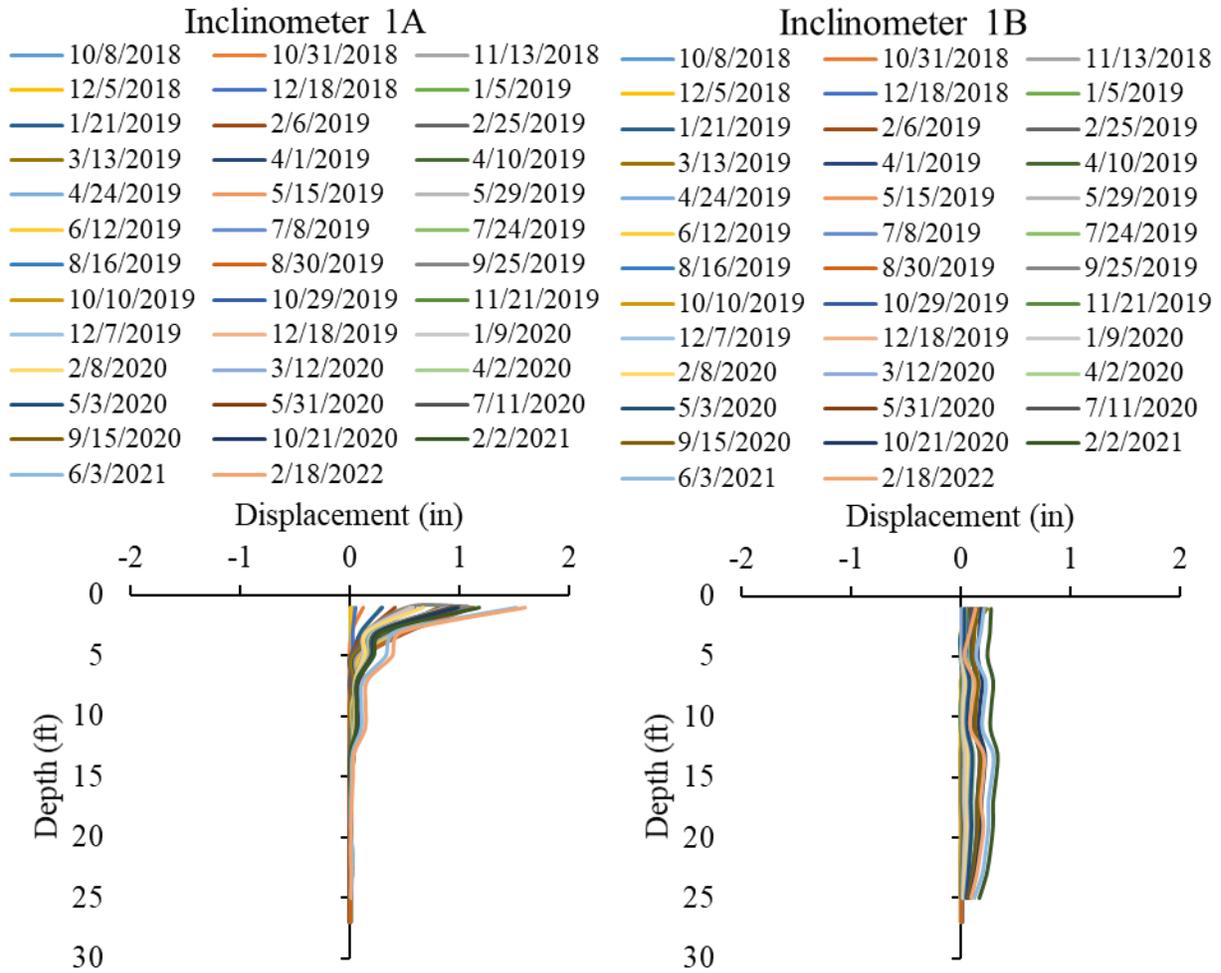
Figure 3.25 Displacements at Inclinator 1 (as built section) of I-Slope 3

Inclinometer data collected at 2 ft. intervals down the pipe were collected and analyzed to assess the slope's movement. Figure 3.25 shows the horizontal movement data from Inclinometer 1 in the reinforced section, while Figure 3.28 illustrates the time-dependent movement at the slope's surface. The analysis revealed that the as-built section of I-Slope 3 experienced movement starting in January 2019, with a maximum displacement of 1.6 inches at the slope surface within a year. The movement occurred at a shallow depth of approximately 6 ft. and requires maintenance. On the other hand, Inclinometer 2 in the reinforced section exhibited no movement, indicating satisfactory performance at the repaired section of the slope.

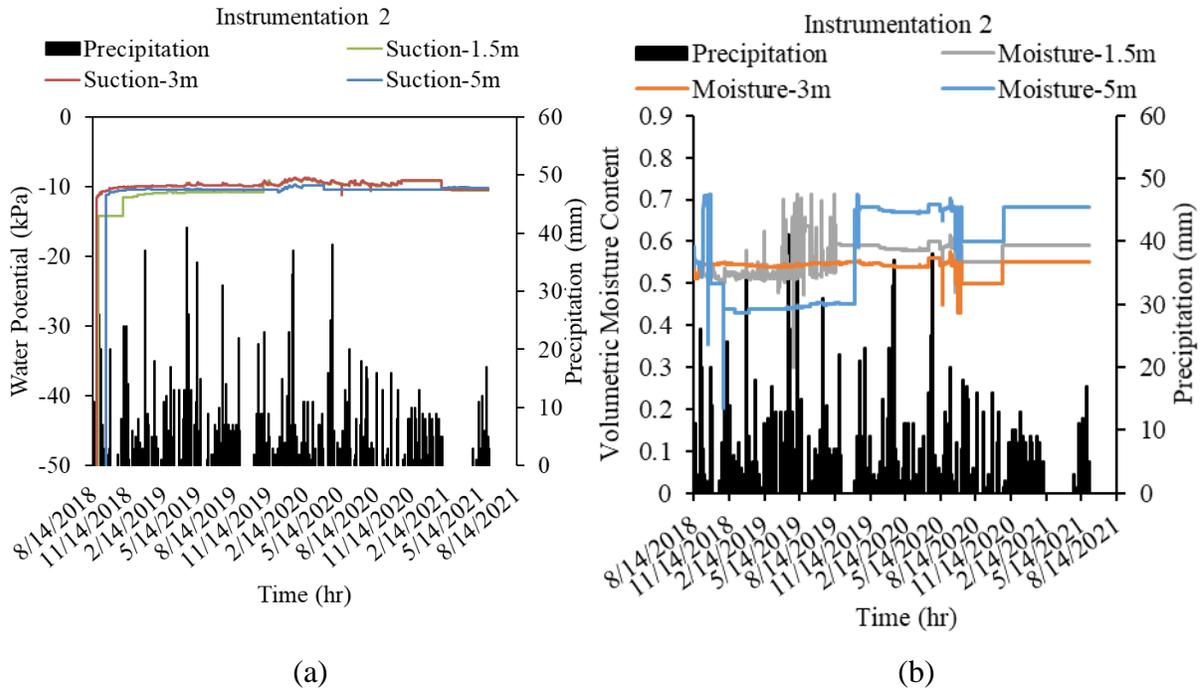
Figure 3.30 Variation of parameters at I-Slope 3 (a) Matric Suction, (b) Moisture Content and Rainfall data from Instrumentation 2

Figure 3.29, Figure 3.30, and Figure 3.31 illustrate the variations in the in situ matric suction profile and moisture content at different depths with rainfall. The monitoring results from Instrumentation 1 indicate that the matric suction initially reached a high value and then stabilized at a low value for the rest of the monitoring period, indicating a fully saturated condition. The volumetric moisture content remained constant during the two-year monitoring period, indicating

a consistently saturated state. The middle sections of the reinforced and as-built areas showed similar suction variations, with indications of rainwater intrusion in the volumetric moisture content. However, the overall moisture content remained constant over time. The constant moisture content and matric suction at Instrumentation 2 and Instrumentation 3 are attributed to the presence of a perched water condition in the slope.

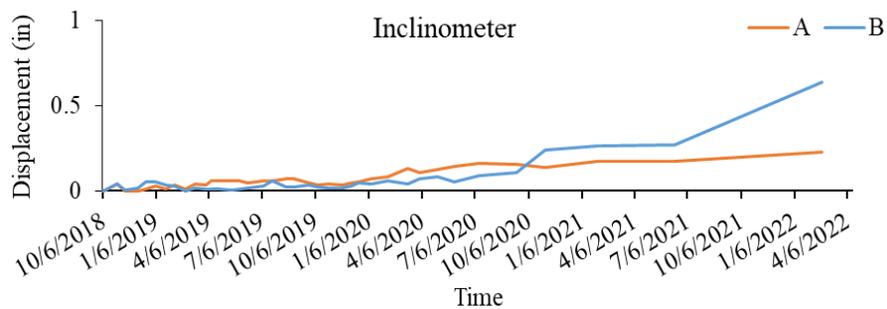
Figure 3.36 Overtime Lateral Deformation at the Top of Inclinator 1 at I-Slope 4

Inclinometer measurements were conducted along the slope inclinometer pipe at 2 ft. intervals to gather data on the horizontal movement of the slope. The collected data were then analyzed to assess the slope's movement. Figure 3.35 displays the horizontal movement data from Inclinometer 1, while Figure 3.36 illustrates the time-dependent movement at the surface of the slope. The data reveals that no significant movement was observed; however, some movement was detected at depths ranging from 5 ft. to 10 ft. During the field inspection, it was noted that a void had formed near Inclinometer 1, as depicted in Figure 3.36, due to erosion of the slope surface. To address this issue, it is recommended to backfill the void with lean clay fill materials.

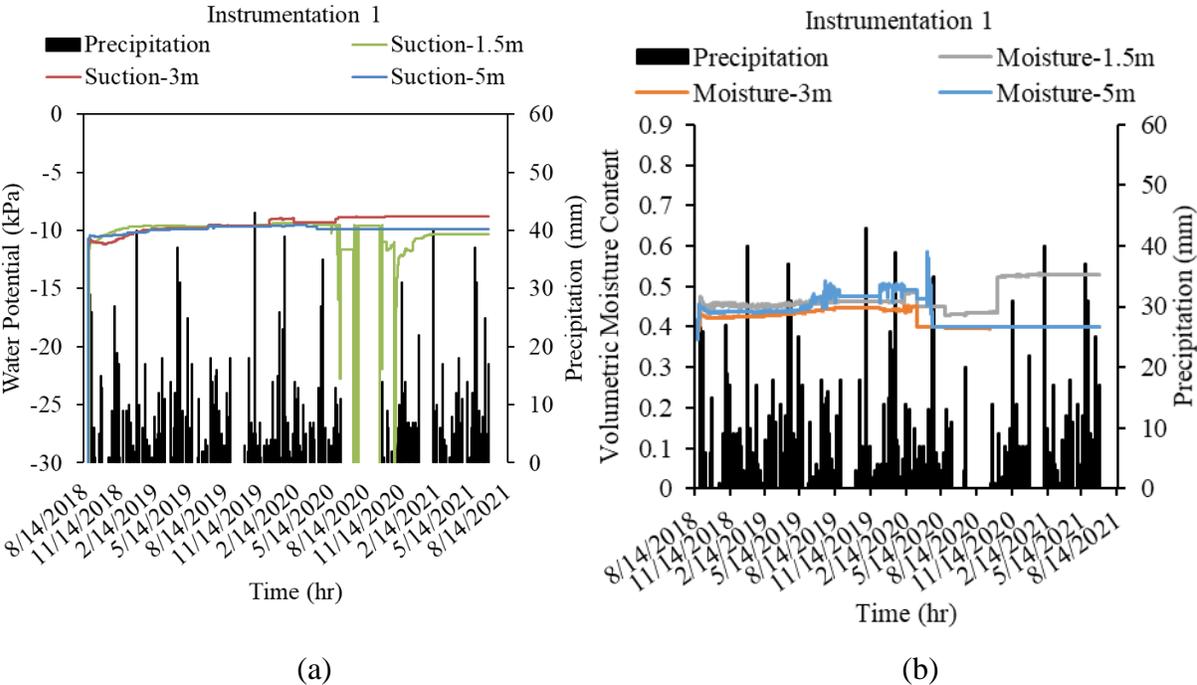
Figure 3.37 Variation of parameters at I-Slope 4 (a) Matric Suction, (b) Moisture Content and Rainfall data from Instrumentation 1.

Figures 3.37, 3.38, and 3.39 provide insight into the variations of the in situ matric suction profile and moisture content at different depths (5 ft., 10 ft., and 15 ft.) with rainfall. Specifically, Figure 3.39 showcases the monitoring results from Instrumentation 1, indicating that the volumetric moisture content remained constant over the two-year monitoring period. Similarly,

the matric suction exhibited a consistently low value of 10 kPa (209 psf). As previously discussed in the context of Slope 3, this consistent low value of matric suction and constant moisture content suggest that the soil is nearing a fully saturated condition. Therefore, it is highly likely that a perched water formation exists within the slope.

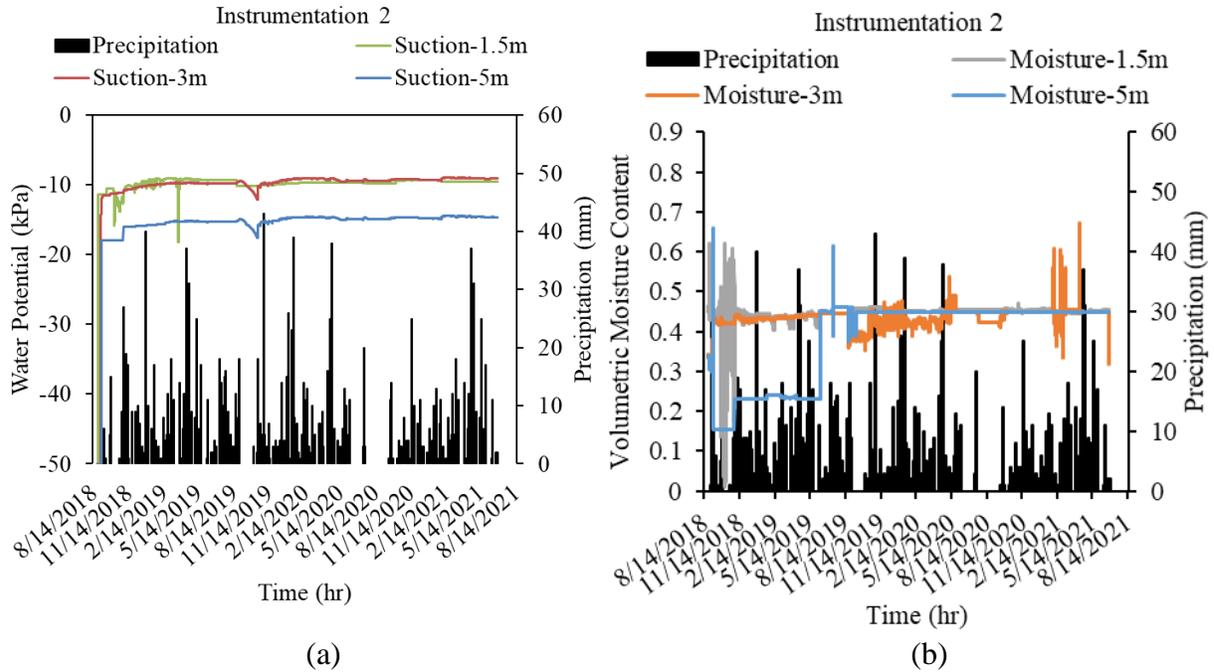
Figure 3.38 Variation of parameters at I-Slope 4 (a) Matric Suction, (b) Moisture Content and Rainfall data from Instrumentation 2

Figure 3.39 reveals significant fluctuations in moisture content at all depths in the middle of the slope, accompanied by lower matric suction values at 5 ft. (1.5 m) and 10 ft. (3 m) depths compared to the value at 15 ft. (5 m) depth. This indicates the infiltration of rainwater into the slope. Similar moisture and matric suction variations were observed at the toe of the slope. Notably, the fill material used in the slope reconstruction has high permeability, allowing consistent rainwater infiltration. However, this fill material is underlain by Yazoo Clay, which has very low permeability. As a result, rainwater infiltrates the fill material and creates a perched water condition, leading to a ponding effect within the fill soil's pore space. The movement observed in Inclinomometer 1 at depths of 5 ft. (1.5 m) to 10 ft. (3 m) is attributed to this perched water condition and the void formation resulting from soil erosion at the slope's surface.

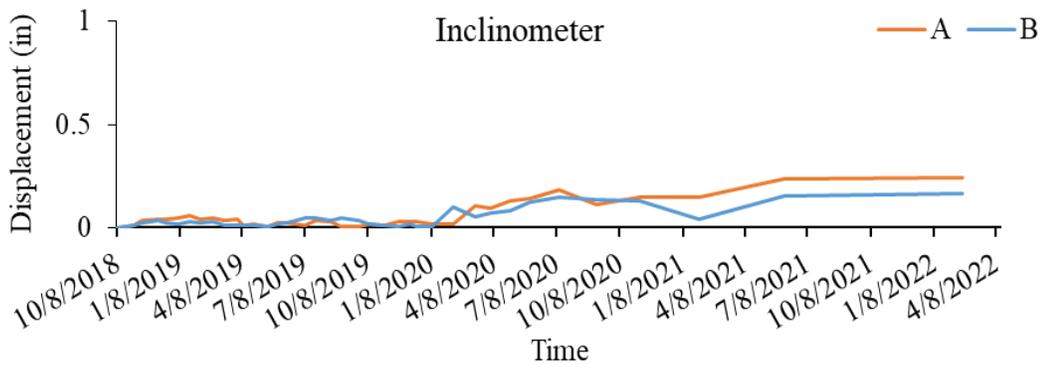
Figure 3.44 Overtime Lateral Deformation at the Top of Inclinator 1 at I-Slope 5.

Data on the horizontal movement of the slope was obtained through inclinometer measurements taken at 2 ft. intervals along the slope. The collected data was then analyzed to determine the slope's movement. Figure 3.43 presents the horizontal movement data from Inclinometer 1 at the reinforced section, while Figure 3.44 displays the time-dependent movement at the slope's surface. Notably, no significant movement was observed in the as-built section of the slope, indicating a stable and satisfactory performance.

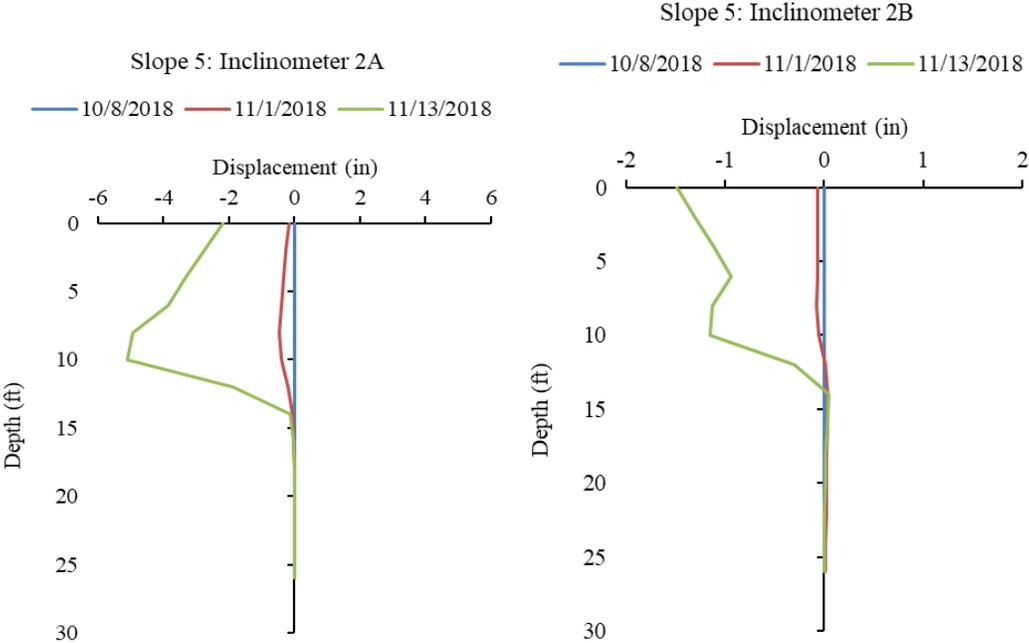
Figure 3.45 Displacements at Inclinator 2 at I-Slope 5

Figure 3.45 displays the horizontal displacement data obtained from Inclinator 2 in the repaired section. The data shows a sliding movement of 14 ft. (4.4 m) depth that occurred in November 2018. An aerial image of the failed slope can be seen in Figure 3.42. The slope was repaired using 40 ft. long H-piles of size HP 14x74 to address the issue. These piles were spaced

at 4 ft. center-to-center in the middle of the slope. The H-piles provided sufficient resistance in the active part of the slope and effectively prevented movement in the upper pavement ramp. However, it is important to note that the bottom part of the slope that experienced landslides was not reinforced. A detailed finite element analysis of the failure was conducted, and the results can be found in Chapter 5 of the study.

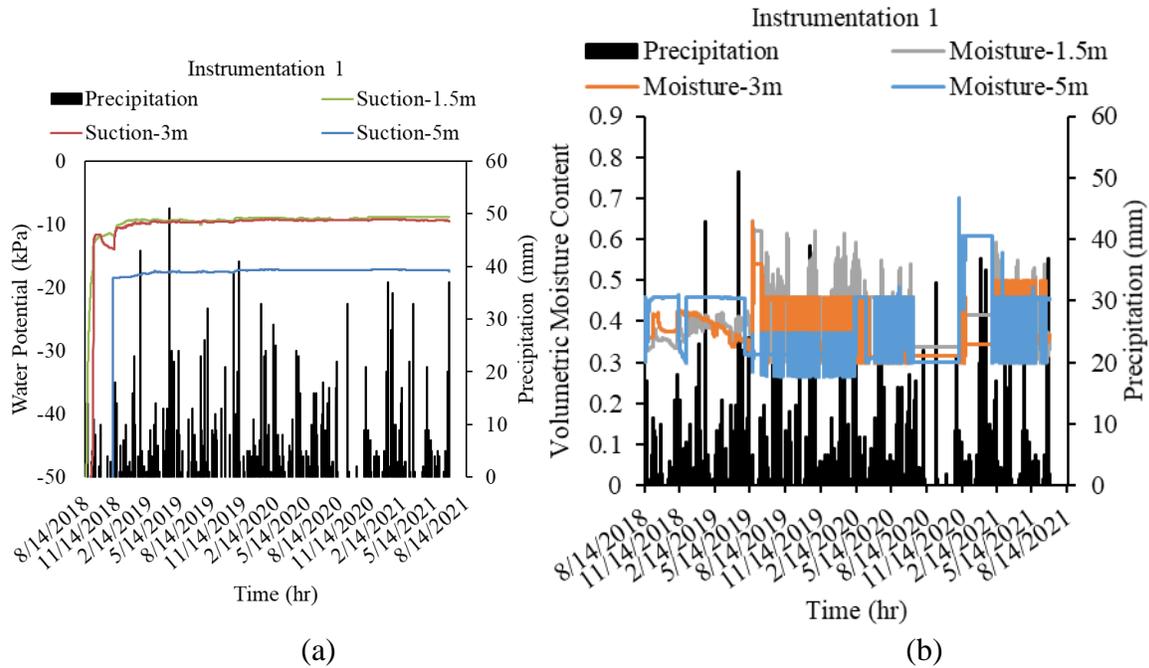
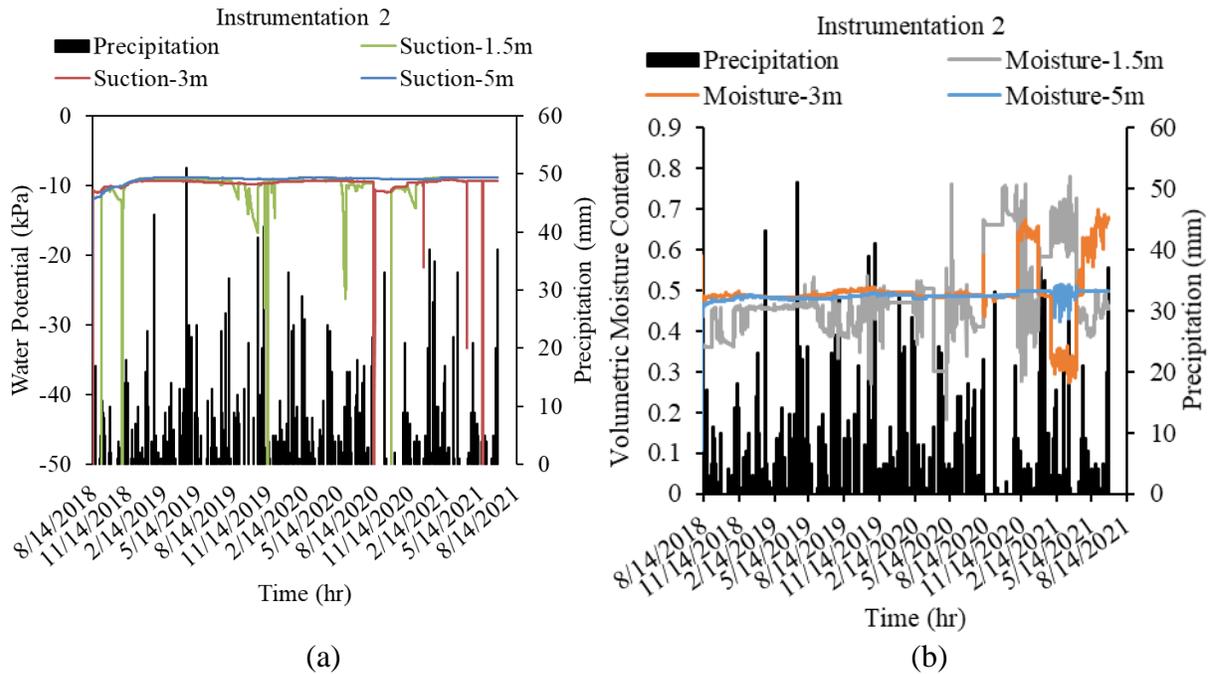
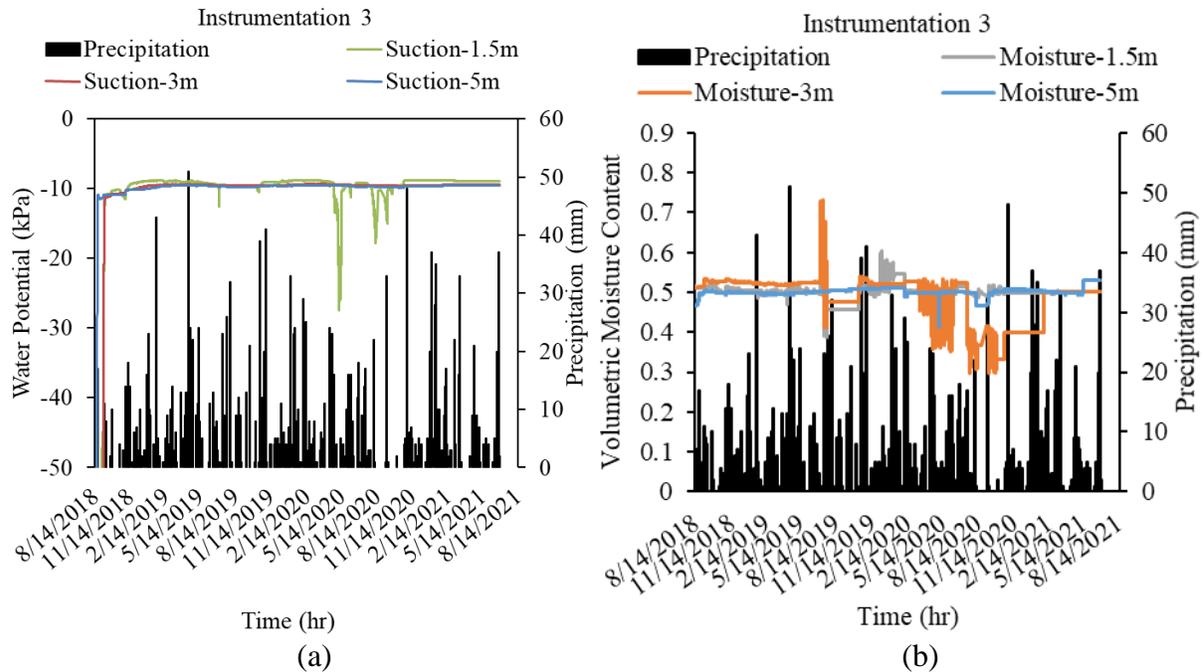
Figures 3.46, 3.47, and 3.48 provide valuable insights into the moisture content changes and daily rainfall distribution at different locations on Slope 5. The data captured the period from September 2018 to April 2019, focusing on the rainfall events before the slope failure. The instrumentation data revealed that the matric suction, a measure of soil moisture tension, remained constant after two to four months of the observation period. The lowest suction value was observed at the top part of the slope, indicating a combination of low shear strength and high moisture content. Significant moisture variations were observed during the dry period, particularly at depths of 5 ft. (1.5 m) and 10 ft. (4 m). These variations suggest that the slope experienced desiccation/shrinkage cracks during the summer of 2019. These cracks acted as preferential paths for rainwater infiltration, increasing the slope's moisture content. Overall, the data highlights the complex interplay between rainfall, moisture content, and slope behavior, providing important insights for understanding the factors contributing to slope failure.

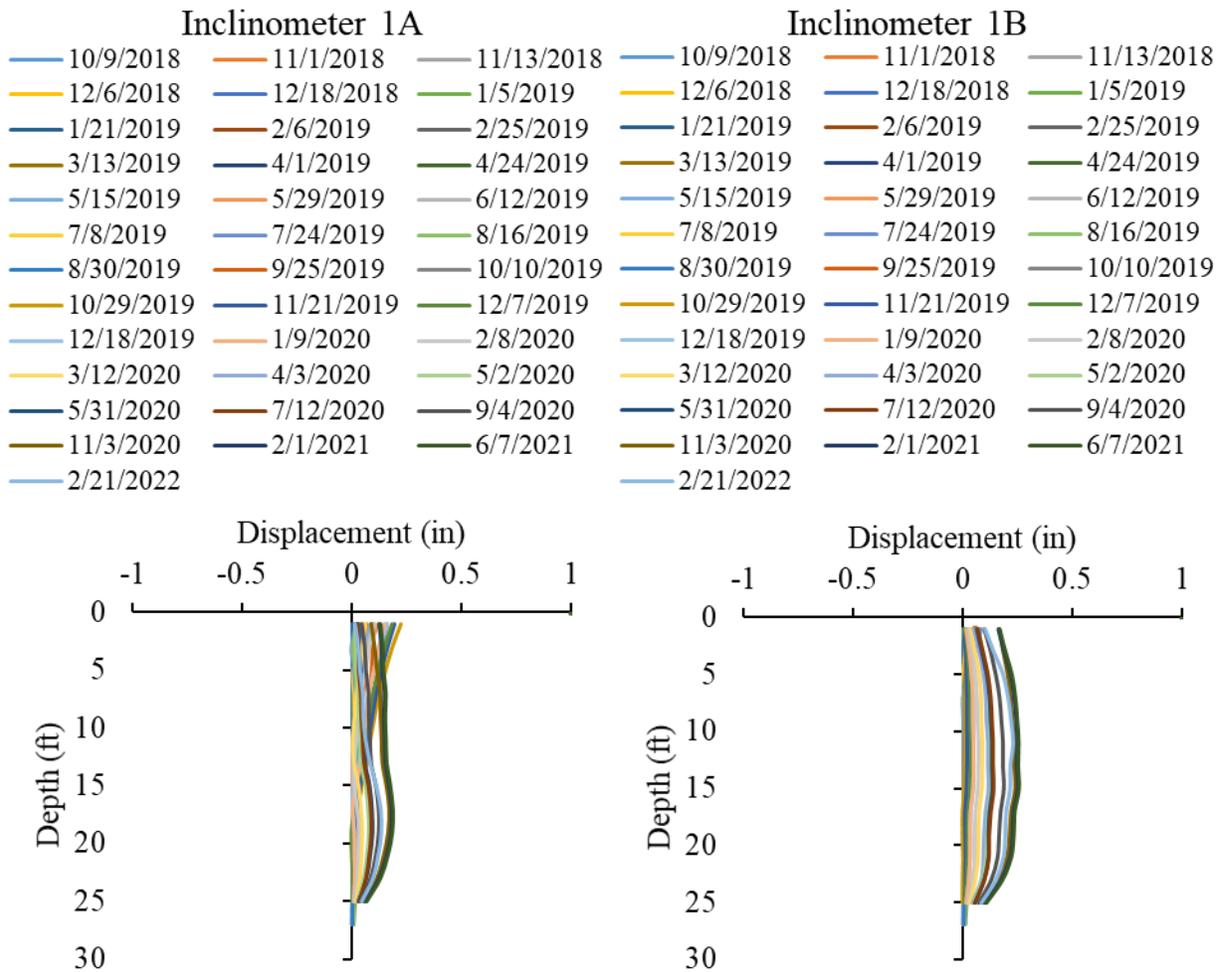
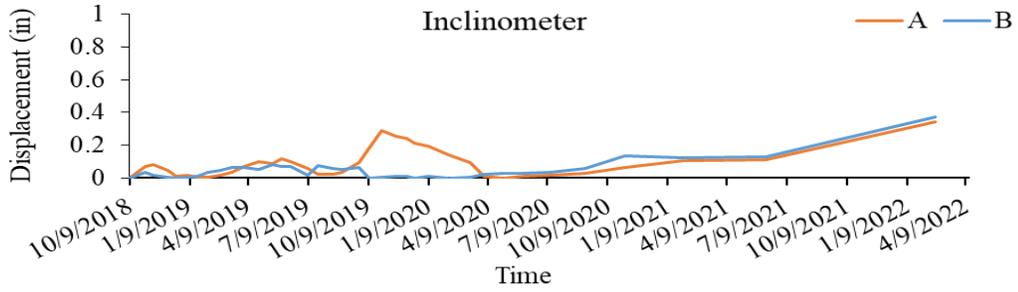
- In the repaired section, depicted in Figures 3.52 and 3.53, no significant movement was observed, indicating satisfactory performance.
- In the as-built section, shown in Figures 3.52 and 3.53, movement of up to 5 inches was observed at the surface during the monitoring period. The depth of the slope movement was approximately 5 ft., indicating a shallow slope failure. Maintenance and repair are required to address this issue.
