MDOT State Study 316 – Development of Advanced Landslide Investigation Protocol Using Geophysical Methods for Mississippi

FINAL REPORT

June 30, 2023

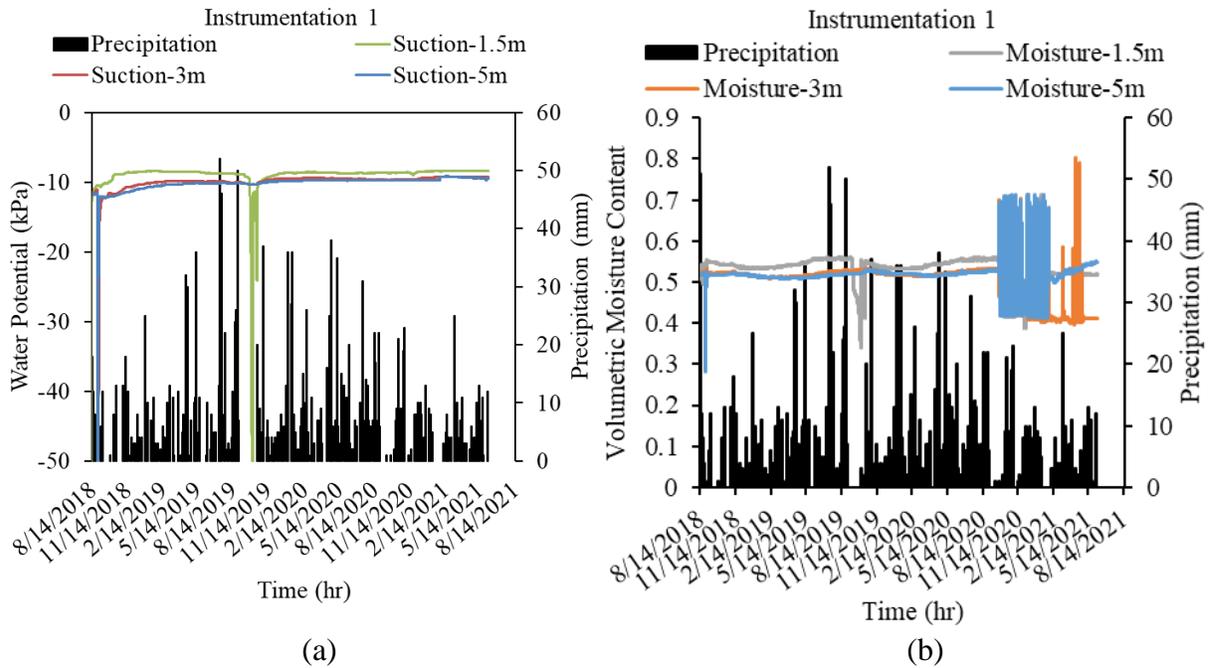
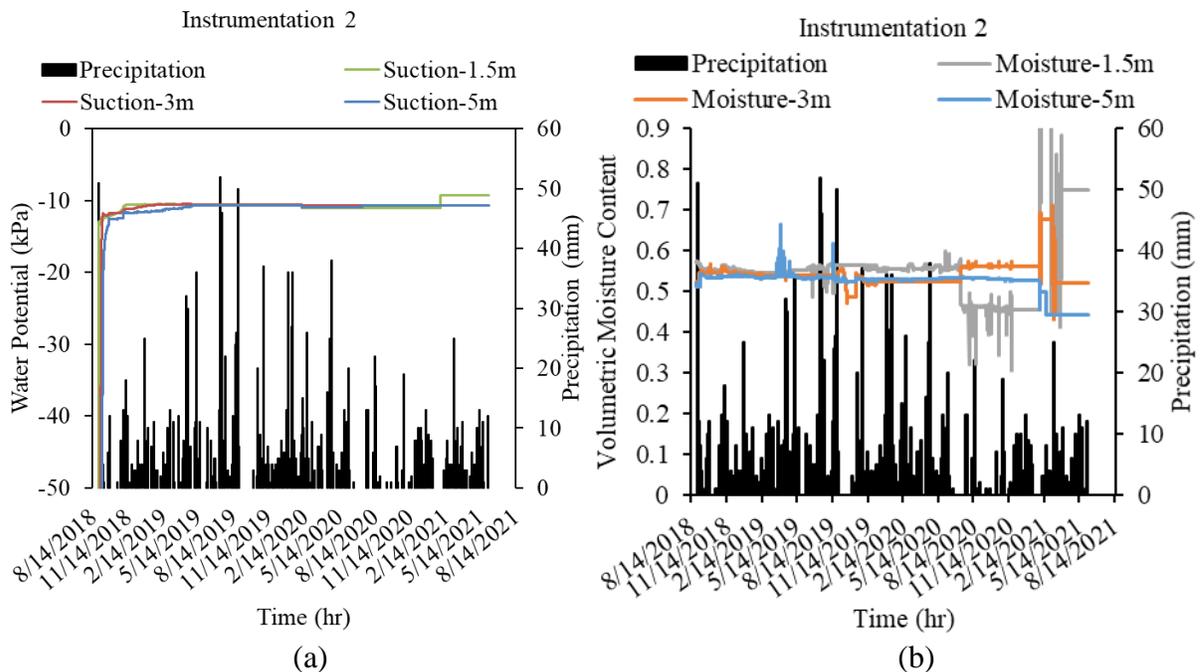
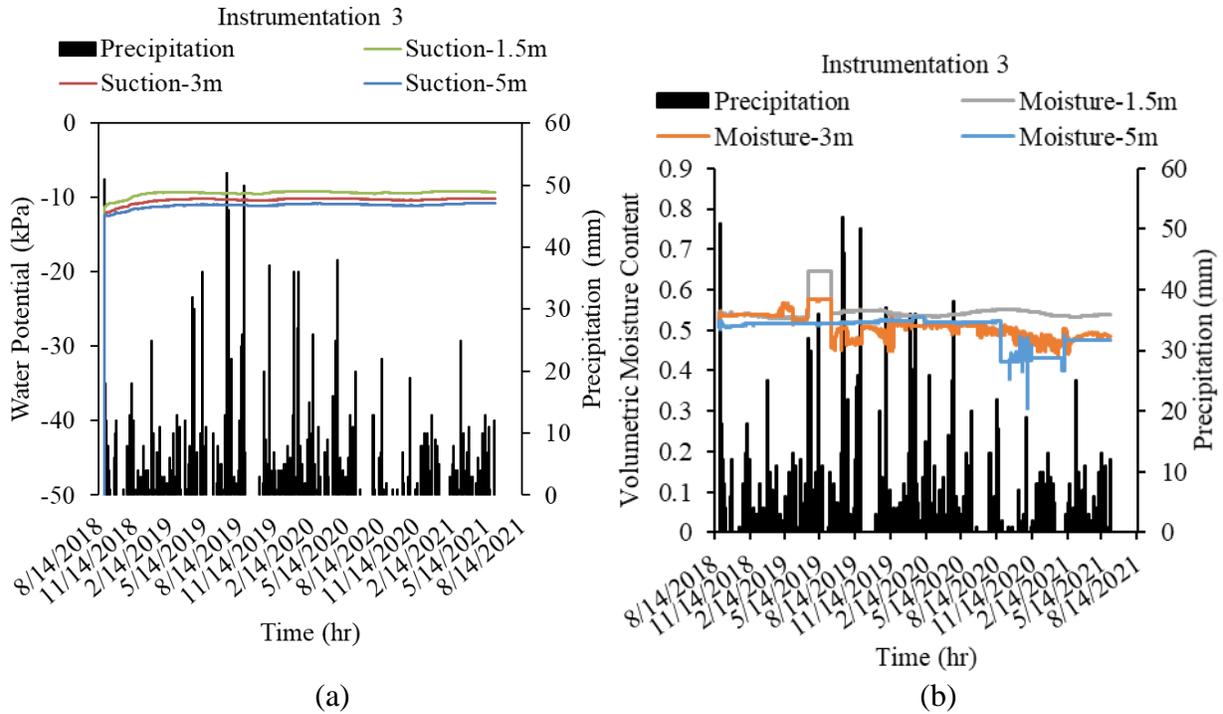
- Figures 3.56, 3.57, and 3.58 present the variations in matric suction and moisture content at the respective instrumentation locations.
- At Instrumentation 1, the matric suction initially remained high for approximately three months and then stabilized at a low value of 10 kPa for the rest of the monitoring period. The volumetric moisture content also remained constant throughout the two-year monitoring period.

- The constant low matric suction and consistently high moisture content indicate that the soil is nearly fully saturated, suggesting the presence of perched water conditions.

- Similar matric suction variations were observed in the middle of the slopes for both the repaired and as-built sections, as depicted in Figure 3.56 and Figure 3.57.

- The overall moisture content remained constant during the monitoring period, with some peaks and drops observed during summer 2019, indicating rainwater infiltration.

- The constant moisture content and matric suction at Instrumentation 2 and Instrumentation 3 are attributed to perched water conditions, similar to what was observed in I-Slope 5, which experienced a shallow slide in the as-built section.

- The movement in the as-built section of the slope is attributed to the formation of perched water at the top of the slope. However, it is important to note that the repaired section also experiences a similar perched water zone but does not exhibit movement due to the repairs implemented.

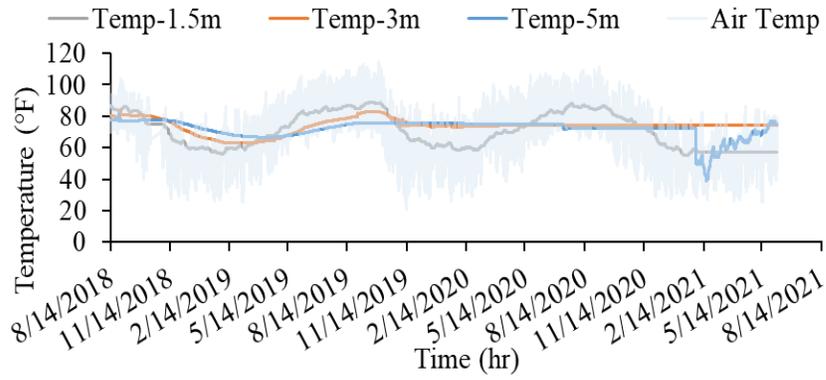
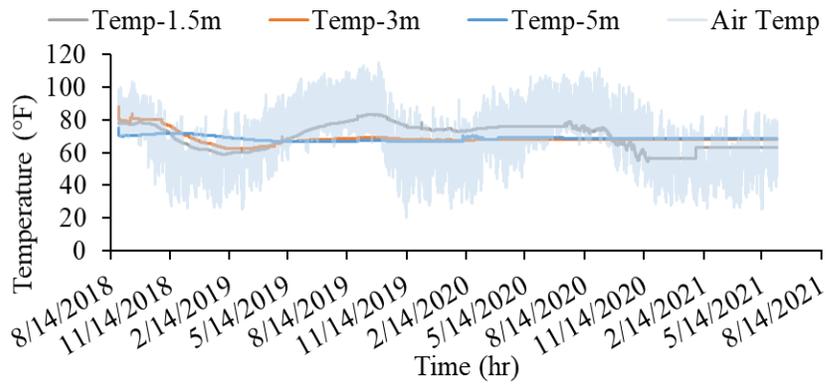
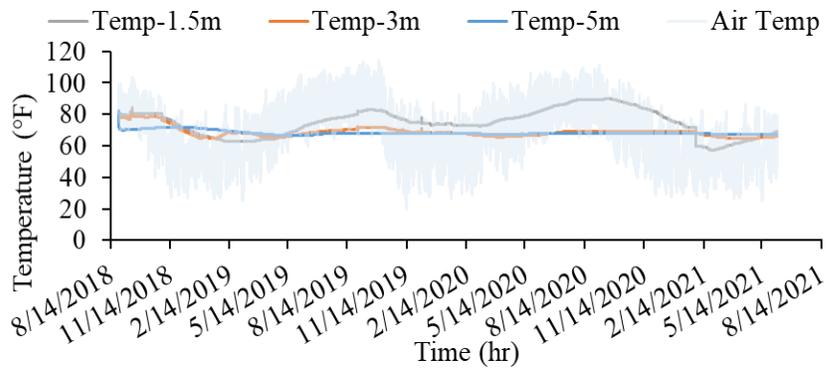
Figure 3.59 Variations of Air and Soil Temperature at I-Slope 6 (a) Instrumentation 1, (b) Instrumentation 2, and (c) Instrumentation 3

Figure 3.59 illustrates the soil and air temperature variations from Instrumentation 1 to Instrumentation 3 in I-Slope 6. The findings are as follows:

- Minor changes in soil temperature were observed at deeper depths, similar to the behavior observed in other slopes.
- At shallower depths, the soil temperature varied in response to changes in the air temperature.

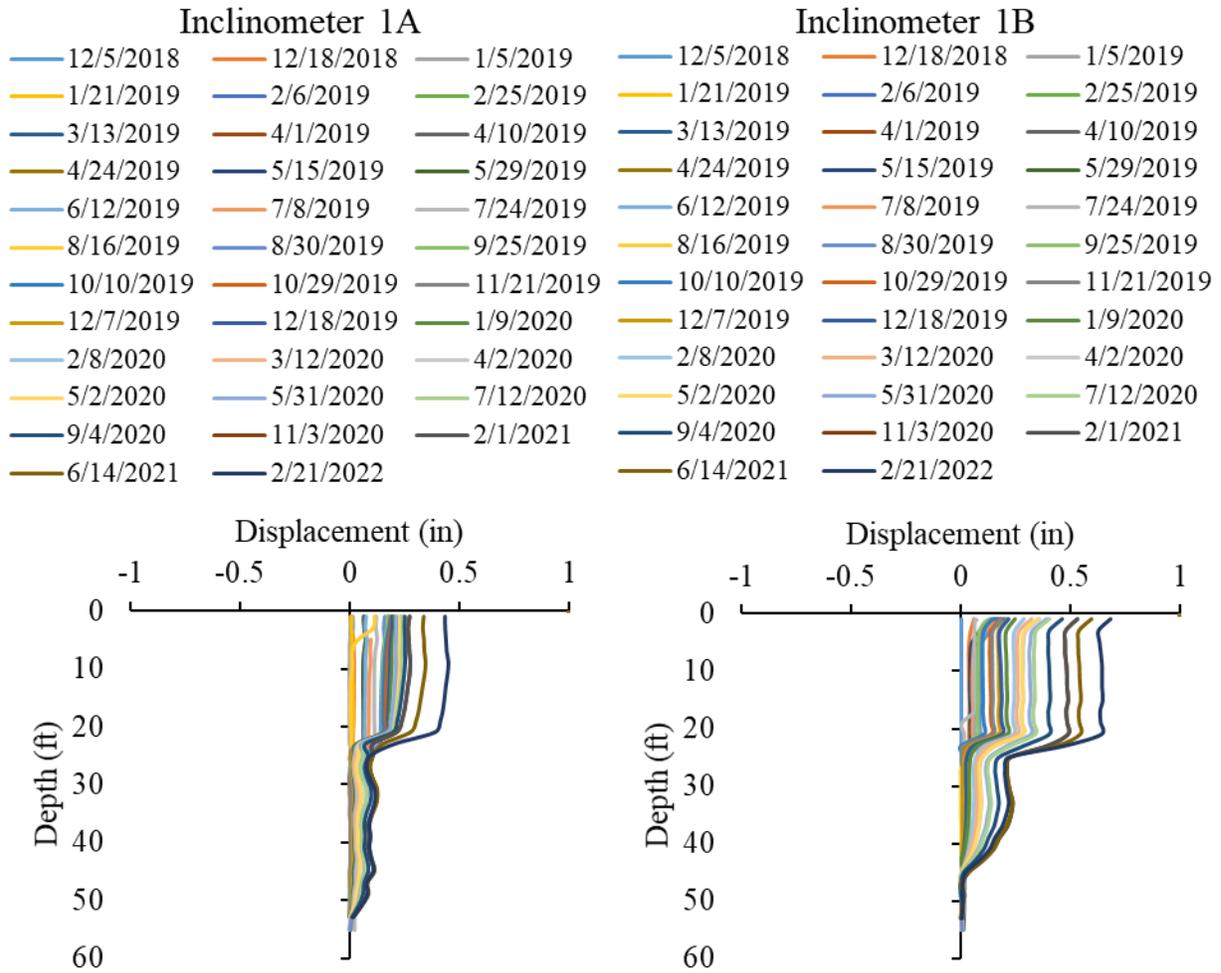
Figure 3.61 Displacement at I-Slope 7

I-Slope7 is located along the exit from I220 South toward I20 East; the location is shown in Figure 3.60. The slope was repaired using H-piles, and a slope inclinometer was installed to monitor movement in the repaired area. JSU's GeoDevelopment research team monitored the slope movement every two weeks, and the lateral overtime deformation variations are presented in Figures 3.61 and 3.62. The figures show no significant deformation or movement in the slope.

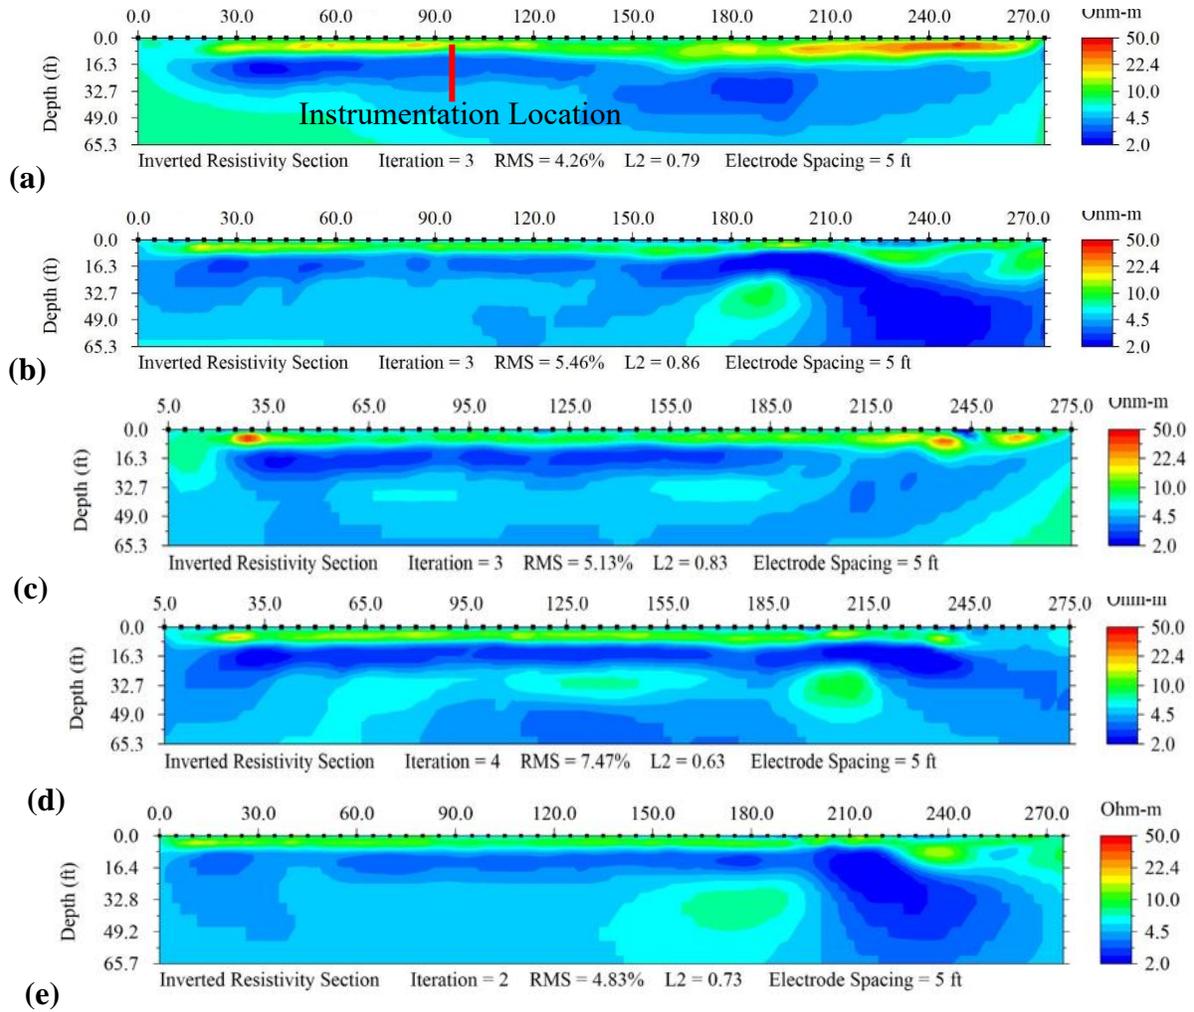
Figure 4.2 Slope 1 ERI Line A: (a) Spring 2021, (b) Summer 2021, (c) Fall 2021, (d) Winter 2021/Spring 2022, (e) Fall/Winter 2022

ERI was performed on Instrumented Slope 1, covering 270 ft. (82.3 m) along the width of the slope. Resistivity image profiles at the crest (Line A) and midway (Line B) of the slope were plotted. The location of the slope and the ERI test line are presented in Figure 4.1. Results for Line A, which was tested from spring 2021 through fall/winter 2022, are presented in Figure 4.2 (a – e). Resistivity was high (30-50 ohm-m) in the unsaturated zone (above 8 ft. or 2.5 m) but decreased to less than 5 Ohm-m near the saturated zone. At depths greater than 15 ft., wetter zones were present. (Wet zones move around and vary as seasons change.) The ERI results for Line B are presented in Figure 4.3 (a-e). Areas with higher resistivity along the shallower depths of the slope were characterized by loose soil occurring from slope movement. Deeper soils with lower resistivities were characterized by wetter zones due to perched water conditions.

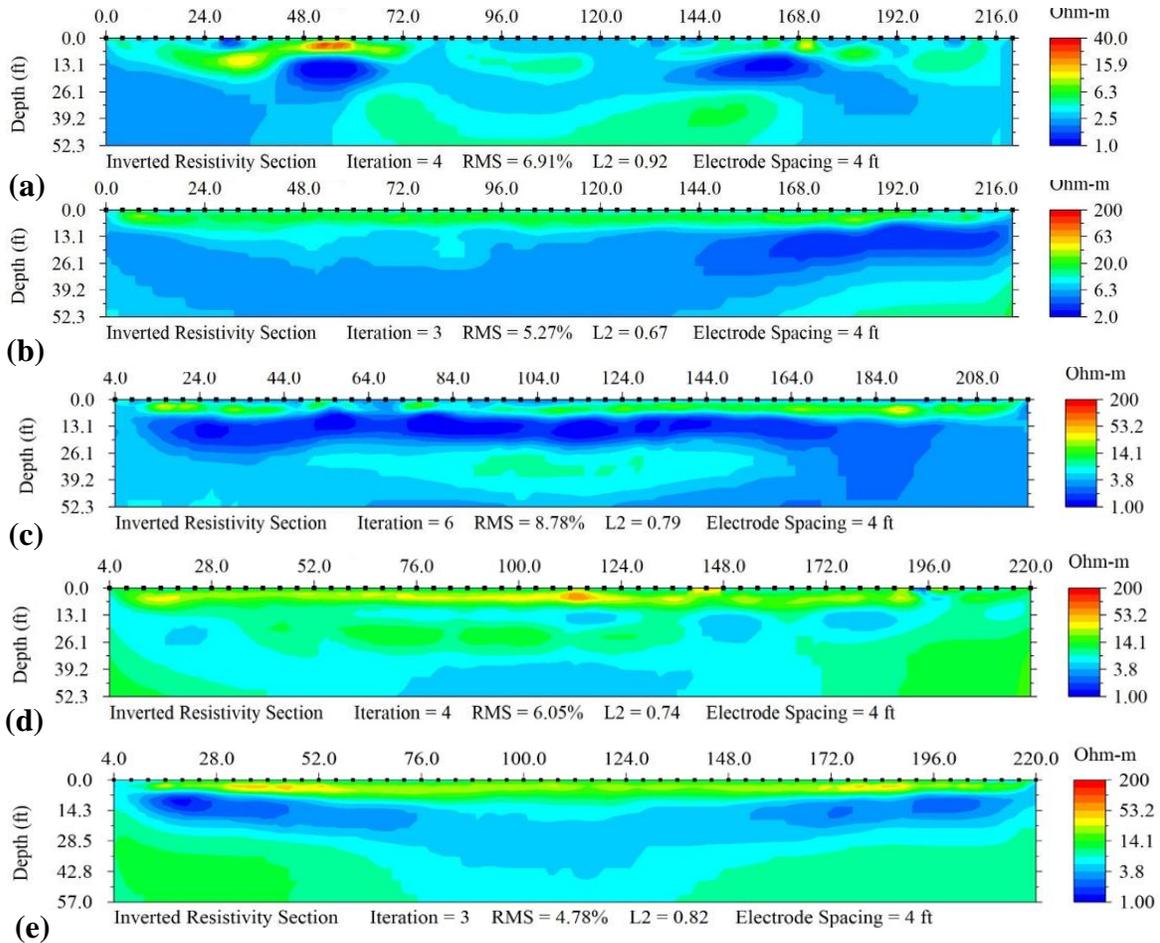
Figure 4.11 Slope 2 ERI Line B: (a) Spring 2021, (b) Summer 2021, (c) Fall 2021, (d) Winter 2021/Spring 2022, (e) Fall/Winter 2022

ERI results for Line B from testing conducted during different seasons are presented in Figure 4.11(a-e). The ERI images demonstrate that resistivity is greatest at shallow depths (more than 6 ft. [2m]) and decreases dramatically at lower depths in the saturated soil zone. There are perched water zones directly below the unsaturated soil zones.

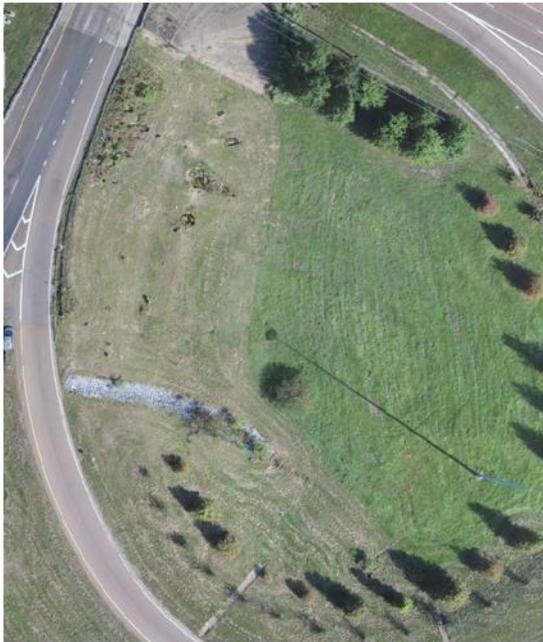
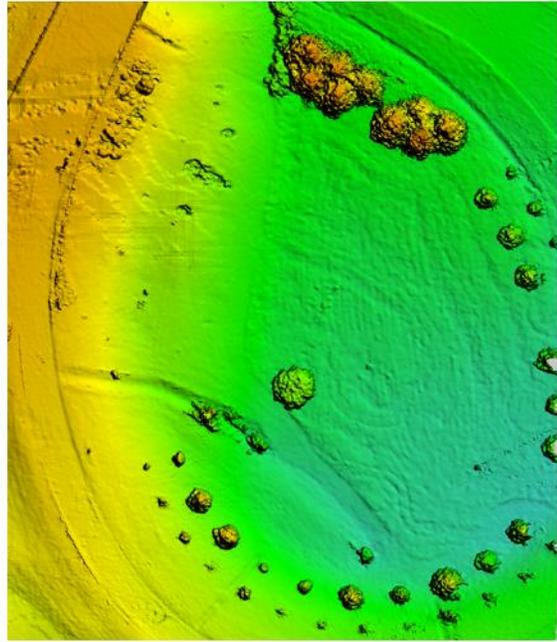
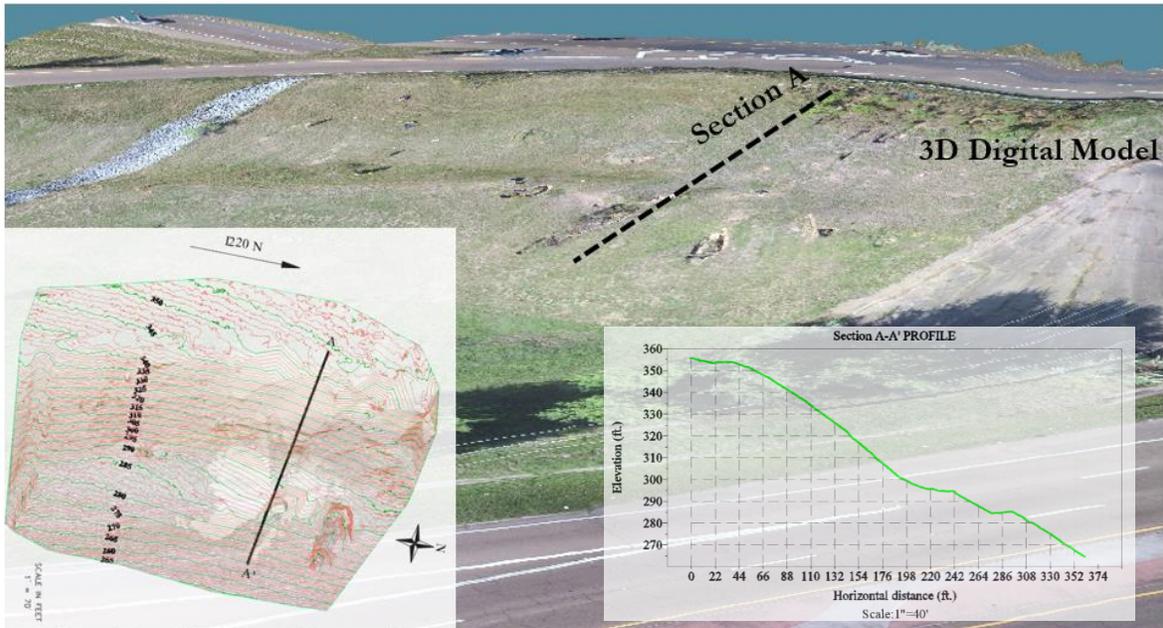
Figure 4.13 Drone Image of Slope 2 in Fall 2021: (a) DEM, (b) 3D Model and Surface Profile

Figure 4.13 (b) shows the 3D model, surface topography of the slope, and the surface profile views for fall 2021. The DEMs of different seasons make the changes experienced near the bridge abutment at the crest evident and show that the voids at the toe of the slope have grown larger over time.

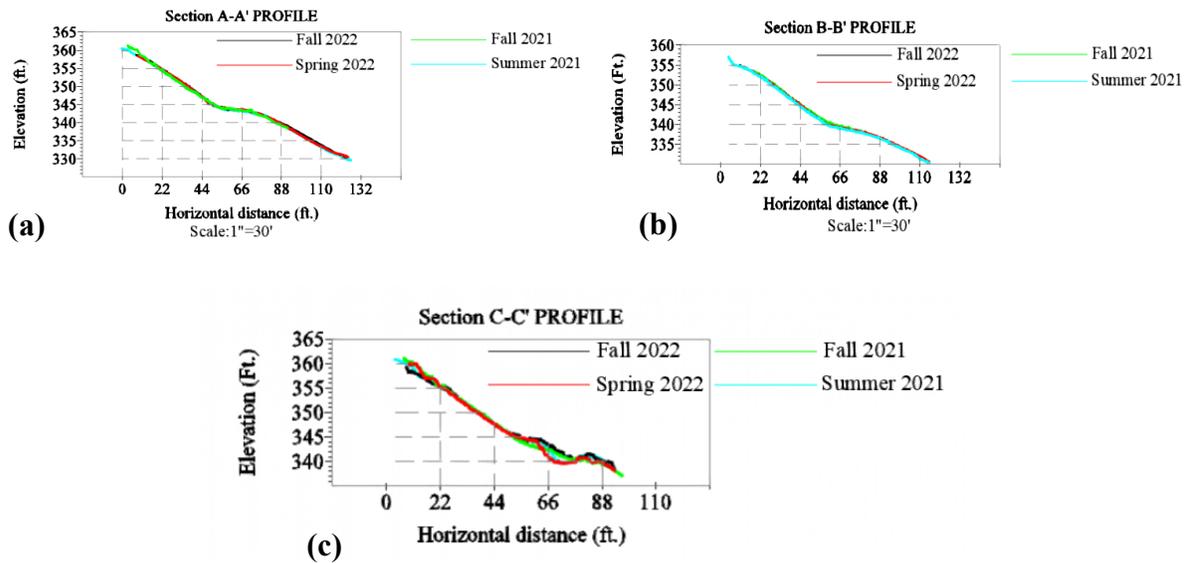
Figure 4.16 Seasonal Variations in Slope 2's LiDAR Point Cloud Surface Profiles: (a) Section A-A', (b) Section B-B', (c) Section C-C'

Surfaces from all of the seasons were overlaid, and alignments were created along the slope. Stacked surface profiles were created, using the alignments along Sections A-A,' B-B' & C-C'. Surface profile variations during the different seasons along the three sections are presented in Figure 4.16 (a, b, and c). Section C-C' in Figure 4.16 (c) reveal that there are considerable seasonal variations at the crest of the slope and at the void (sinkhole), located between elevations of 340 and 345 ft.

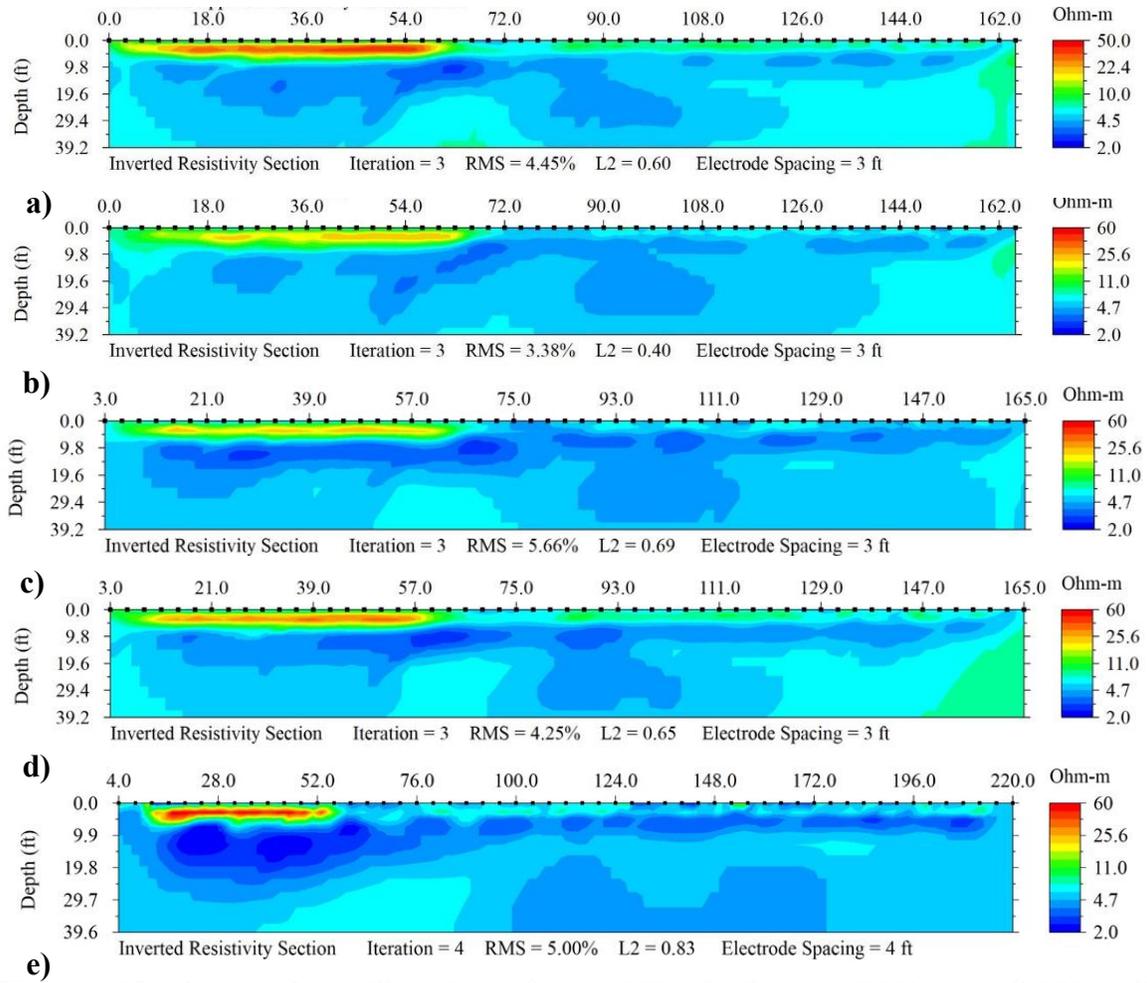
Figure 4.19 ERI Line B of I-Slope 3: (a) Spring 2021, (b) Summer 2021, (c) Fall 2021, (d) Winter 2021/Spring 2022, (e) Fall/Winter 2022

Figure 4.19 (a-e) depicts the ERI results for Line B from testing performed during different seasons and shows the presence of a high resistivity zone, indicating soil movement, at shallow depths (between 5 ft. [1.5m] and 54 ft. [16.5m], and up to a depth of 6 ft. (2m). Resistivity is extremely low (less than 5 Ohm-m) beyond 6 ft. at the crest and middle of the slope (Line A and Line B), just below the unsaturated soil zone at the 54 ft. (16.5m) horizontal distance mark. These low resistivity zones could be attributed to the development of perched water zones.

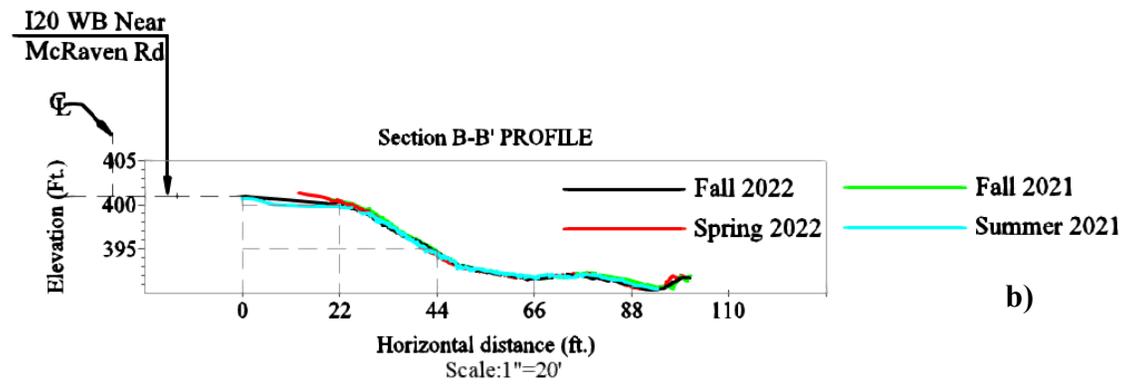
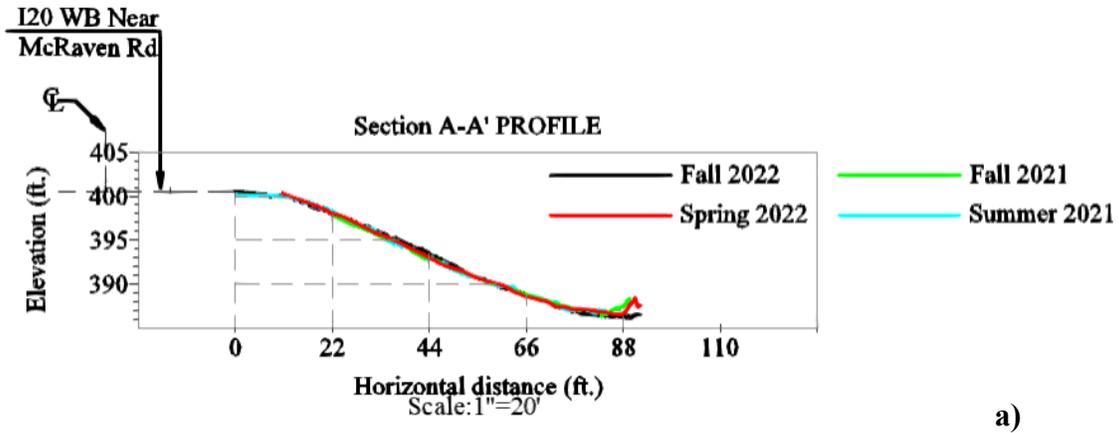
Figure 4.49 LiDAR Point Cloud Surface Profiles of Seasonal Variations in Slope 6: (a) Section A-A', (b) Section B-B'

Surfaces from all seasons were overlaid, and alignments were created along the slope. Stacked surface profiles were then created using the alignments along Sections A-A' and B-B' and presented in Figure 4.49 (a) & (b). Minor elevation changes were observed on the slope surface, with more pronounced ones appearing at the toe of the slope along both profile sections. A comparison between the DEMs generated by drone images and LiDAR point cloud for I-slope 6 is presented in Figure 4.50. Although the drone DEM provides good results for the surface elevations, terrestrial LiDAR scanning provides substantially better results for the surface elevation variation and surrounding features, such as trees and signposts.

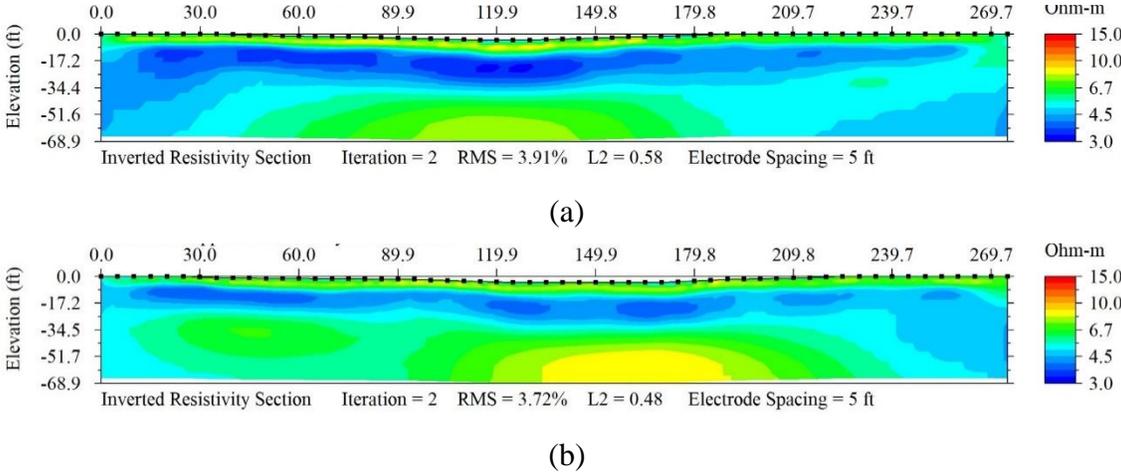
Figure 4.53 ERI Test Results of Failed Slope 2: (a) Line A and (b) Line B

An ERI test was performed for failed Slope 2, along two lines spanning 270 feet between the crest and the middle (Lines A and B). The test lines and slope location are presented in Figure 4.52. The results for Lines A & B presented in Figure 4.53 (a) & (b) for summer 2021 show that low resistivity areas exist below 8 ft. of depth, indicating wet soil along the whole span, likely caused by rainfall infiltration. The resistivity increases somewhat at 35 ft. (10.7 m), indicating that the soil is slightly less saturated at those depths.

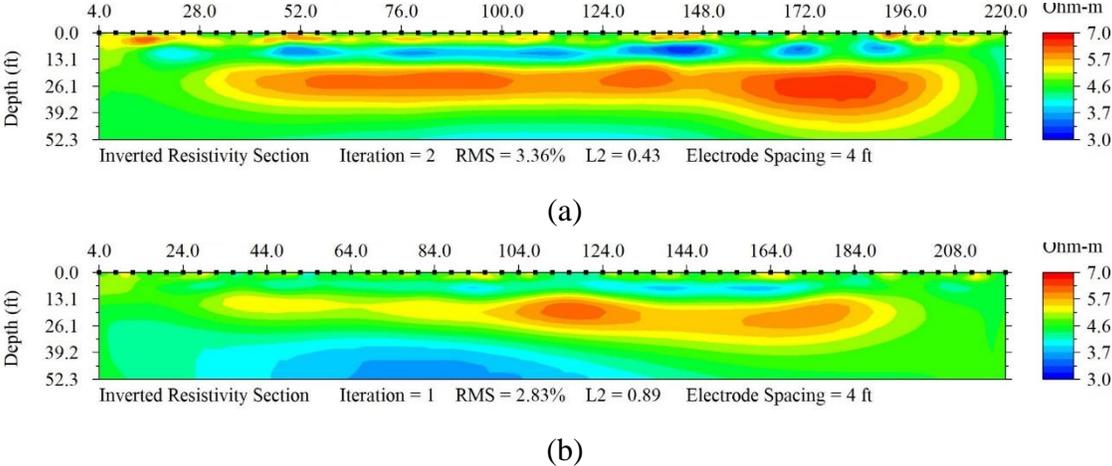
Figure 4.57 ERI Test Results of Failed Slope 3

An ERI test for failed Slope 3 was conducted along two lines spanning 220 feet at the crest and middle (Lines A and B). The test line and slope location are presented in Figure 4.56. The results of the test conducted in summer 2021 for Lines A & B are presented in Figure 4.57 (a) & (b). At Line A, the results indicated that soil deformation exists at the shallow levels, at

horizontal distances of 52 ft., 78 ft., 100 ft., and 148 ft. Just below the deformations, there are wet zones that are perched water zones formed most likely due to surface water infiltration through deformed soil. A similar phenomenon was also observed at the middle of the slope (Line B), where surficial deformations are followed by perched water zones, but to a lesser degree than those found in the crest of the slope.

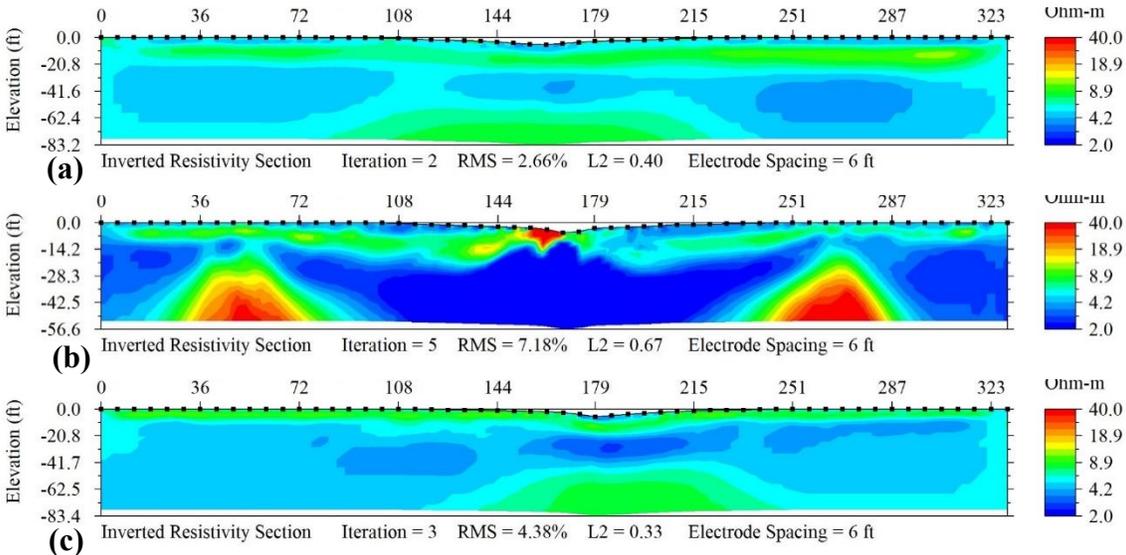
Figure 4.59 ERI Test Results of Failed Slope 4 -Slope along SR25 SB: (a) Line A, (b) Line B, (c) Line C

are presented in Figure 4.58, and the results are presented in Figure 4.59 (a) and (b). The highest level of wet soil below 15 ft. depth is in Line B. Between 144 and 179 ft. horizontal distance, the soil deformation is clear by the sag in the resistivity profile. At the middle line (4.58 (b)), the high resistivity at the surficial level at the 144' horizontal distance indicates soil deformation. Lines A and C also show high resistivity zones at the surficial level, followed by low resistivity zones at depths under 15 ft., indicating the presence of wet soil.

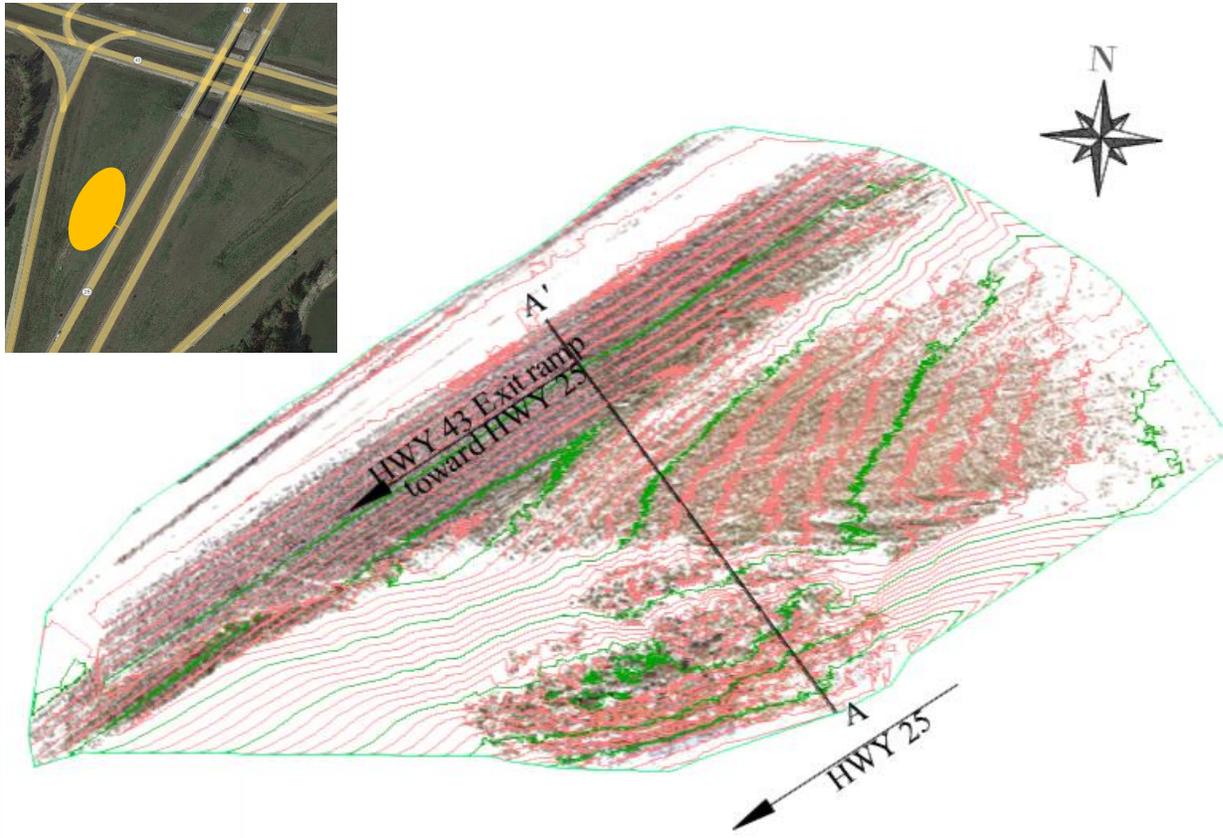
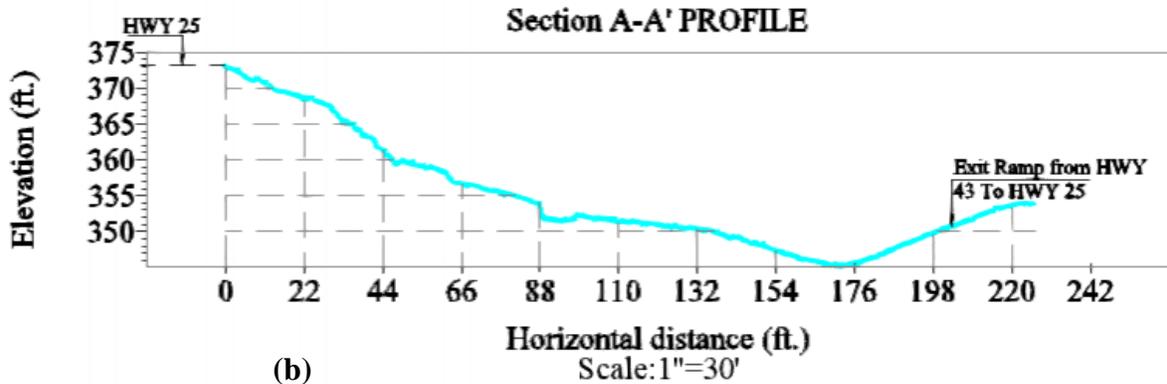
Figure 4.65 Slope 4 Slide Failure: (a) LiDAR Point Cloud Surface Topography, (b) Surface Profile

Terrestrial scanning was performed at three locations: along the slope of SR25 southbound and along the left and right bridge abutments of the SR25/43 interchange. The laser scanner was placed at four or five stations, and the overlapping point cloud data were collected. The point clouds were then post-processed on a computer and registered together to form a single point cloud. The combined point cloud was then georeferenced using field ground control points with known coordinates. Using a ground extraction algorithm, low surface points were extracted to create the bare ground point clouds. The bare ground point clouds for all seasons collected were imported into Civil 3D, and digital elevation model surfaces were generated using the kriging interpolation method. Topographic surface views were generated at 1 ft. major and 5 ft. minor contour intervals. The topographic and surface profile views of the SR25 slope slide failure are presented in Figure 4.65. The uneven slope surface along the failed area is clearly visible from the surface profile view in Figure 4.65 (b).

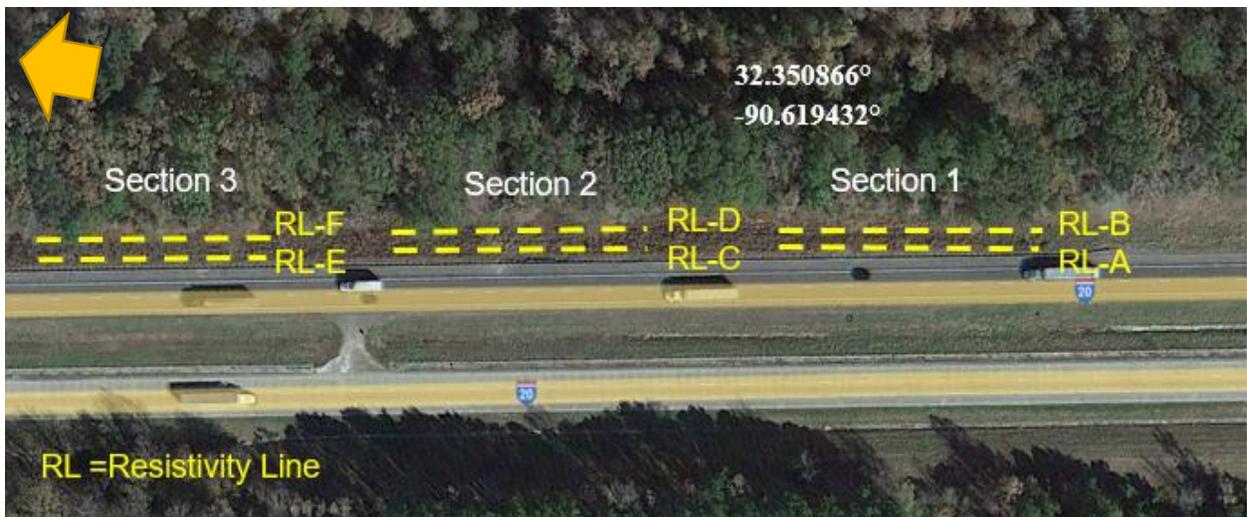
Figure 4.68 Location of ERI Test Lines in Failed Slope 5 (Big Black River)

ERI tests for failed Slope 5 were carried out in the summer of 2021 at the three locations identified in Figure 4.68 as Sections 1, 2 and 3. In Section 1, the ERI test was conducted along two test lines (Lines A & B) over a span of 323 ft., and the results are presented in Figure 4.69 (a) and (b). In Section 2, the ERI test was conducted along Lines C & D over a span of 270 ft., and the results are presented in Figure 4.70 (a) and- (b). In Section 3, the ERI test was conducted along Lines E and F, over a span of 108 ft., and the results are presented in Figure 4.71 (a) and (b). The results for Sections 1 and 2 show high resistivity zones along the whole test span up to 10 ft. depth. Wet soil zones are present below the deformed soil, up to 65 ft. depth. The higher resistivity shown by the ERI profiles for Section 3 is probably because the images were taken at a depth of 26 ft. and the wet zones are below that depth.

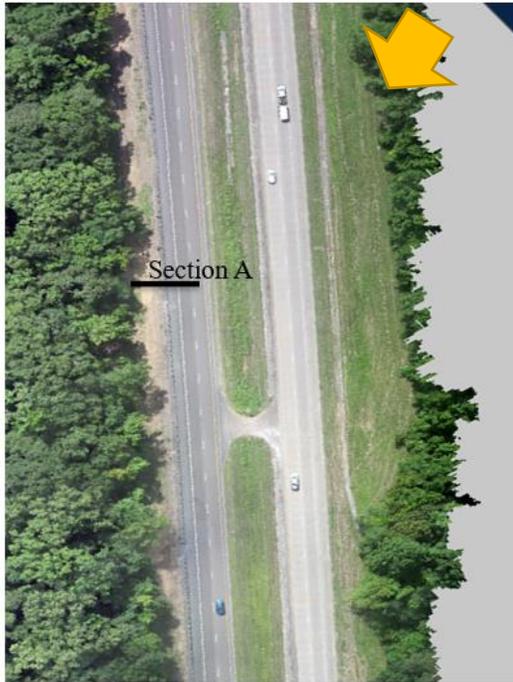
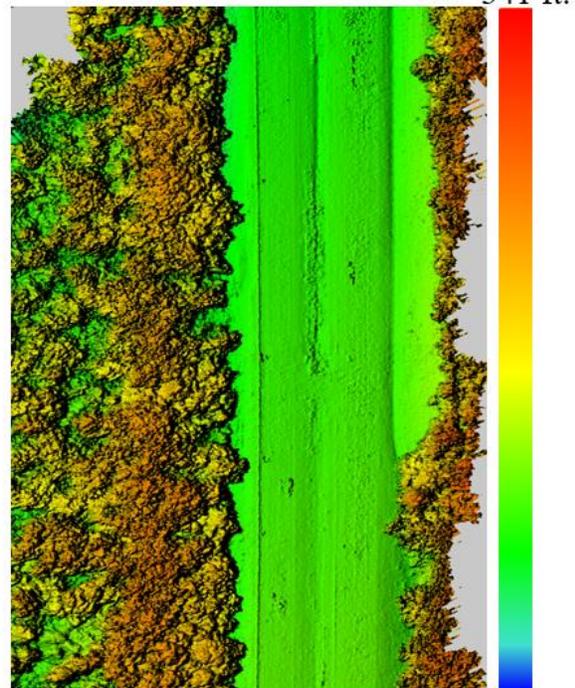
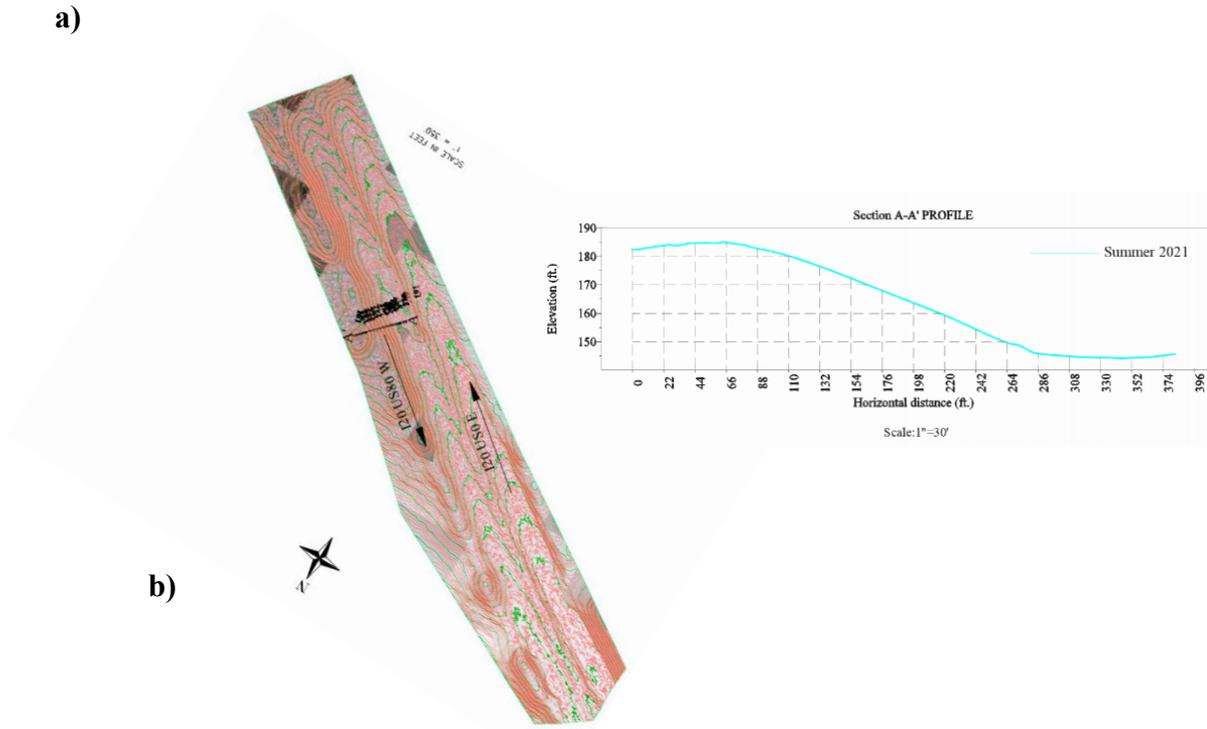
Figure 4.72 Drone Images of Failed Slope 5: (a) Digital Elevation Model, (b) Surface Topography and Profile (Summer 2021)

A drone survey mission was conducted for failed Slope 5 (Big Black River Slope) in the Summer of 2021 at three locations designated as Sections 1, 2 and 3 in Figure 4.6872. The aerial imagery captured by the drone was processed using specialized image processing software. Aerial triangulation was performed with multiple tie points to stitch the images together and develop a digital elevation model (DEM), digital terrain models (DTM), and mosaics. DEM was imported into Civil 3D, and the surface was created using the kriging interpolation method. Alignment along the slope was created, and a surface profile view was generated. Figure 4.72 (a) and (b) show the 3D model of the slope and the surface profile views.

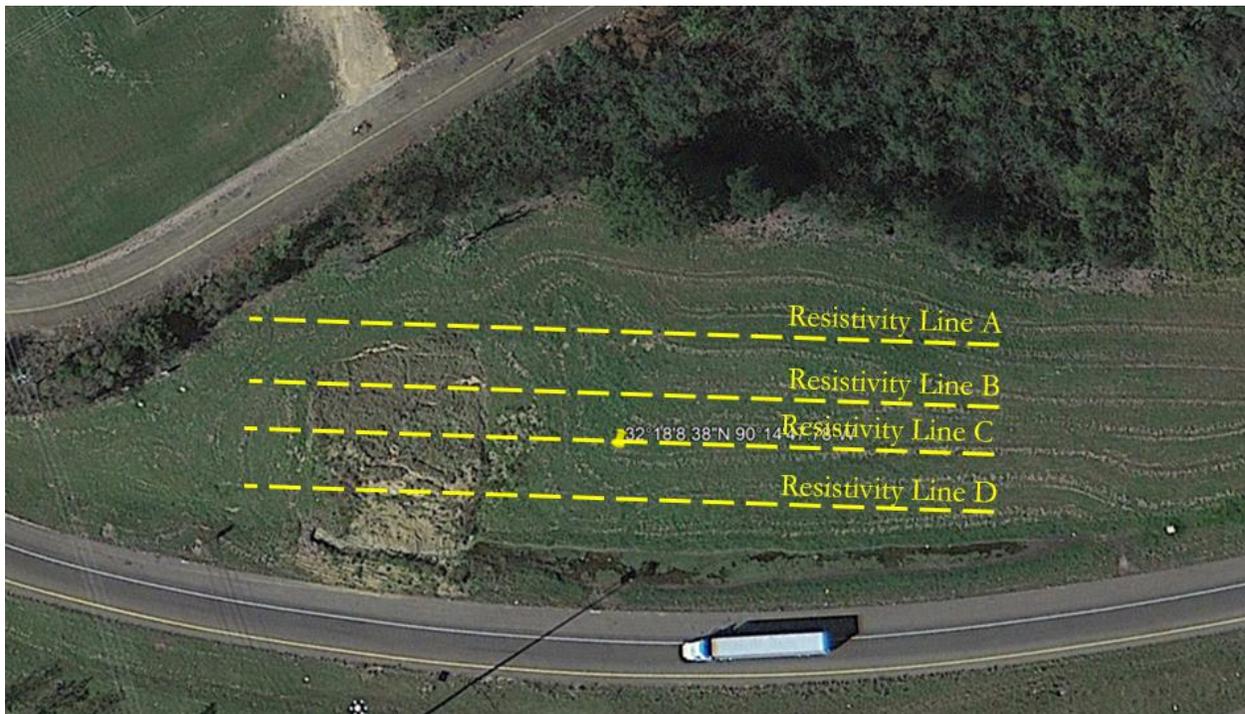
Figure 4.76 Location of Test Lines for Failed Slope 6

The ERI test for the Metrocenter test site was performed at lines A, B, C, and D, spanning 270 feet between the crest and the toe of Slope 6 after it failed in the fall of 2021. The location of the slope and the test lines are presented in Figure 4.76. ERI results for all four lines are presented in Figure 4.77 (a -d). High resistivity is probably the cause of the surface deformation that exists at Lines A, B and C between the 10 ft. and 70 ft. horizontal distances. At lower depths, lower resistivity indicates that the soil is wet, probably because of rainfall infiltration. ERI test results indicate surface deformation at the surficial level between the 10' – 70' horizontal distances.
