MDOT State Study 316 – Development of Advanced Landslide Investigation Protocol Using Geophysical Methods for Mississippi

FINAL REPORT

June 30, 2023

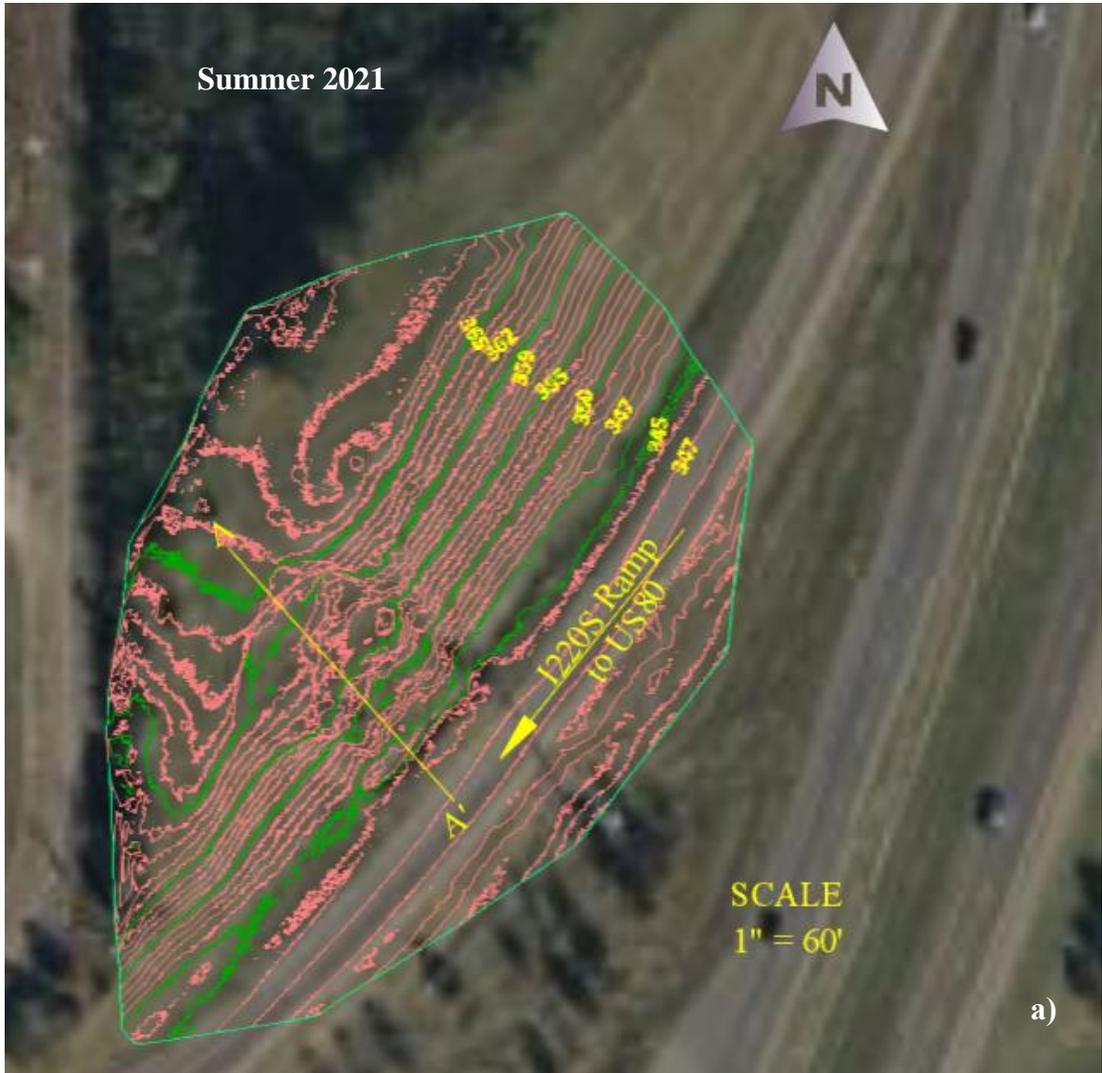
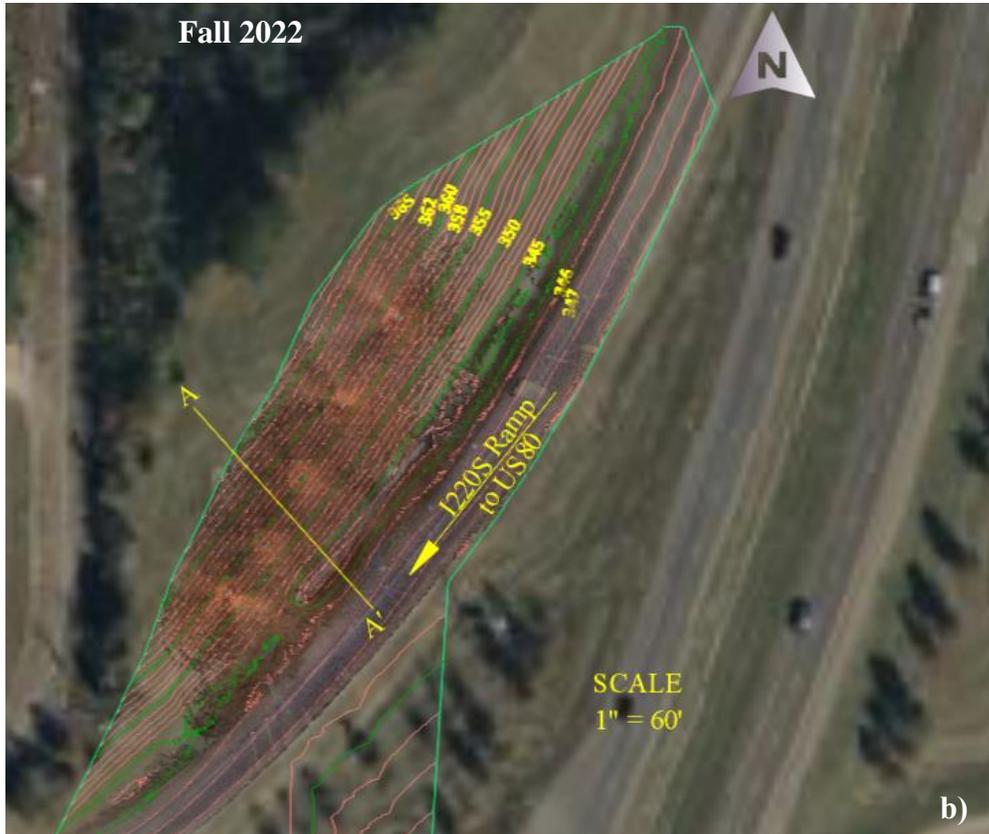
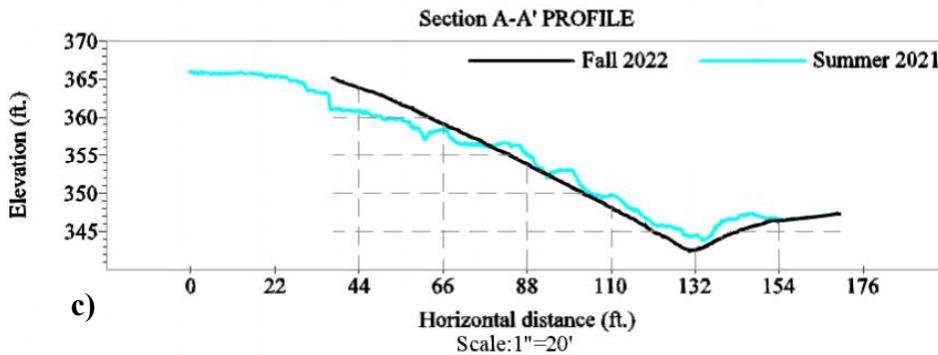
Figure 4.80 LiDAR Point Cloud Surface Topography of Failed Slope 6: (a) Summer 2021, (b) Fall 2021, (c) Overlaid Surface Profile

Terrestrial LiDAR scanning data was collected in the summer of 2021 after the slope failed and then again in the fall of 2022 after it was stabilized. Laser scanning was performed at several stations, and the overlapping point cloud data were collected, processed, and registered together to form a single point cloud. The combined point cloud was then georeferenced using field ground control points with known coordinates. Using a ground extraction algorithm, low surface points were extracted to create the bare ground point clouds. The bare ground point clouds for all seasons collected were imported into Civil 3D, and digital elevation model surfaces were generated using the kriging interpolation method. Topographic surface views were then generated at 1 ft. major and 5 ft. minor contour intervals for summer 2021 and fall 2022 and are presented in Figure 4.80 (a) and (b), respectively.

The surfaces from the two seasons were overlaid, and alignments were created along the slope. Stacked surface profiles were created using the alignments along Sections A-A' and are presented in Figure 4.80 (c). The rugged slope profile of summer 2021 is indicative of the terrain after the failure of the slope, which is unlike the smooth profile captured in fall 2022.

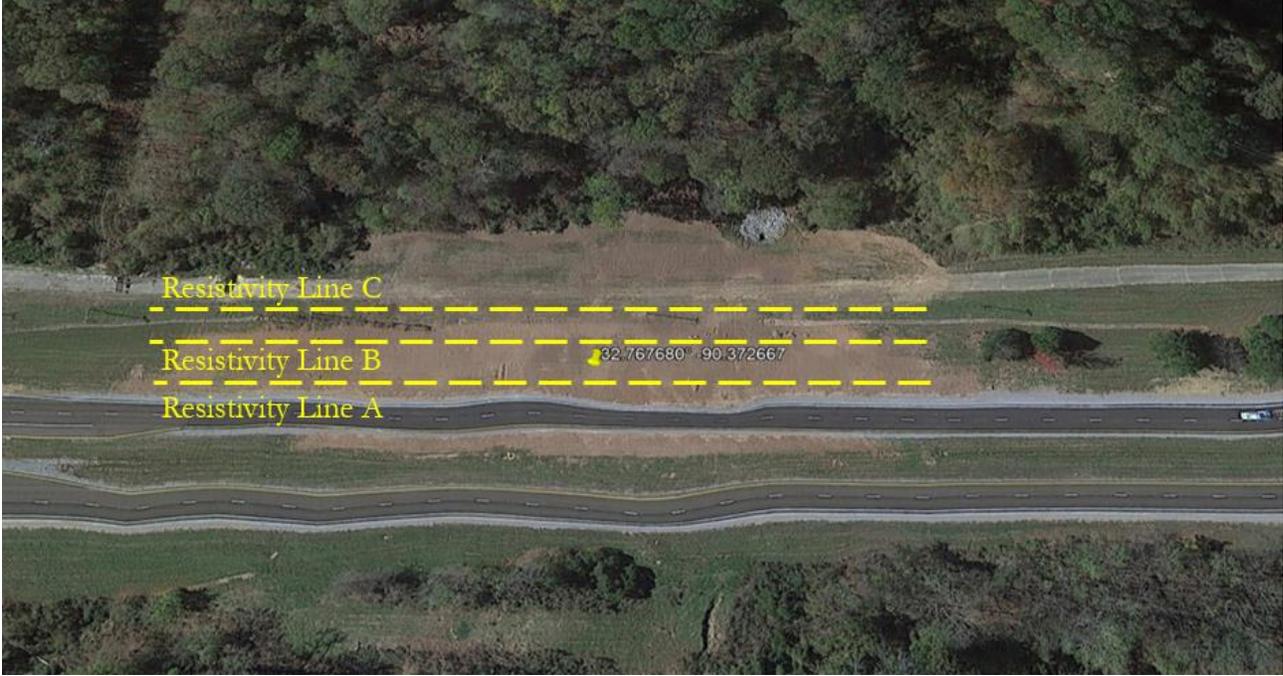
Figure 4.81 Location of ERT Test Lines for Failed Slope 7

The ERI test for failed Slope 7 was conducted along three lines: Lines A & B, which spanned 270 feet at the crest and middle, and Line C, which spanned approximately 82 ft. at the toe of the slope. The location of the slope and test lines are presented in Figure 4.81. The ERI results for Lines A & B for summer 2021 are presented in Figure 4.82 (a), (b) and (c). The ERI results indicated that from the surface of the crest up to a depth of 15 ft., there are high resistivity layers that indicate loose soil with air voids. Low resistivity areas exist below the loose soil,

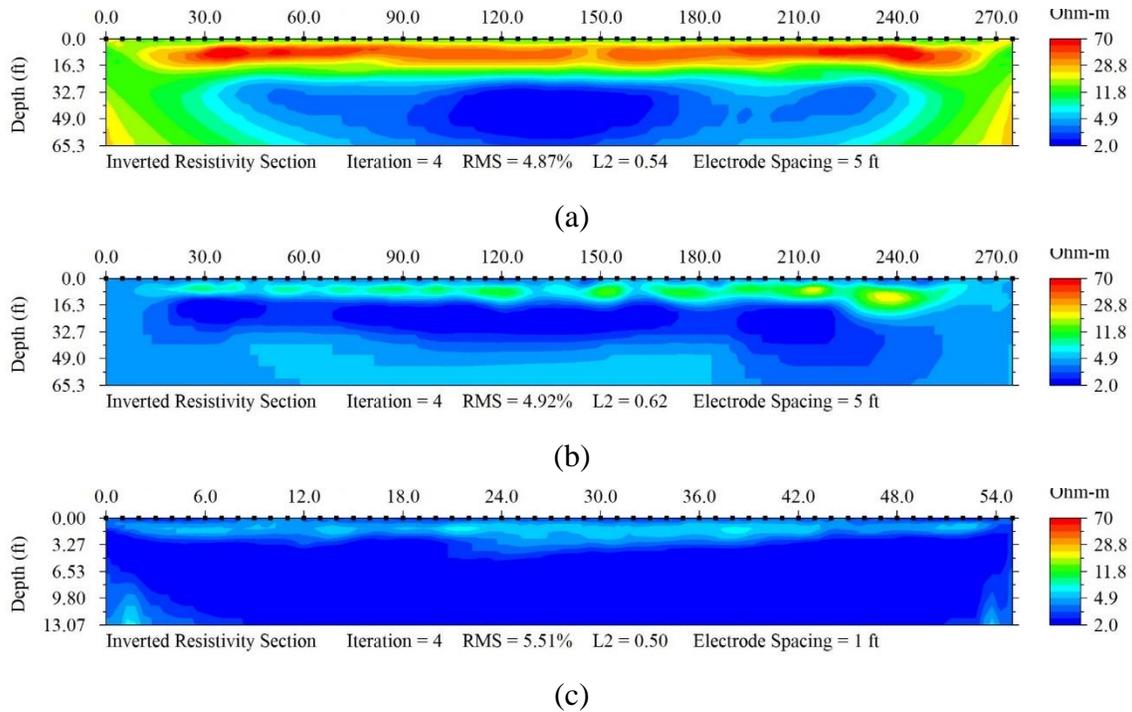
Figure 4.82 ERI Test Results of Failed Slope 7: (a) Line A, (b) Line B, (c) Line C

indicating wet soil along the entire span, likely caused by rainfall infiltration. Line B in the middle of the slope has lower resistivity than the crest. The soil at Line C is wetter from the surficial levels to the surveyed depth of 13 ft.

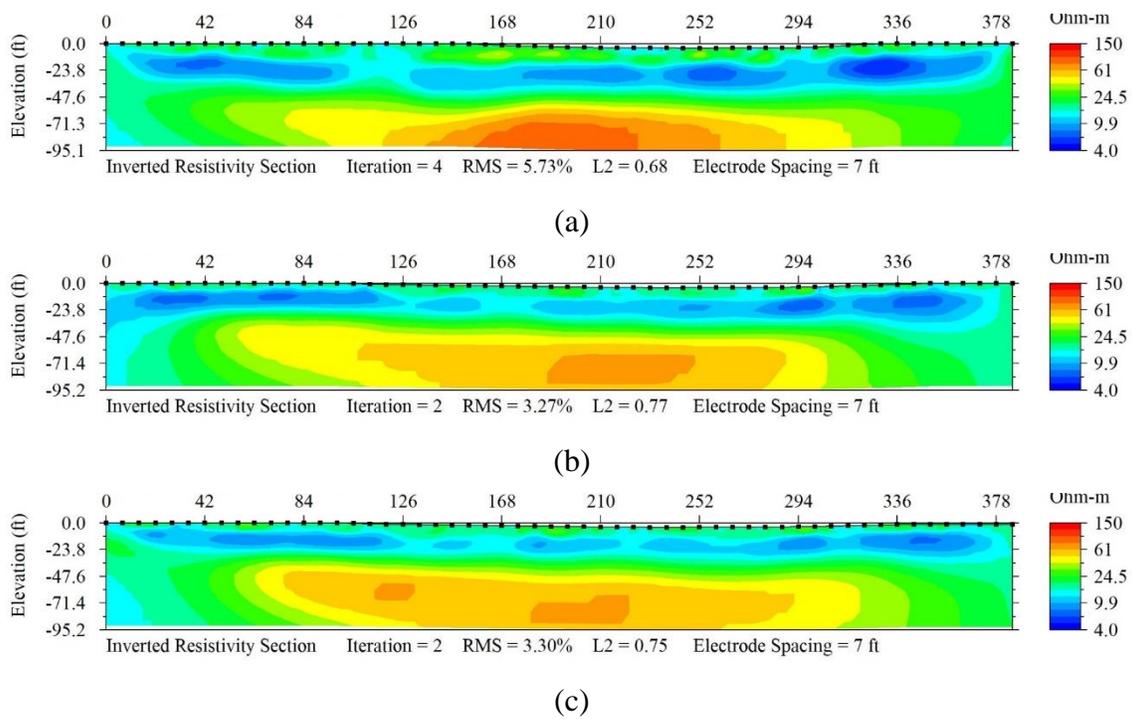
Figure 4.85 Results of ERI Test Results for Failed Slope 8: (a) Line A, (b) Line B, (c) Line C

ERI tests were performed along three lines, Lines A, B & C, for failed Slope 8, all spanning 378 feet. The location of the slope and the test lines are presented in Figure 4.84. The results for Lines A, B & C are presented in Figure 4.865 (a), (b) and (c). The results showed the presence of high resistivity layers, indicating loose soil with air voids, from the surface of the crest (Line A) down to 6 ft. and also below 47 ft. Low resistivity areas are below the loose soil, indicating wet soil along the entire span, likely caused by rainfall infiltration.

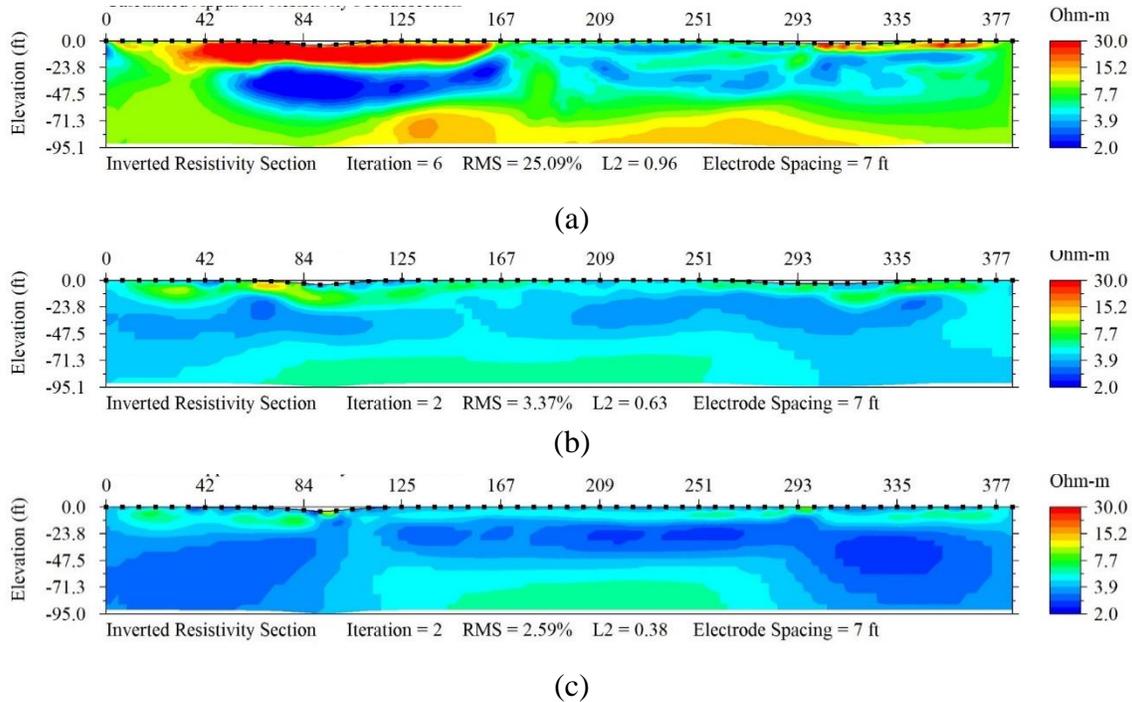
Figure 4.87 ERI Test Results for Failed Slope 9 -Dogwood Slope: (a) Line A, (b) Line B, (c) Line C

ERI tests were performed along three lines, A, B & C, of failed Slope 9, each spanning 378 feet. The locations of the slope and ERI test lines are presented in Figure 4.86. ERI results for Lines A, B & C are presented in Figure 4.87 (a), (b) and (c). The results showed that high resistivity layers exist up to a depth of 20 ft. at the crest line (Line A), between a horizontal distance of 40 and 65 ft., indicating deformed soil. Low resistivity areas are directly below the loose soil, indicating perched water conditions from rainfall infiltration. Lines B & C, shown in Figure 4.87 (b) and (c) indicate a similar pattern but to a lesser degree than that in Line A.

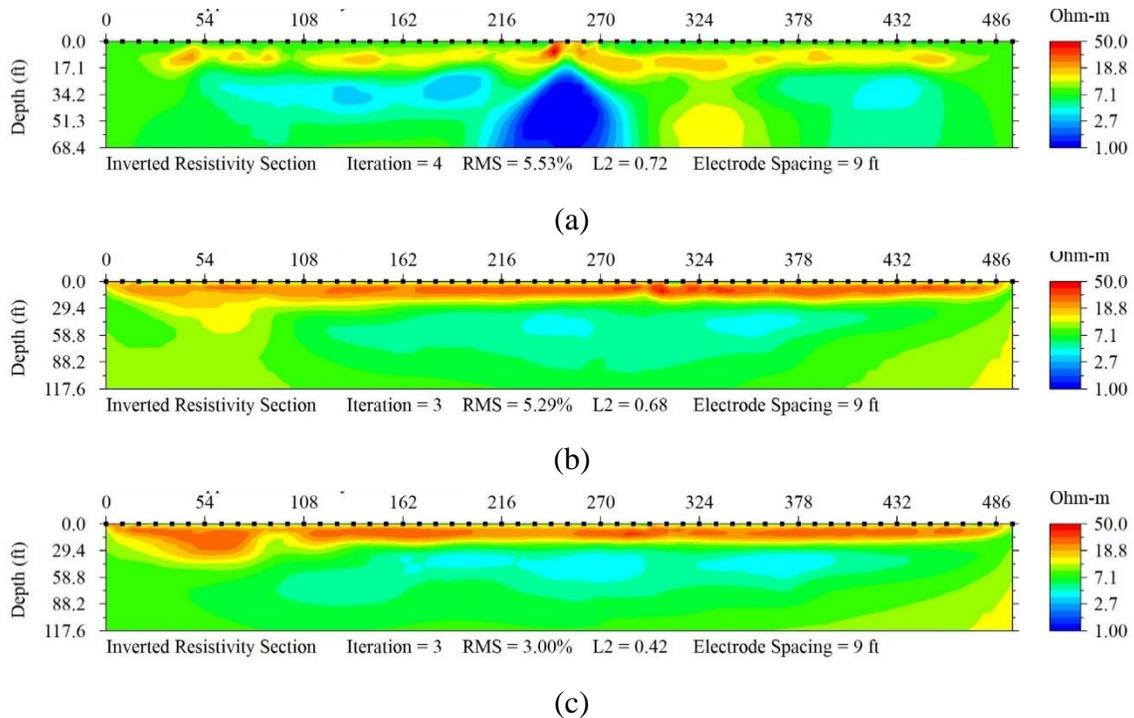
Figure 4.91 ERI Test Results for Failed Slope 10: (a) Line A, (b) Line B, (c) Line C

ERI tests were conducted for failed Slope 10 along three lines, A, B & C, each spanning 486 feet, with electrodes spaced at intervals of 9 ft. The location of the slope and the test lines are presented in Figure 4.90. The results for Lines A, B & C are presented in Figure 4.91 (a), (b) and (c). The results revealed high resistivity layers at all three lines up to approximately 25 ft. depth, indicating deformed soil. Low resistivity areas exist directly below the loose soil, indicating perched water conditions caused by rainfall infiltration.

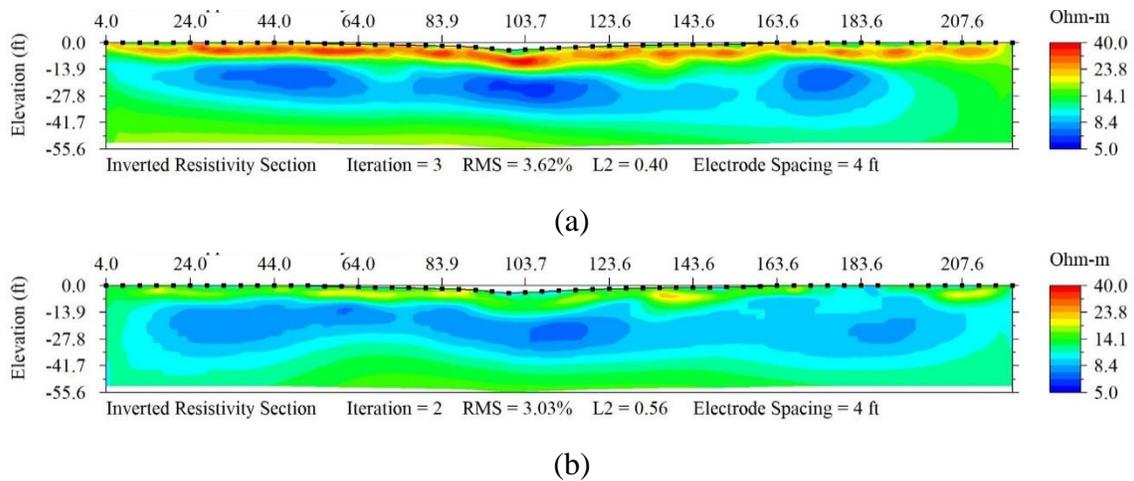
Figure 4.95 ERI Results of Failed Slope 12: (a) Line A (b) Line B

ERI tests for failed Slope 12 were performed along the A and B lines that span approximately 220 ft. and are equipped with electrodes spaced at 5 ft. intervals. The location of the slope and test lines are presented in Figure 4.94. The ERI results for Lines A & B are presented in Figure 4.95 (a) & (b) and show that high resistivity layers are present up to approximately 8 ft. depth, indicating deformed soil. Low resistivity areas exist directly below the loose soil, indicating perched water conditions from rainfall infiltration.

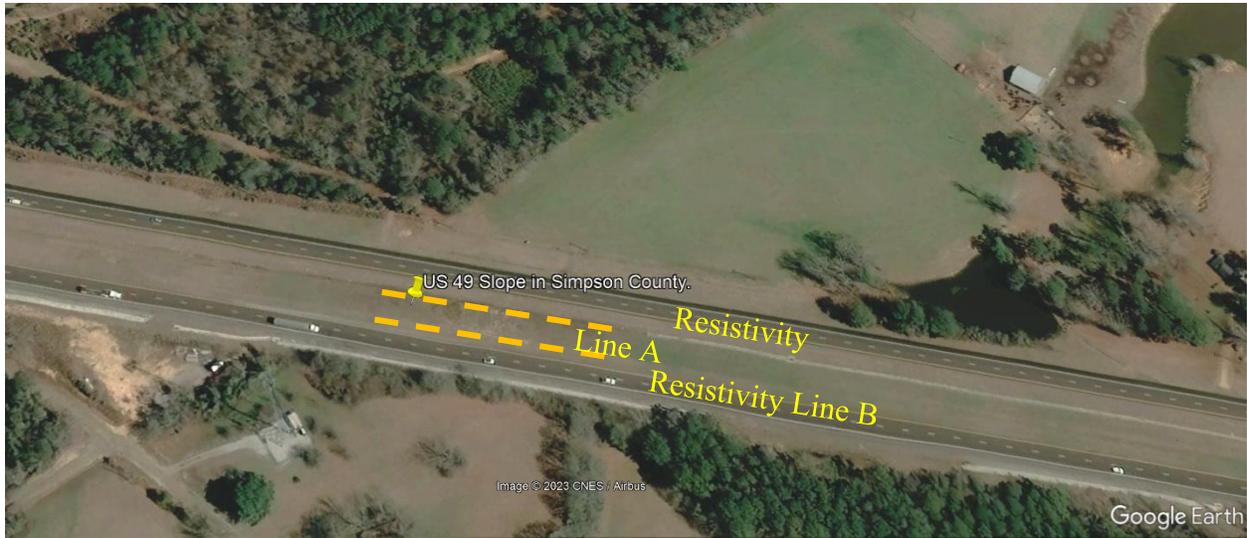
Figure 4.98 Location of ERI Test Lines in Failed Slope 14

ERI tests were conducted for failed Slope 14 across two lines, A & B, spanning 320 ft. and equipped with electrodes spaced at 5 ft. intervals. The location of the slope and test lines are presented in Figure 4.98. The ERI results are presented in Figure 4.99 (a) and (b).

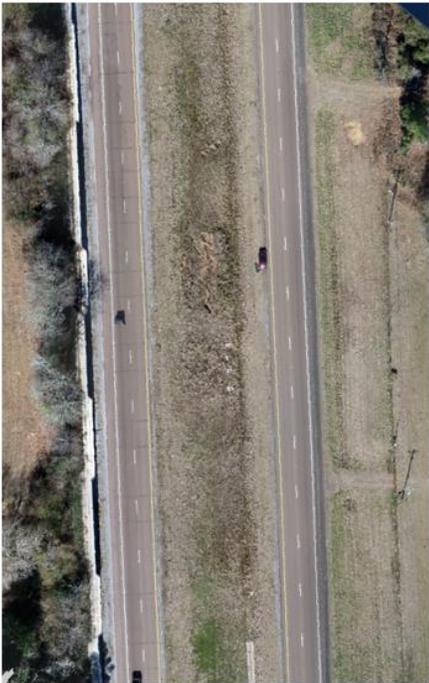
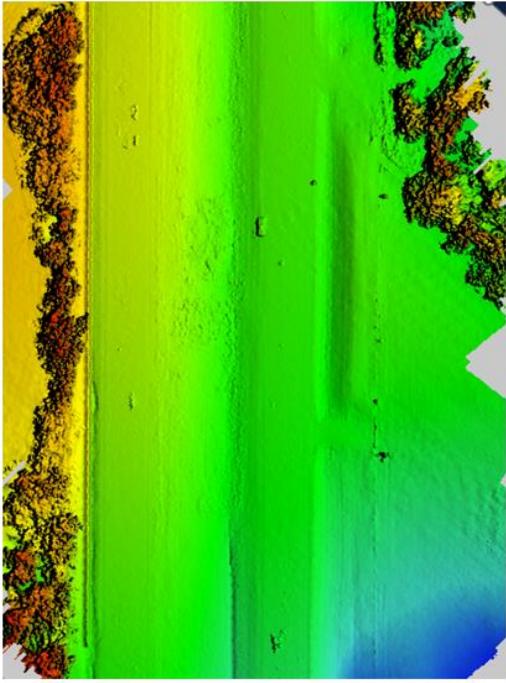
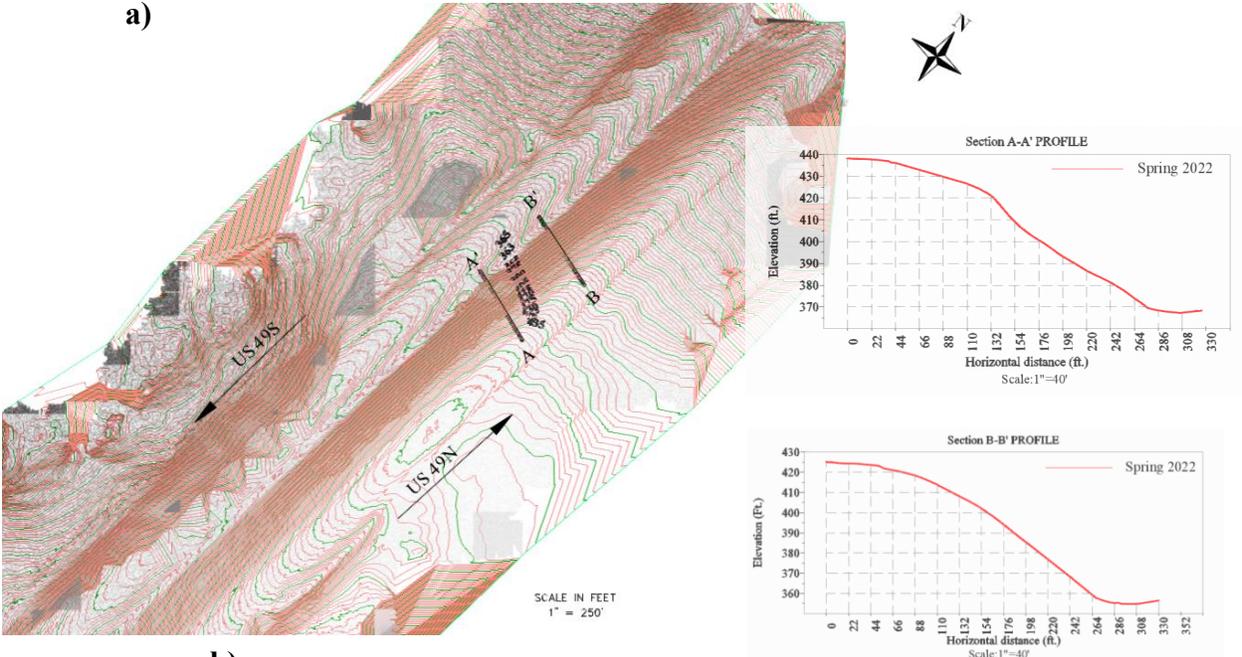
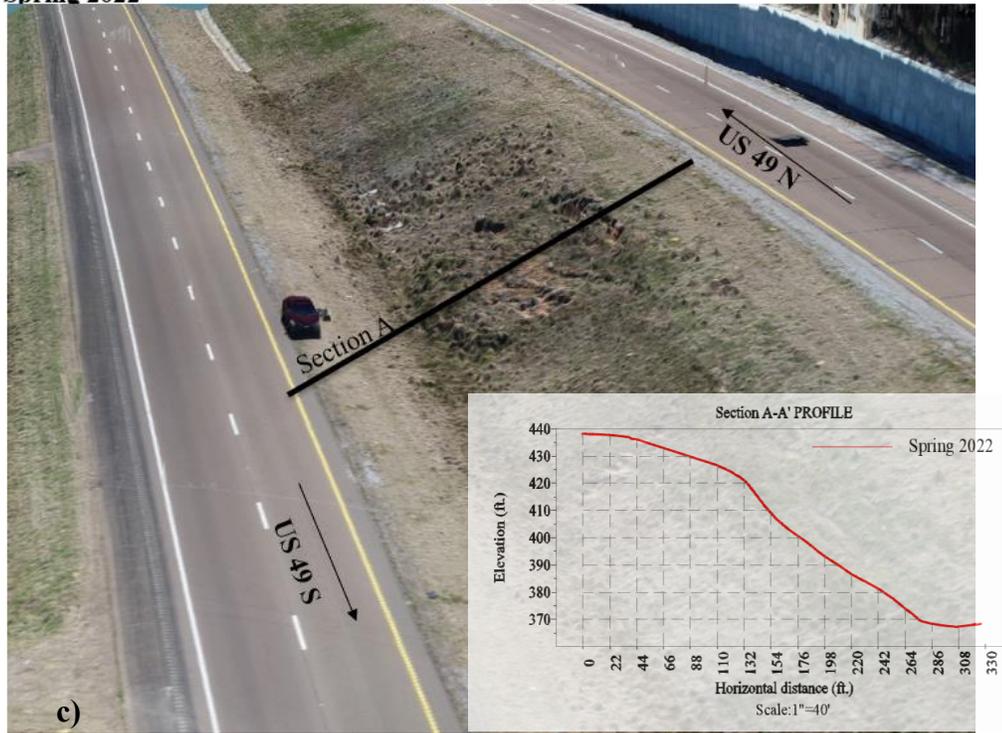
Figure 4.100 Drone Images of Failed Slope 14: (a) Digital Elevation Model, (b) Surface Topography & Profiles, (c) 3D Model & Surface Profile (Spring 2022)

Drone survey missions were conducted over failed Slope 14 in spring 2022 and fall 2022, and the aerial imagery captured was processed using specialized image processing software. Aerial triangulation was performed with multiple tie points to stitch the images together and develop digital elevation model (DEMs), digital terrain models (DTMs), and mosaics. The DEM and orthomosaic digital image representations are presented in Figure 4.100 (a) & Figure 4.101 (a).

The DEMs were imported into Civil 3D, and surfaces were created using the kriging interpolation method. Alignments along the slope were created, and surface profile views were generated along the slope. The topographic contour views and surface profile views for spring 2022 and fall 2022 are presented in Figure 4.100 (b) & Figure 4.101 (b) respectively. The 3D

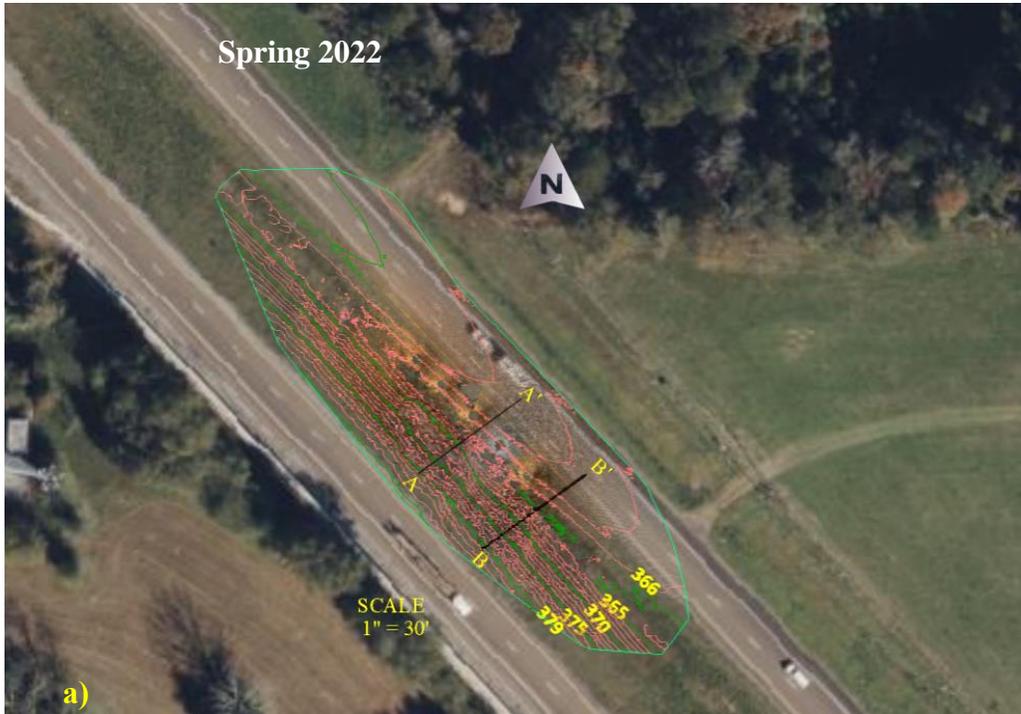
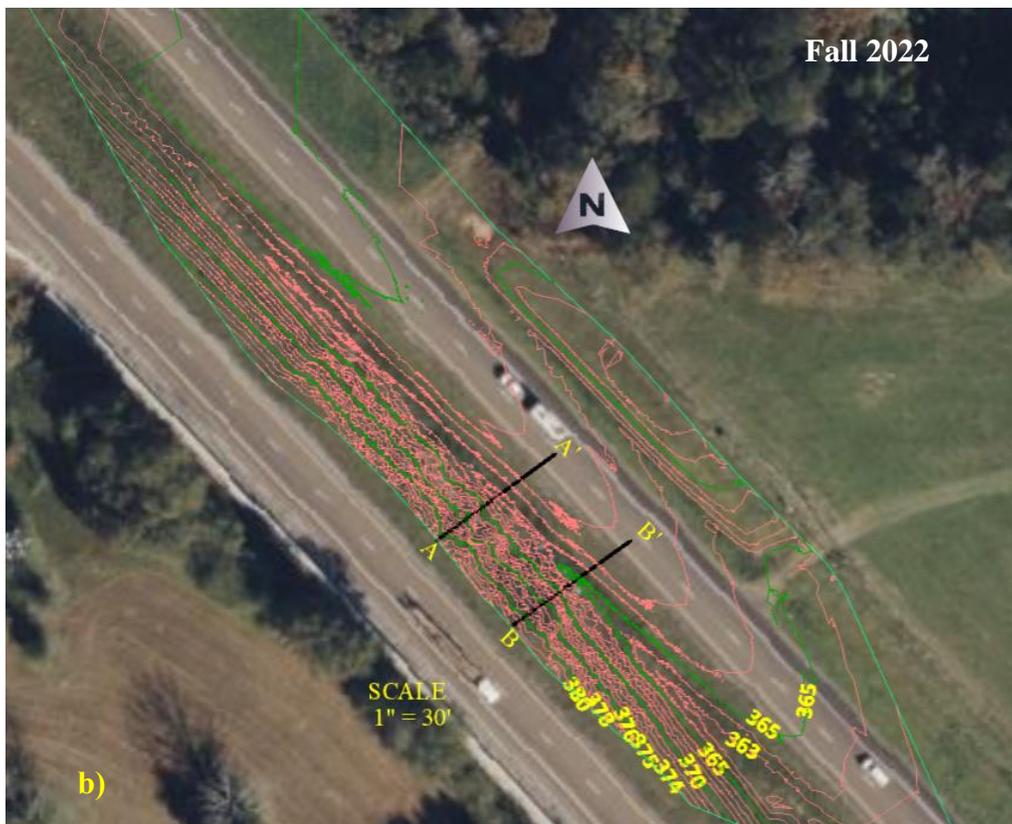
Figure 4.102 LiDAR Point Cloud Surface Topography for Failed Slope 14: (a) Fall 2021, (b) Fall 2022

4.2.13.3 *LiDAR:*

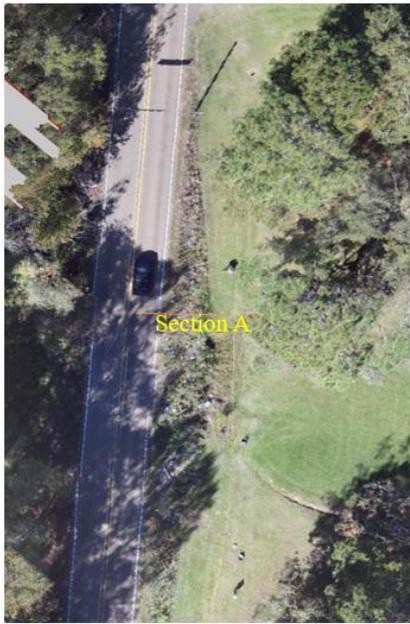
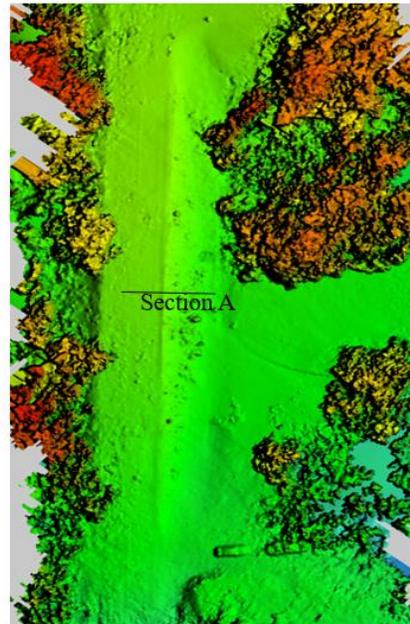
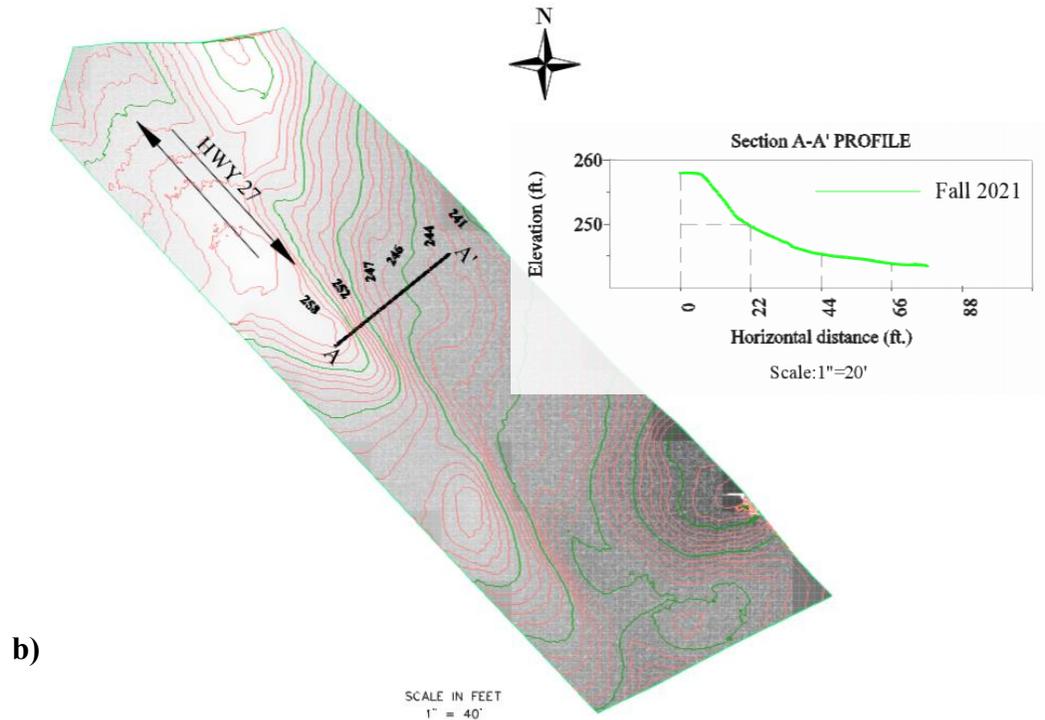
Figure 4.104 Drone Images of Failed Slope 15: (a) Digital Elevation Model (b) Surface Topography and Profile (Fall 2021)

A drone survey mission was conducted over failed Slope 15 in the fall of 2021, and the captured aerial imagery was processed using specialized image processing software. Aerial triangulation was performed with multiple tie points to stitch the images together and develop a digital elevation model (DEM), digital terrain models (DTMs), and mosaics. The DEM and orthomosaic digital image representations are presented in Figure 4.104 (a). The DEM was imported into Civil 3D, and the surface was created using the kriging interpolation method. Alignment along the slope was created, and a surface profile view was generated along Section A. The topographic contour and surface profile for fall 2021 are presented in Figure 4.104 (b).

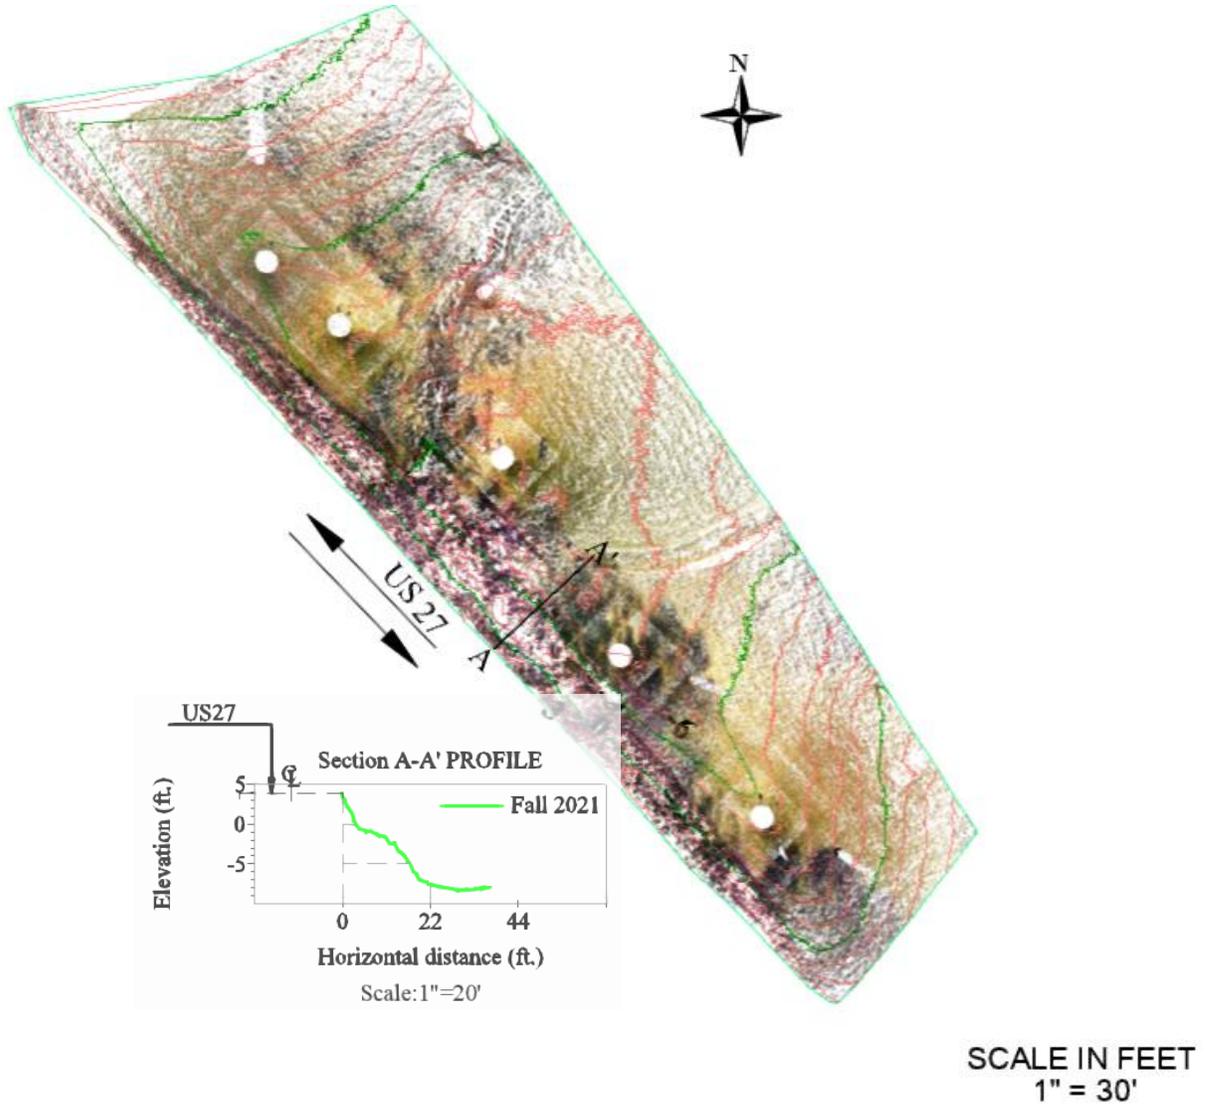
Figure 4.105 LiDAR Point Cloud Surface Topography and Profile View for Failed Slope 15 (Fall 2021)

Terrestrial LiDAR scanning data was collected of failed Slope 15 in the fall of 2021. Laser scanning was performed at several stations, and the overlapping point cloud data were collected, then post-processed on a computer and registered together to form a single point cloud. Using a ground extraction algorithm, the low surface points were extracted to create the bare ground point cloud, which was processed in Civil 3D. The topographic surface view was generated at 1 ft. major and 5 ft. minor contour intervals, then a surface profile view was generated, using alignment. The slope's topographic contour view and surface profile view along section A-A' are presented in Figure 4.105

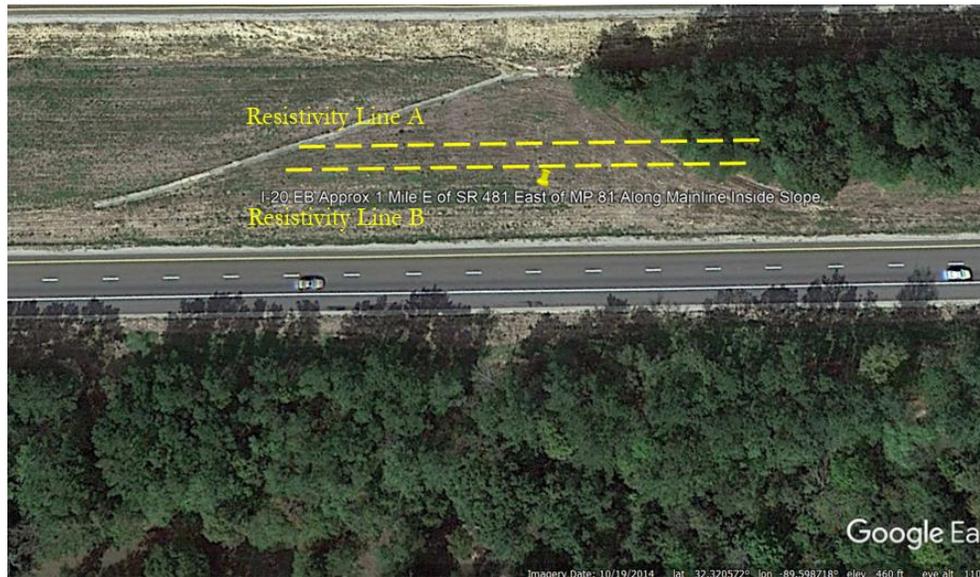
Figure 4.106 ERI Test Lines at Failed Slope 17

ERI tests were conducted along two lines, A & B, of failed Slope 17, spanning approximately 270 ft. and having electrodes paced at 5 ft. intervals. The slope of the location and the ERI test lines are presented in Figure 4.106. The results, presented in Figure 4.107 (a) & (b), show the presence of high resistivity layers up to approximately 15 ft. depth at Line A, between 30 ft. and 230 ft. horizontal distance, indicating deformed soil. Low resistivity areas are directly below the loose soil, indicating perched water conditions from rainfall infiltration. Line B has a similar ERI pattern but has lower resistivity.

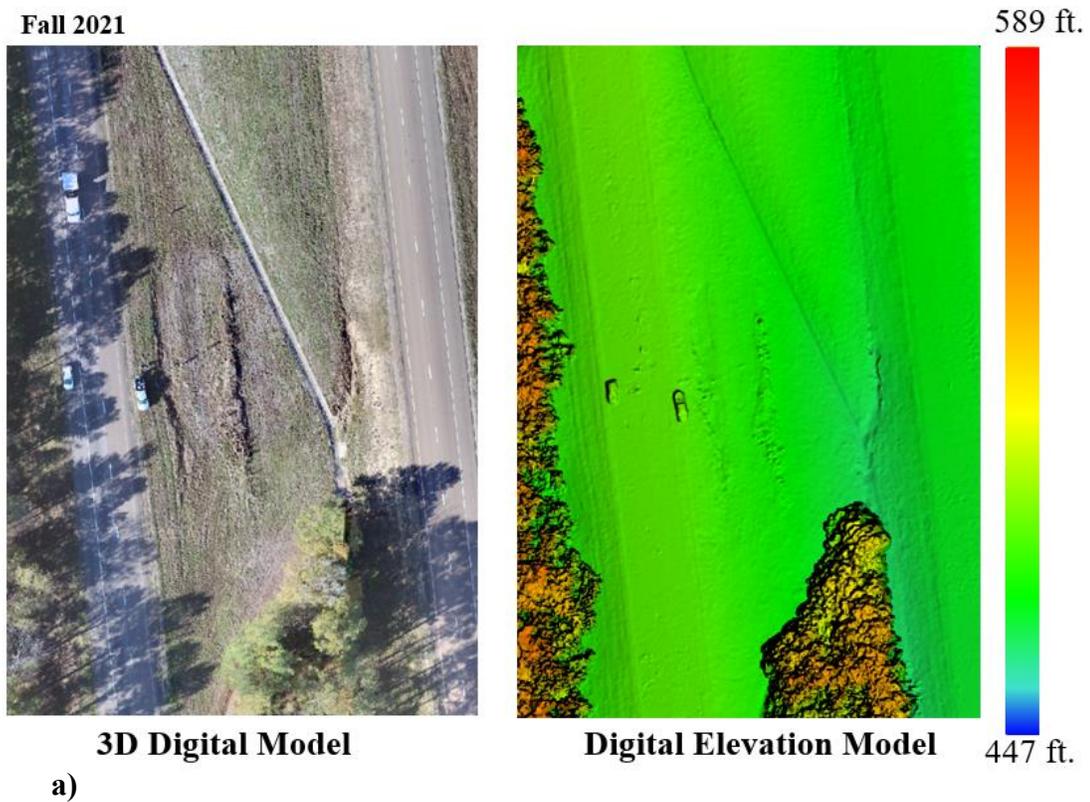
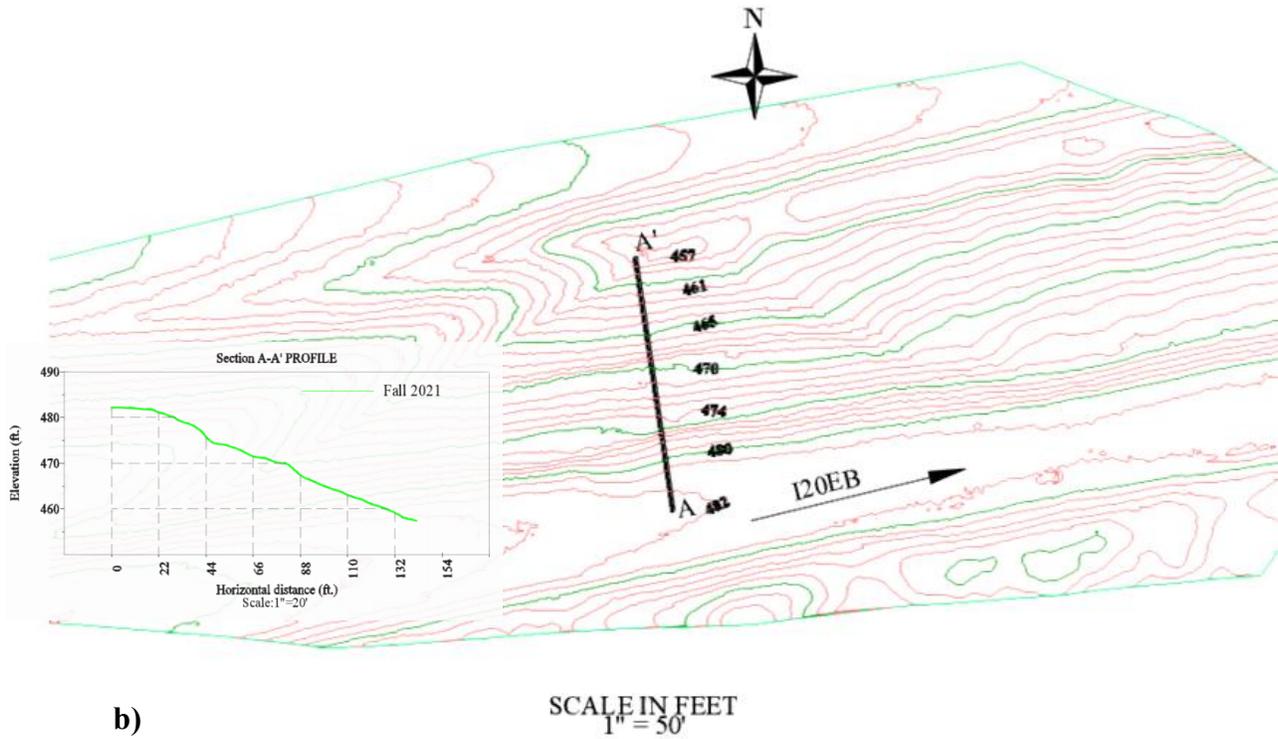
Figure 4.108 Drone Images of Failed Slope 17 from Fall 2021: (a) Digital Elevation Model and (b) Surface Topography and Profile

Drone survey missions were carried out over failed Slope 17 in fall 2021 and fall/winter 2022, and the captured aerial imagery was processed using specialized image processing software. Aerial triangulation was performed with multiple tie points to stitch the images together and develop a digital elevation model (DEM), digital terrain model (DTM), and mosaics. The DEM and orthomosaic digital image representations for Fall 2021 and Fall/Winter 2022 are presented in Figure 4.108 (a) & Figure 4.109 (a). DEMs were imported into Civil 3D, and surfaces were created using the kriging interpolation method. Alignments along the slope were created, and surface profile views were generated along the slope. The topographic contour views and surface profile views for Fall 2021 and Fall/Winter 2022 are presented in Figure 4.108 (b) and Figure 4.109(b). The 3D model representation of the slope and surface profile views for Fall 2021 and Fall/Winter 2022 are presented in Figures Figure 4.108 (c) and Figure 4.109 (c).

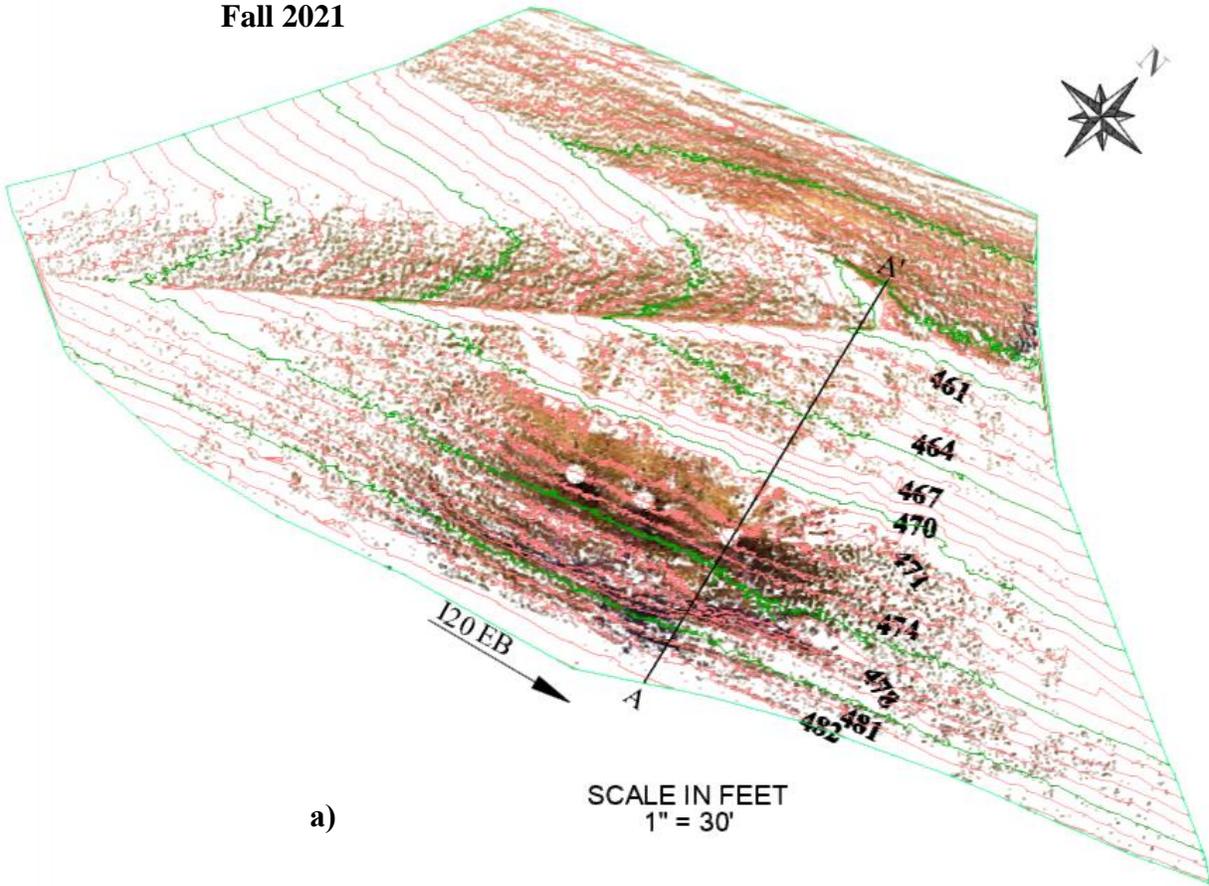
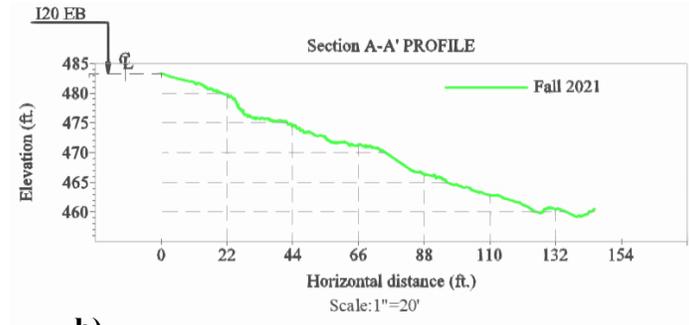
Figure 4.110 LiDAR Point Cloud Surface for Failed Slope 17: (a)Topography, (b) Surface Profile (Fall 2021)

Terrestrial LiDAR scanning data was collected for failed Slope 17 in fall 2021 and fall 2022. Laser scanning was performed at several stations, and the overlapping point cloud data were collected, then post-processed on a computer and registered together to form a single point cloud. The ground control points weren't available for the data collected in fall 2021, so the point cloud wasn't georeferenced; however, the point cloud for fall 2022 was georeferenced using field ground control points with known coordinates. Using a ground extraction algorithm, the low surface points were extracted to create the bare ground point clouds for both seasons, which were imported into Civil 3D, and digital elevation model surfaces were generated using the kriging interpolation method. Topographic surface views for Fall 2021 and Fall/Winter 2022 were generated at 1 ft. major and 5 ft. minor contour intervals and are presented in Figure 4.110 (a) and Figure 4.111 (a), respectively. Surface profile views for Fall 2021 and Fall/Winter 2022 were generated using alignments and are presented in Figure 4.110 (b) and Figure 4.111 (b)

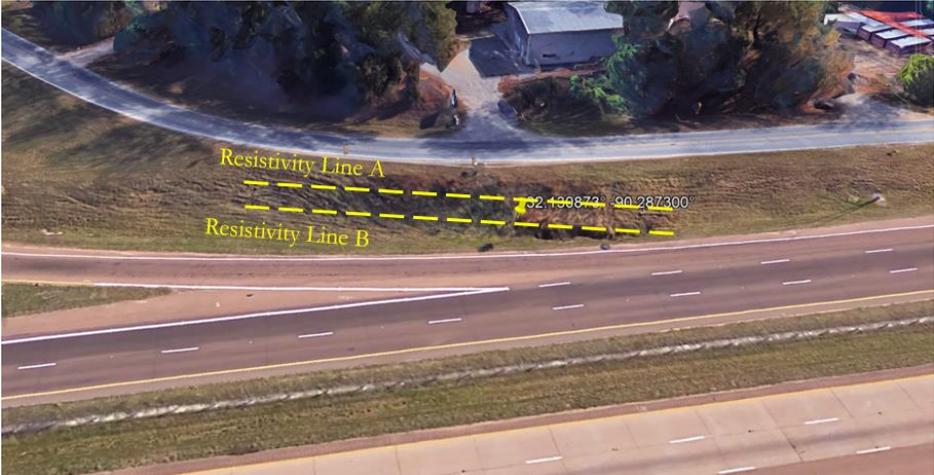
Figure 4.112 Location of ERI Test Lines in Failed Slope 18

ERI tests were conducted at failed Slope 18, along Lines A and B spanning approximately 275 ft. and equipped with electrodes spaced at 5 ft. The locations of the slope and test lines are presented in Figure 4.112. The test results are presented in Figure 4.113(a) and (b). The slope is deformed at the surficial level, and there are low resistivity zones at Line A, at shallow depths up to approximately 12 ft., indicating infiltration of water due to surficial soil deformation. High

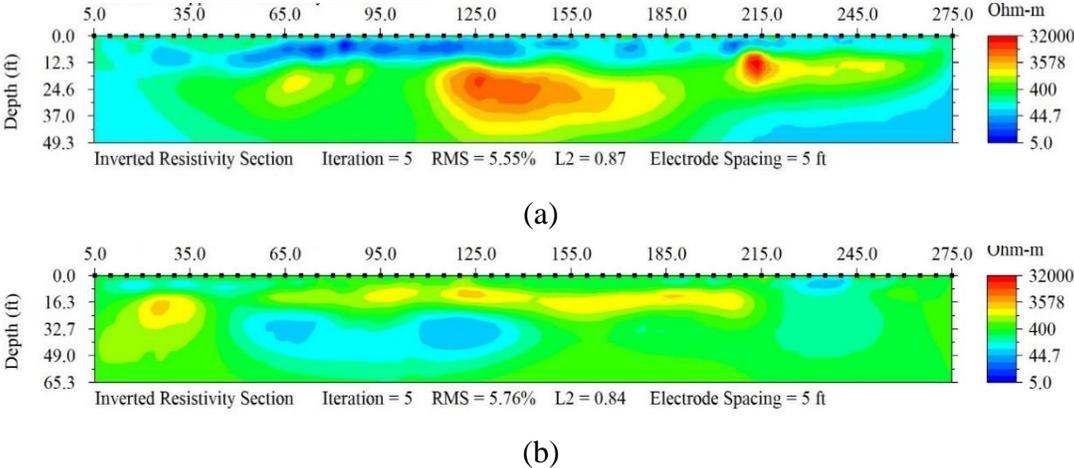
Figure 4.113 ERI Test Results of Failed Slope 18: (a) Line A and (b) Line B

resistivity layers are present between 155 ft. and 185 ft. horizontal distances, at a depth of 15 ft. to 40 ft..
