MDOT State Study 316 – Development of Advanced Landslide Investigation Protocol Using Geophysical Methods for Mississippi

FINAL REPORT

June 30, 2023

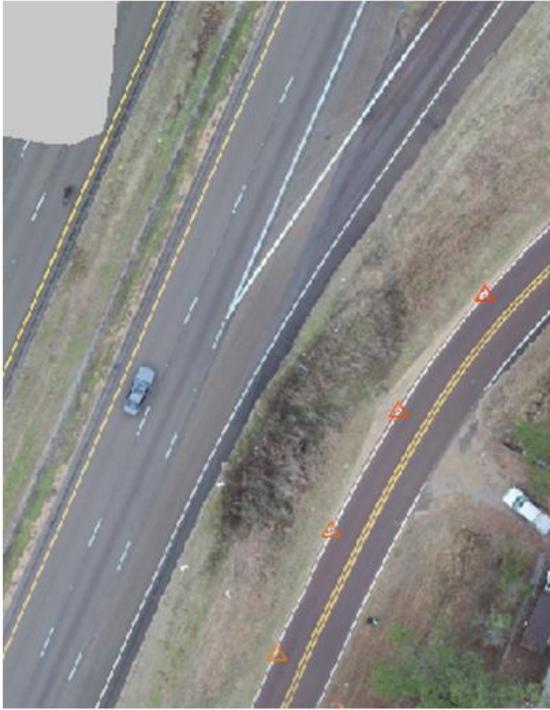
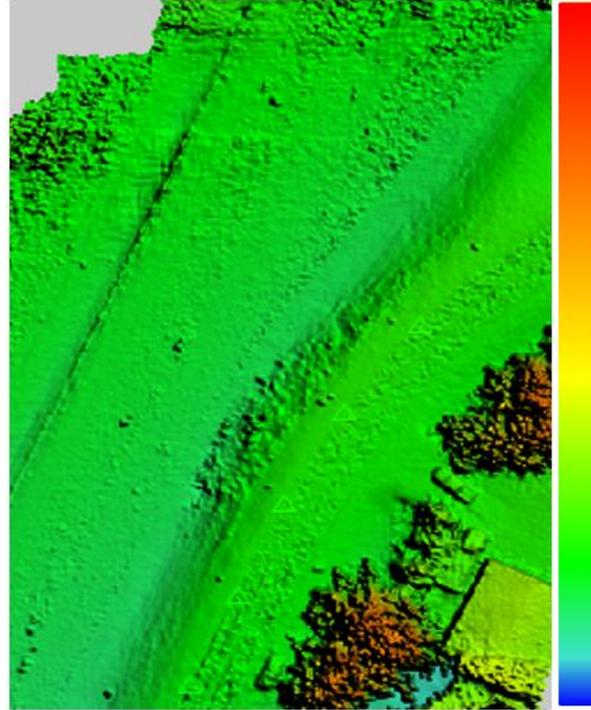
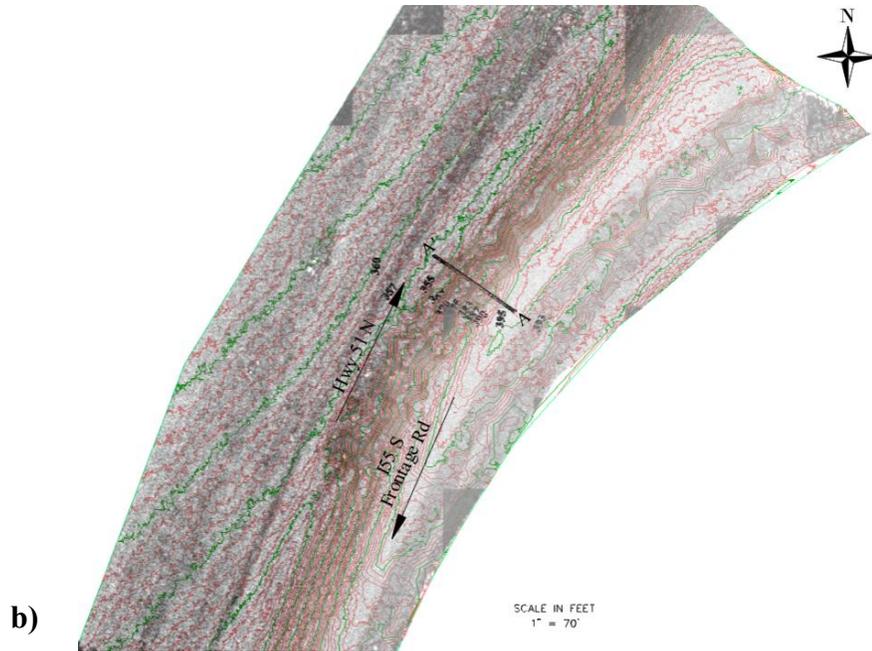
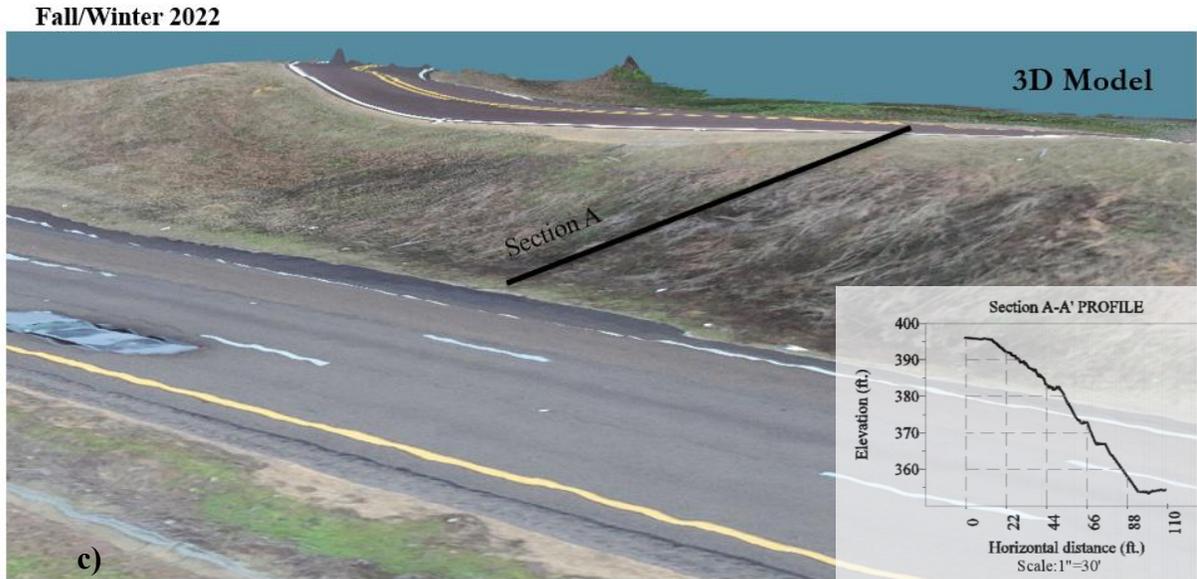
Figure 4.114 Drone Images of Failed Slope 18: (a) Digital Elevation Model, (b) Surface Topography, and (c) 3D Model and Surface Profile (Fall 2022)

A drone survey mission was carried out over failed Slope 18 in fall/winter 2022, and the aerial imagery captured was processed using specialized image processing software. Aerial triangulation was performed with multiple tie points to stitch the images together and develop a digital elevation model (DEM), digital terrain models (DTMs), and mosaics. The DEM and orthomosaic digital image representations are presented in Figure 4.114 (a). The DEM was imported into Civil 3D, and the surface was created using the kriging interpolation method. Alignment was created and a surface profile view was generated along the slope (section A). The topographic contour is presented in Figure 4.114 (b). The 3D model representation created from the drone imagery, along with the surface profile view, is presented in Figure 4.114(c).

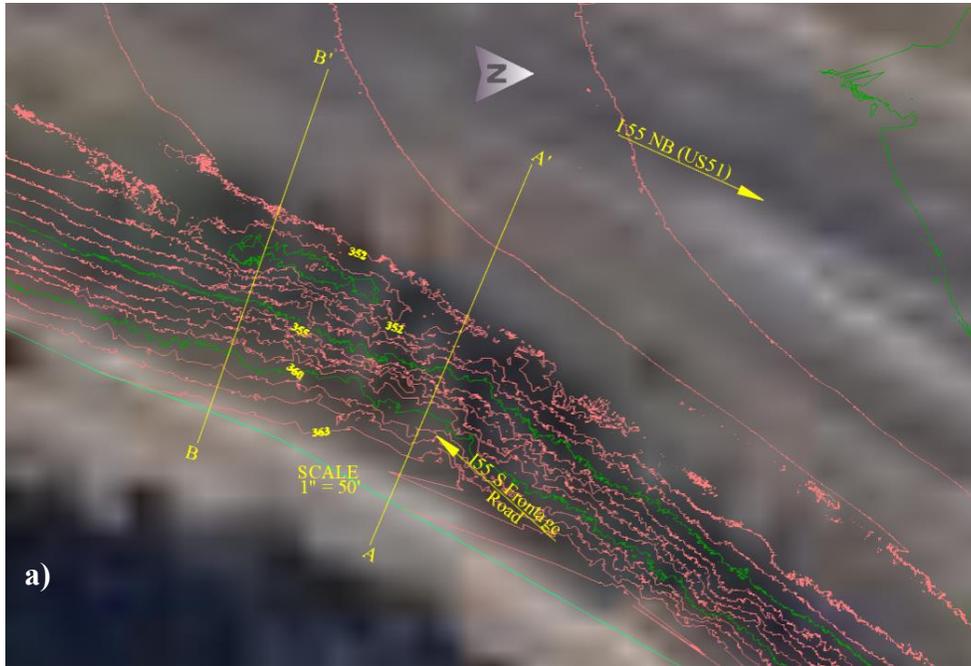
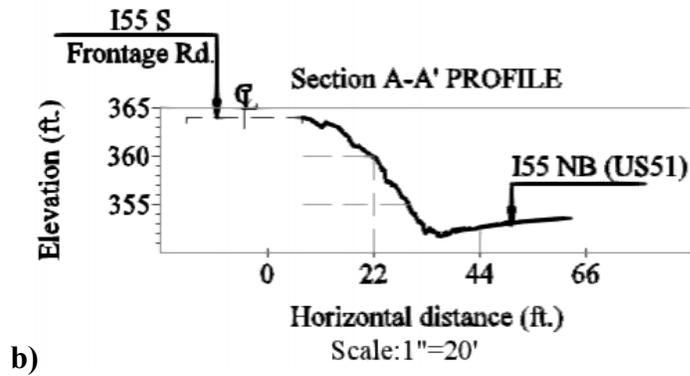
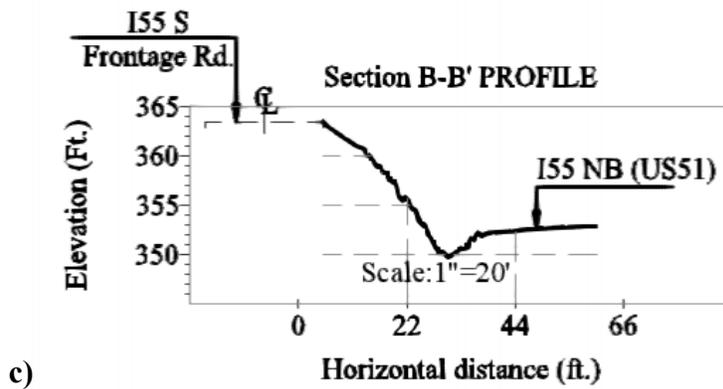
Figure 4.115 LiDAR Point Cloud Surface Topography of Failed Slope 18: (a) Surface Topography, (b) Surface Profile Section A-A', (b) Surface Profile Section B-B' (Fall 2022)

Terrestrial LiDAR scanning was performed at several stations in fall/winter 2022, and overlapping point cloud data were collected, then post-processed on a computer and registered together to form a single point cloud. Using a ground extraction algorithm, low surface points were extracted to create the bare ground point clouds, which were processed in Civil 3D. The topographic surface view was generated at 1 ft. major and 5 ft. minor contour intervals, then a surface profile was generated, using the alignment. The slope's topographic contour view is presented in Figure 4.115 (a), and surface profile views along sections A-A' and B-B' are presented in Figure 4.115 (b) and (c).

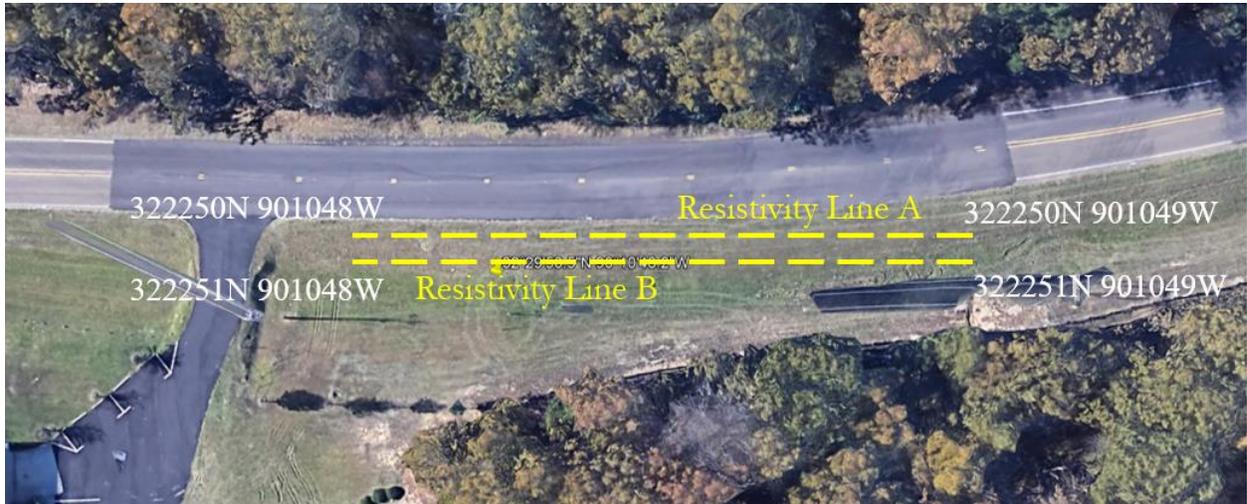
Figure 4.116 Location of ERI Test Lines in Failed Slope 19

ERI tests were conducted for failed Slope 19 along lines A and B that spanned 440 ft. and were equipped with electrodes spaced at 8 ft. intervals. The location of the slope and test lines are presented in Figure 4.116. ERI results for Lines A & B are presented in Figure 4.117 (a) and (b). Patches of low resistivity zones exist at both lines, across the entire horizontal span of the ERI profile, as the slope and road have suffered extensive settlement over the years due to the condition of the soil.

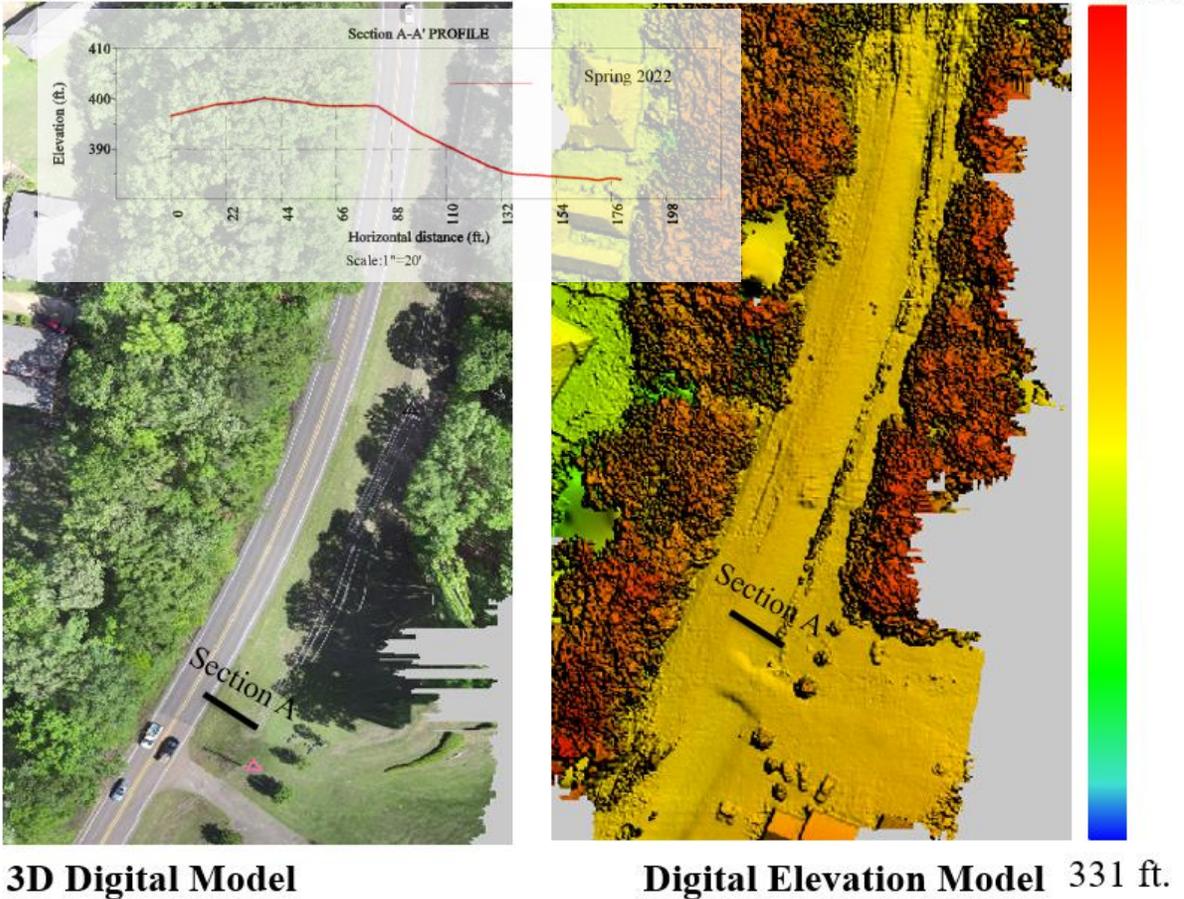
Figure 4.118 Drone Images of the DEM and Surface Profile of Failed Slope 19 (Spring 2022)

imported into Civil 3D, and the surface was created using the kriging interpolation method. Alignment was created along the slope, and a surface profile view was generated along Section A of the slope. The DEM and orthomosaic digital images and the surface profile view are presented in Figure 4.118.

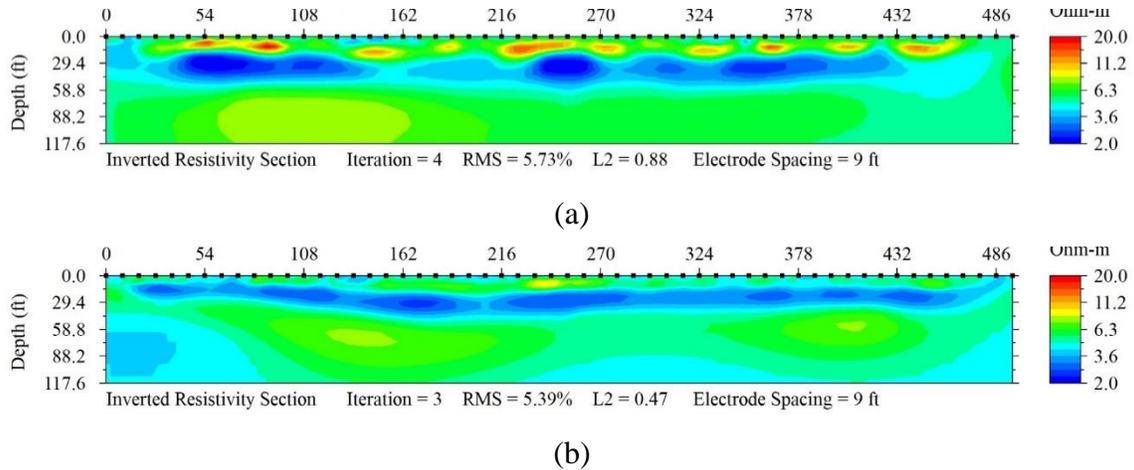
Figure 4.122 ERI Test Results of Failed Slope 20: (a) Line A and (b) Line B

ERI tests were performed along Lines A and B of failed slope 20 that spanned 495 ft. and were equipped with electrodes spaced at 9 ft. intervals. The locations of the slope and ERI test lines are presented in Figure 4.121. The ERI results are presented in Figure 4.122 (a) and (b). Patches of high resistivity exist along both lines in the shallow depths, indicating loose or deformed soil. Low resistivity areas exist directly below the loose soil, from 15 to 30 ft. depths, indicating perched water conditions from rainfall infiltration.

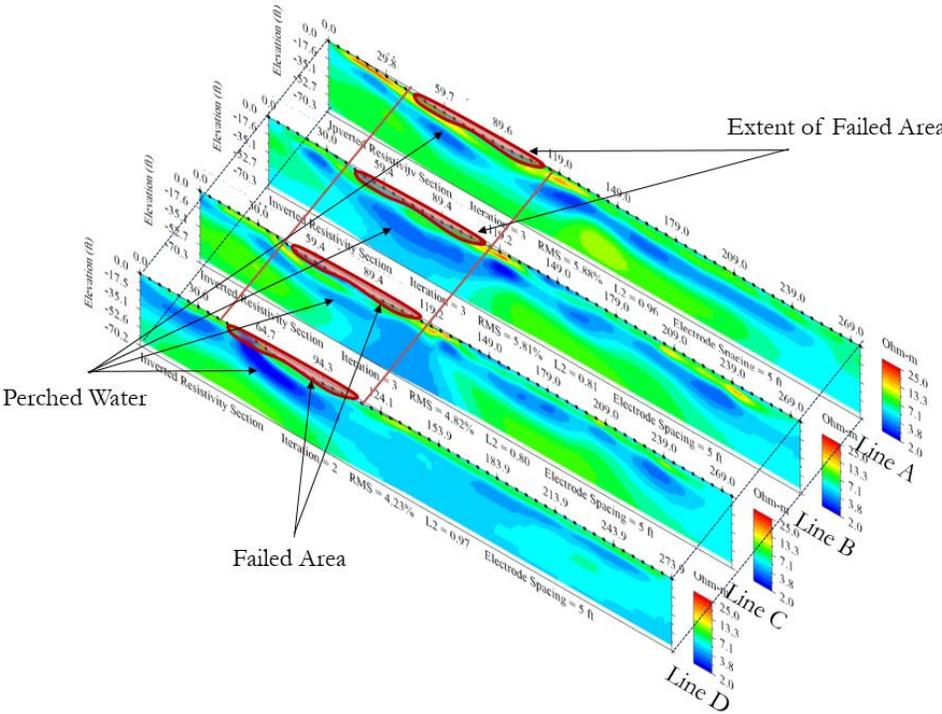
Figure 5.3 ERI Test Results of Line A, B, C & D for Slope along I220N and I55 N Interchange

The results of the ERI analysis for embankment lines A, B, C, and D at the Metrocenter site indicate the presence of multiple low-resistivity areas within the embankment. (See Figure 5.3.) The ERI profiles show areas characterized by low resistivity in blue. These regions exhibit resistivity values ranging from 2 to 6 Ohm-m. The presence of low resistivity indicates a high degree of soil saturation and the presence of water accumulation zones, known as perched water zones, within the embankment. Areas with high resistivities, indicated by yellow and red colors, are relative, depending on the nature of the soil. High resistivity areas are denoted by deformed and loosely packed soil that tends to have larger air voids. The extent of a failed area can be

identified based on high resistivity areas (red-colored zones) and by the sag in the ERI profile, as seen in Figure 5.3.

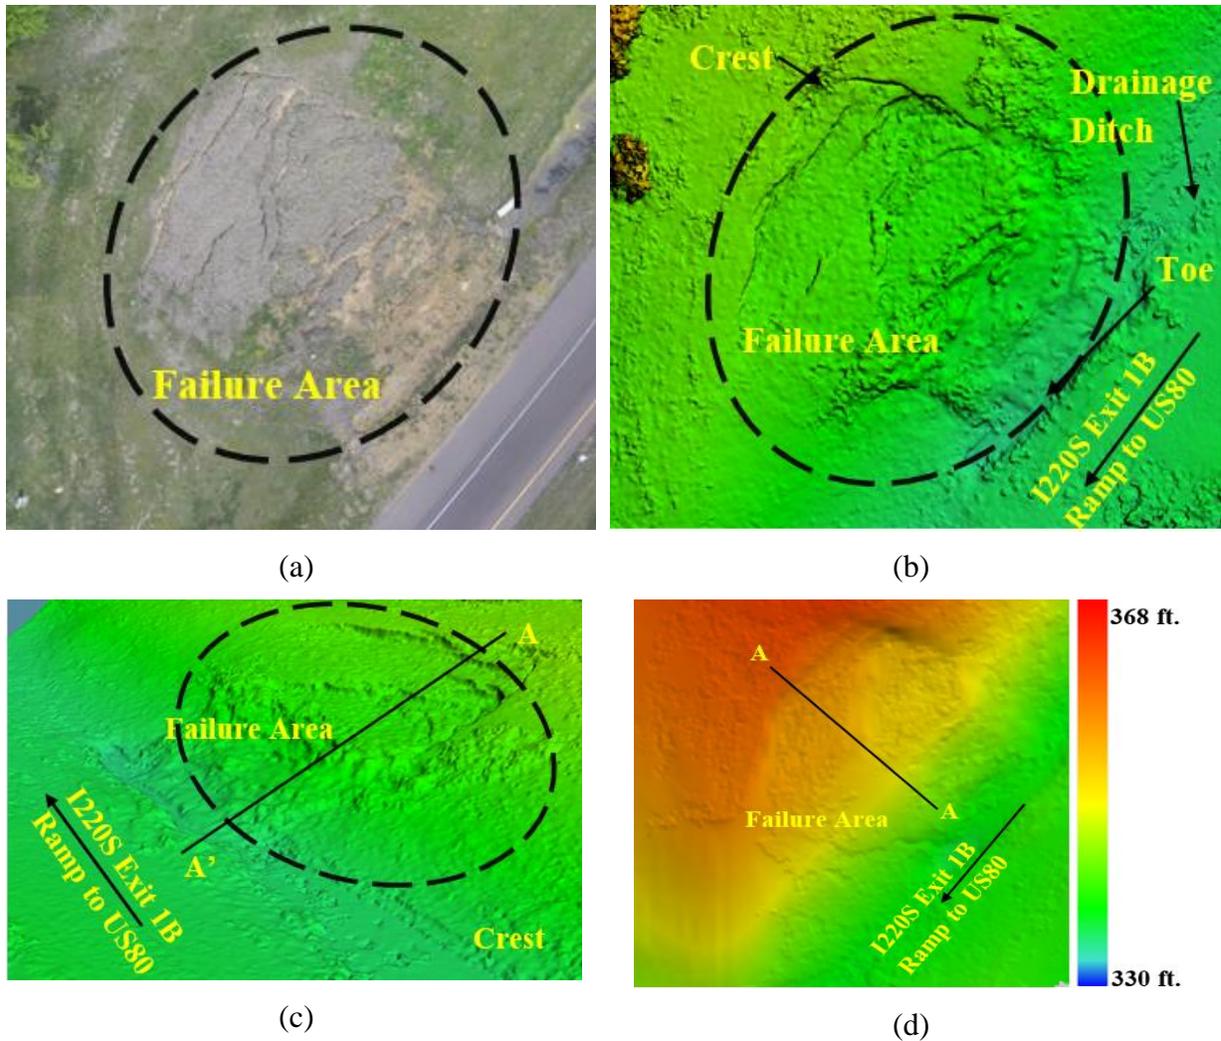
Figure 5.4 ERI Test Site for Slope at Metrocenter (I220S Exit 1B Ramp Toward US80): (a) UAV Orthomosaic Image, (b) UAV DSM, (c) UAV 3D DSM, (d) UAV DTM, (e) UAV Surface Profile

After collecting the data, the images were processed using specialized software, and digital elevation models (DEM) were created, using the principles of photogrammetry. The DEMs were further classified into digital surface models (DSMs) and digital terrain models (DTMs). DSMs capture the elevation of all objects such as vegetation; DTMs eliminate all artificial and natural features and retain only the natural surface of the earth. DTMs provide more precise information about elevation changes than DSMs, as they capture both natural and artificial features of the slope failure and provide more detailed information about the soil profile settlement. The elevation changes were calculated by measuring the slope of each pixel. The DTM, DSM, and 3D output data created using the results of UAV surveying are presented in Figure 5.4 and help clearly identify the characteristics of the slope failure. The failure area can be clearly delineated from the drone DSM, and the area of soil that moved was estimated as 10522 sq. ft.; the volume of soil that moved was estimated as 4550 cu. ft.

Analysis of LiDAR-captured point cloud data and drone DEM showed variations in the surface profile settlement. The LiDAR output was far more detailed regarding surface variations, but the drone imagery provided excellent visualization, as seen in the DSM and DTM presented in Figure 5.4. The results of the UAV surveying analysis helped identify the characteristics of slope failure. The ERI analysis of embankment lines A, B, C, and D at the Metrocenter site showed the presence of multiple low resistivity areas within the subsurface embankment, which suggests a high level of soil saturation and the existence of water accumulation zones. These perched water zones may have caused the eradication of suction over time in the surficial level and resulted in slide failure. The ERI image profile also confirmed the depth of the slip surface, which was highlighted by areas of high resistivity due to the presence of loose soil with air voids.

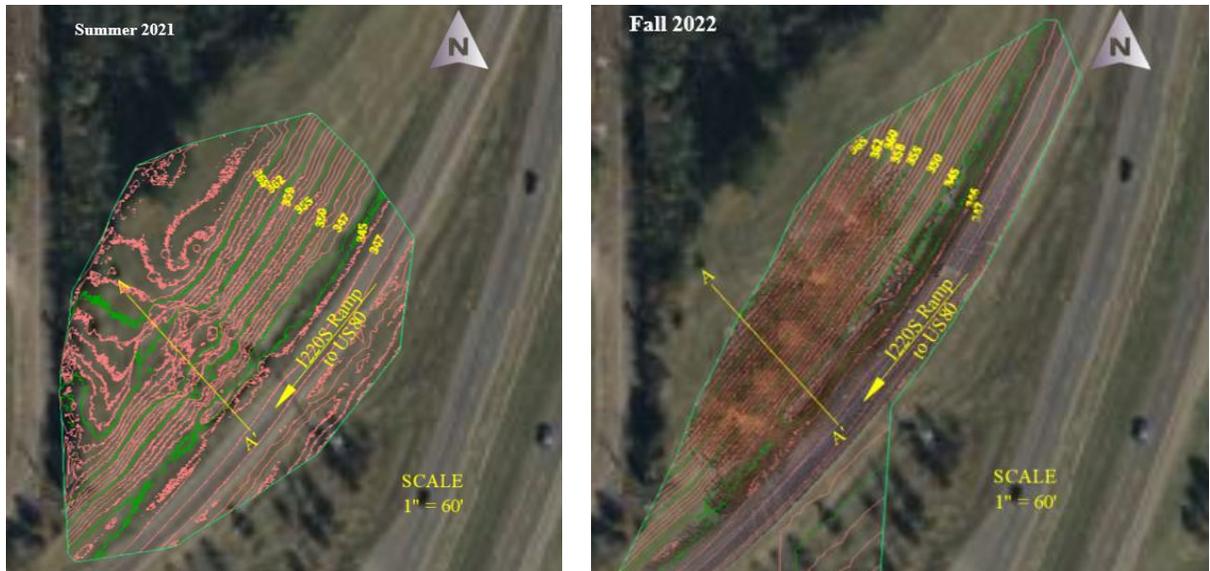
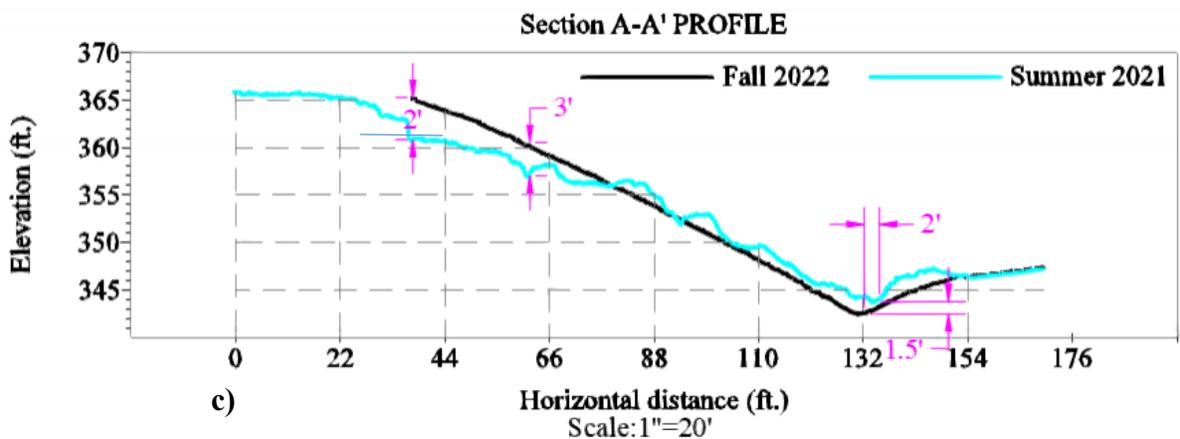
Figure 5.5 ERI Test Site for Slope at Metrocenter (I220S Exit 1B Ramp Toward US80): (a) LiDAR Surface Topography Summer 2021, (b) LiDAR Surface Topography Fall/Winter 2022, (c) LiDAR Stacked Surface Profiles

The point cloud data collected during the summer of 2021 and the fall/winter of 2022 were processed and analyzed following the workflow described in Section 5.1.3. The resulting surface profiles, obtained at different time intervals, are shown in Figure 5.5. The point clouds from both seasons were registered independently. The temporally spaced point clouds were georeferenced and stacked on each other to compare them and detect any changes that occurred. The slope surface profiles for different seasons were extracted from the same locations on both point clouds. Comparing the pre-failure profile with the post-repair surface profile revealed crucial information. From Figure 5.5(c), it is evident that the crest of the slope is 2 ft. higher than the collapsed part of the slope. Near the middle of the slope, the elevation had to be raised 3 ft. from the failed level. At the toe of the slope, the excess dirt had to be removed, and as a result, the repaired slope at toe was about 1.5 ft. lower than that of the collapsed slope.

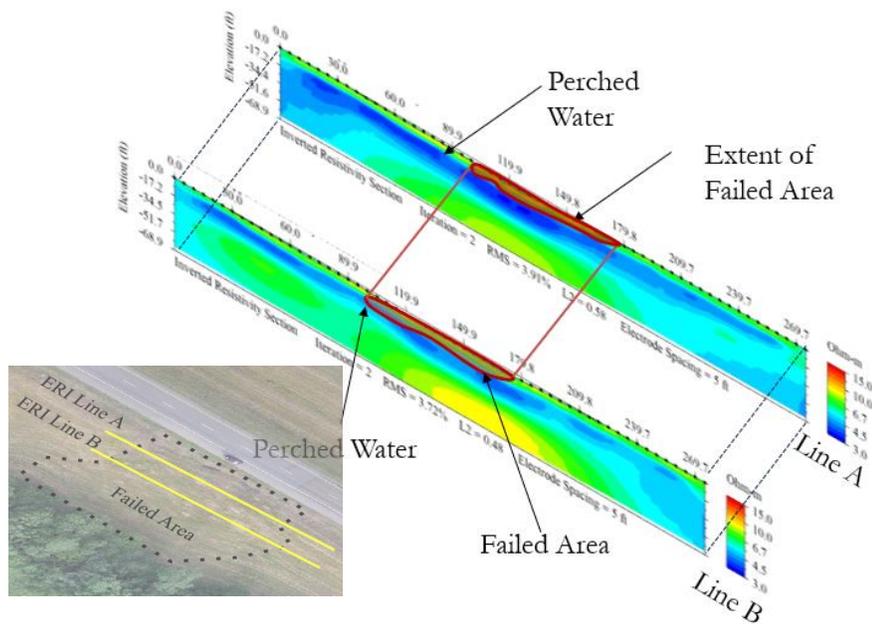
Figure 5.6 ERI Test Results for Lines A & B for Slope along I20E Before Exit 100

The ERI analysis of Lines A & B of the failed slope along I20 near exit 100 is presented in Figure 5.6. Several low resistivity areas are located at different points along the embankment profile, suggesting soil saturation and water accumulation (perched water zones) within the embankment. For example, the dark blue area between 90 ft. and 150 ft. on the ERI profile along line A, which has the lowest resistivity value (less than 3 Ohm-m at a depth of 34 ft.), suggests a high potential for soil movement due to high soil saturation.

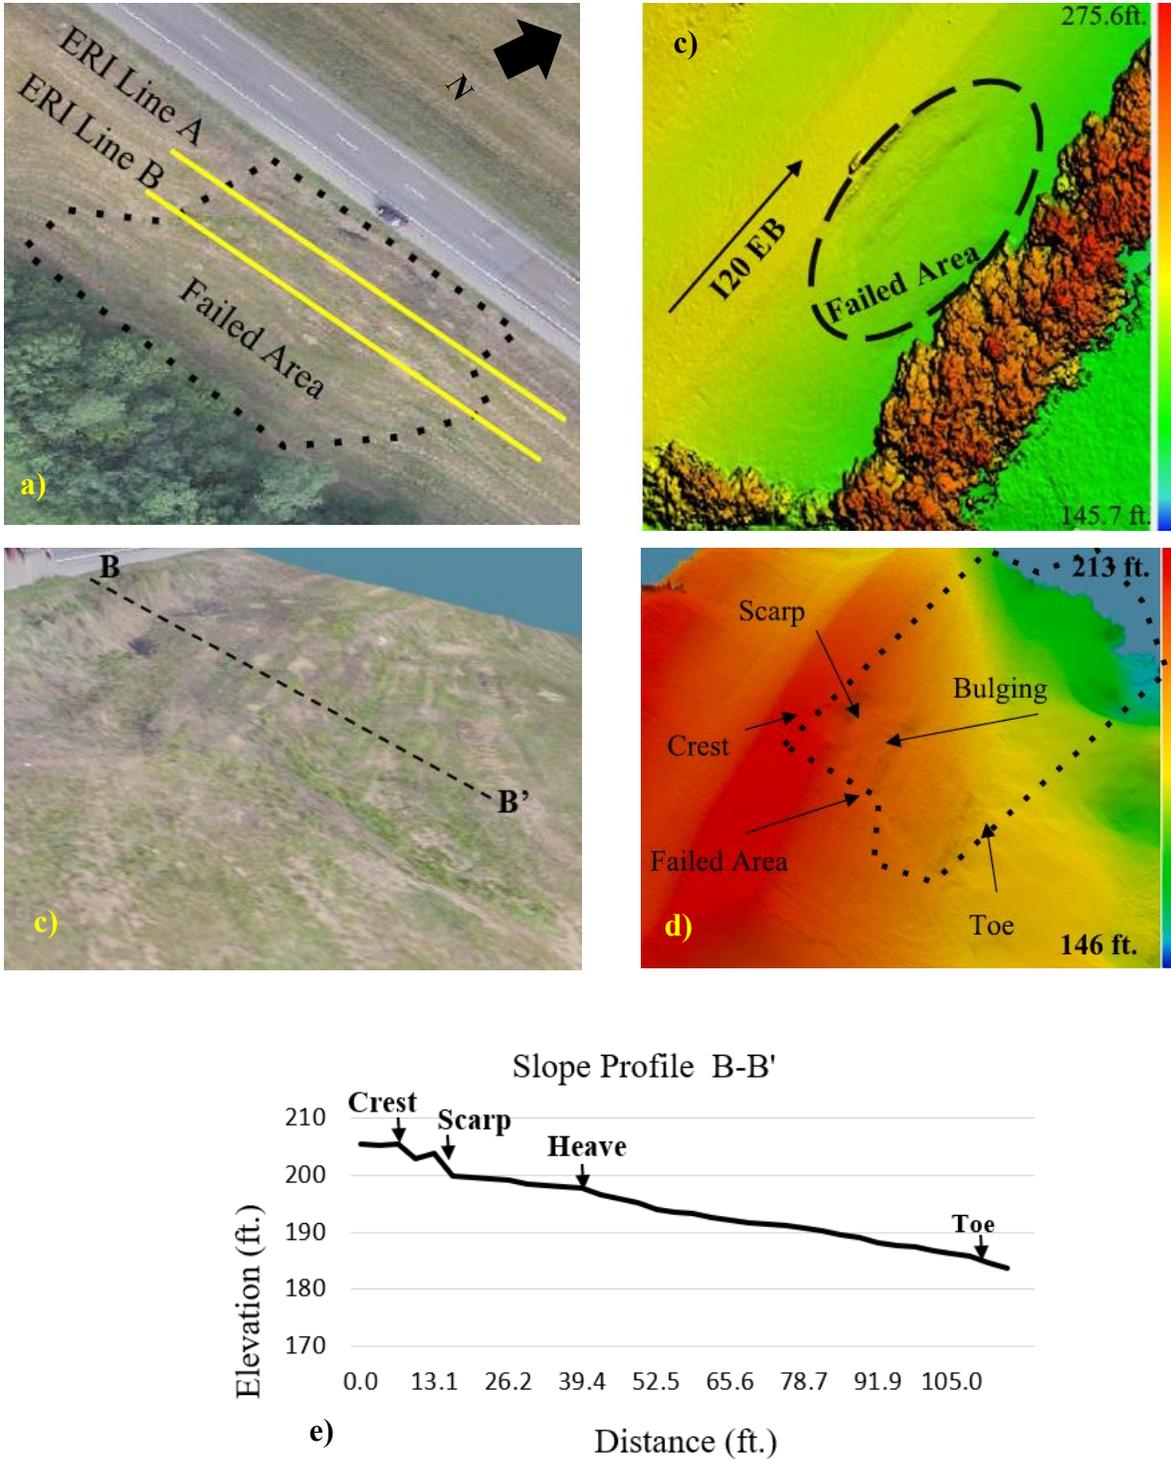
Figure 5.7 Slope at I20 EB Exit 100: (a) UAV Orthomosaic Image, (b) UAV DSM, (c) UAV 3D Model, (d) UAV DEM, (e) UAV Surface Profile

The failed slope near Exit 100 on I20 EB was analyzed using imagery captured by the drone. The aerial imagery was processed, the DEM, DSM, and 3D output data were generated, and the surface failure profile was extracted using the DEM model, as shown in Figure 5.7. The profile reveals that the soil has settled 5.14 ft. at 10 ft. from the crest of the embankment and 5.56 ft. at the toe of the embankment. By using DEM, it is possible to create a detailed map of the failure area, accurately define the failure's boundaries, and measure the area of the soil that has moved (15,801.73 sq. ft.) and the amount of dirt that has been displaced (33,270.30 cubic ft.).

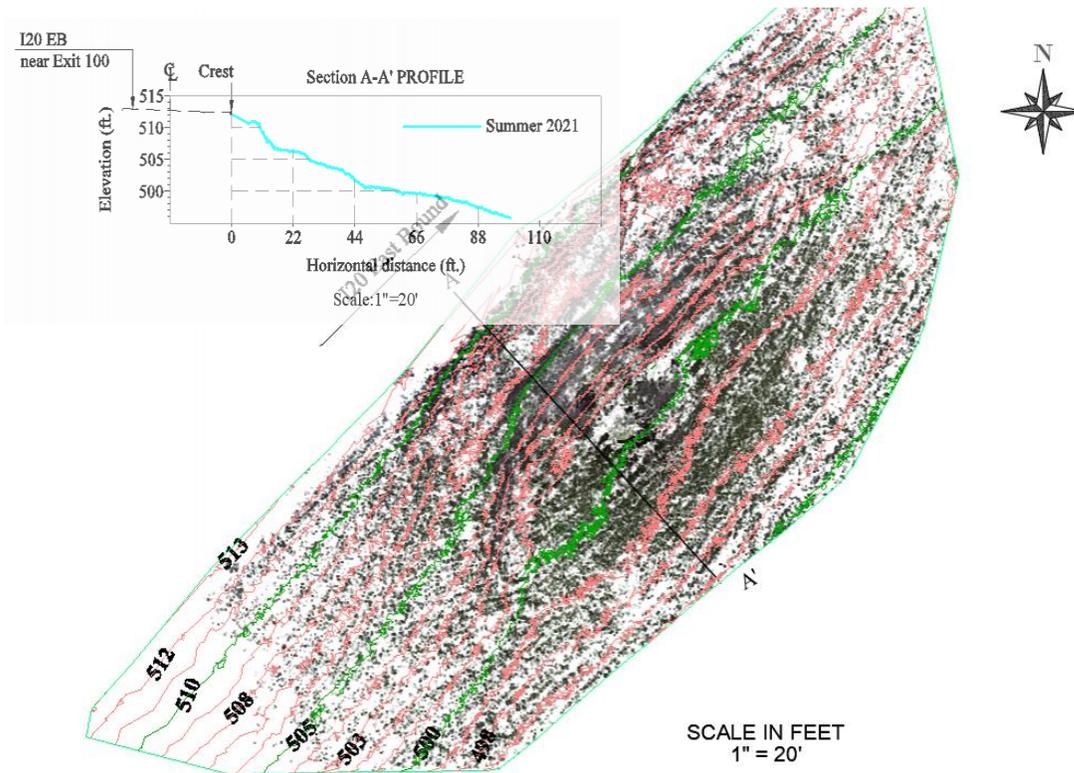
Figure 5.8 LiDAR Results: Surface Topography and Profile View

The elevations presented below are from the Mississippi State Plane Coordinate System and are different from the drone results, which are in the GPS system. The surface topography and profile obtained from the LiDAR survey are presented in **Figure 5.8**. Regardless of the coordinate system, the surface profile developed from the LiDAR point cloud is similar to that obtained from the drone DEM.

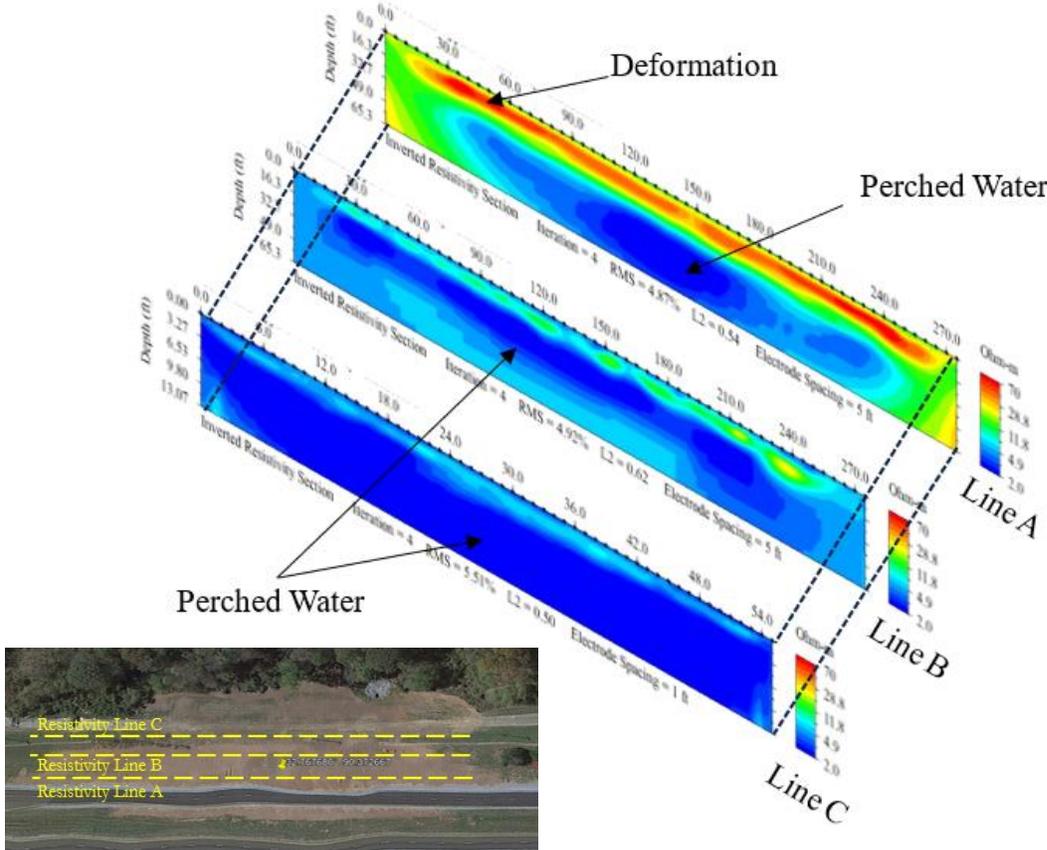
Figure 5.9 ERI Test results for Lines A, B & C for Failed Slope along US49S toward Jackson

The ERI profiles of the embankment at Lines A, B, and C in Figure 5.9 indicate several zones with low resistivity. The red color in the Line A profile represents high resistivity areas that were covered with a mesh to repair the embankment. The low resistivity blue color in the Line A profile below 10 ft. represents areas with soil saturation and water accumulation, or perched water zones within the embankment. According to the inspection findings of Line C, the

embankment toe has been completely saturated with water due to rainwater infiltration. This suggests that there is a high risk of the embankment failing.

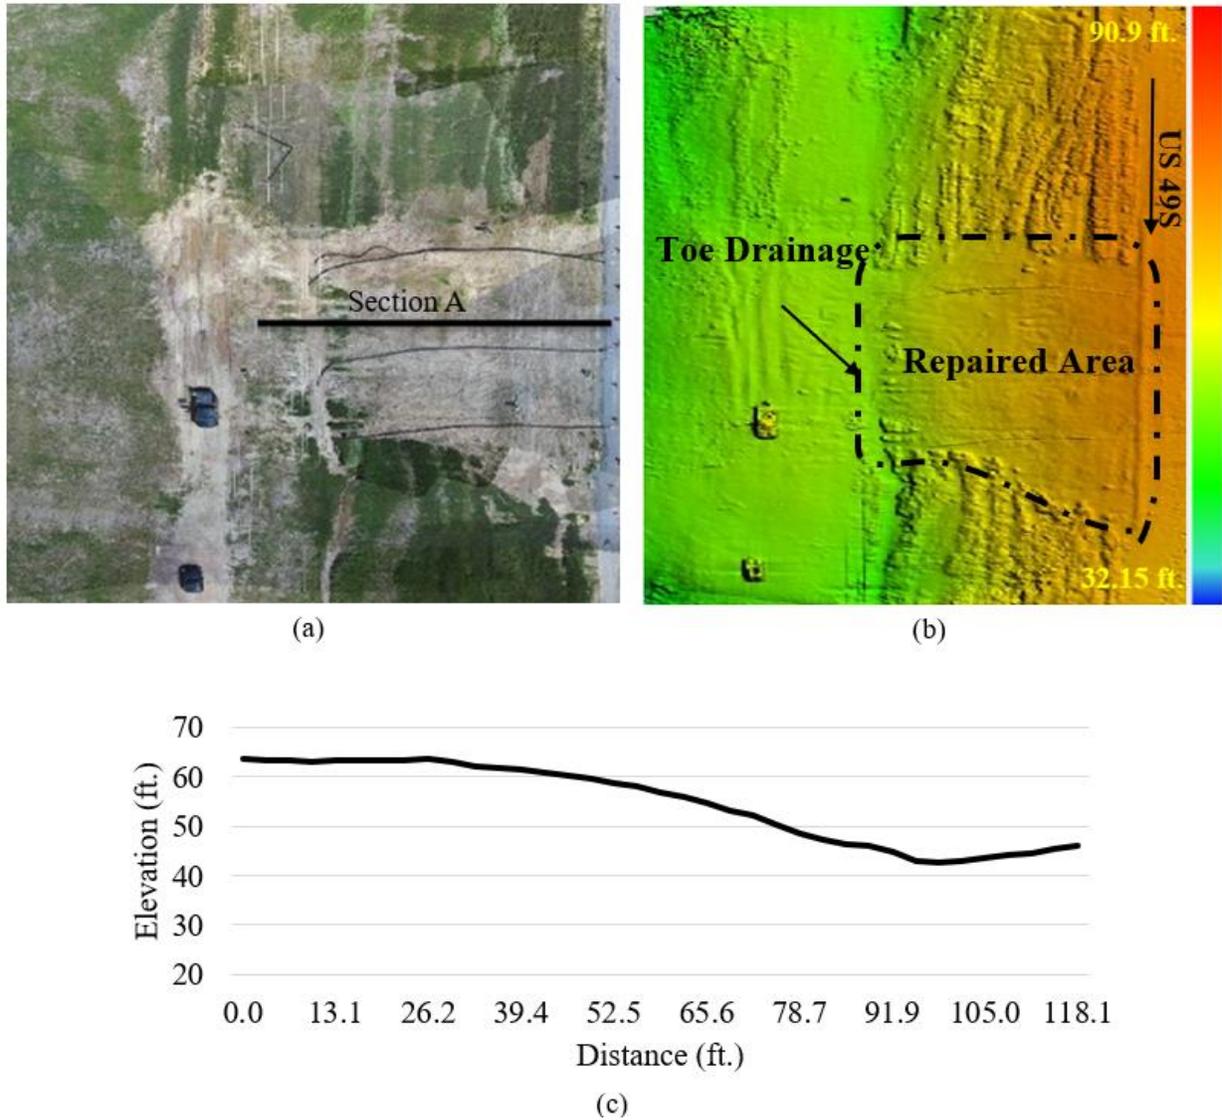
Figure 5.10 Slope at US49S 20 EB Exit 100: (a) UAV Orthomosaic Image, (b) UAV DSM, (c) UAV Surface Profile

The analysis results of the UAV survey imagery for the embankment are presented in Figure 5.10. The images were captured after the slope failure was repaired; therefore, little settlement is visible from the surface profile. The orthomosaic and the DEM are presented in Figure 5.10, and the failure length and width were delineated and measured as 95 ft. long x 145 ft wide. The DSM provides clear boundaries around the failure area and an accurate measurement of the amount of soil moved (12,948.98 sq. ft.).

Comparing the ERI results of the drone survey results provided much valuable information. For instance, the extent of the repaired area, which is clear from the UAV DEM in Figure 5.10, coincides with the subsurface higher resistivity areas in the ERI profiles in Figure 5.11, thus informing the extent of the repair of the previously failed area in x, y and z directions. The high resistivity zones up to a depth of 16 ft. at Lines A, B & C indicate the depth of the slip surface, which was repaired.

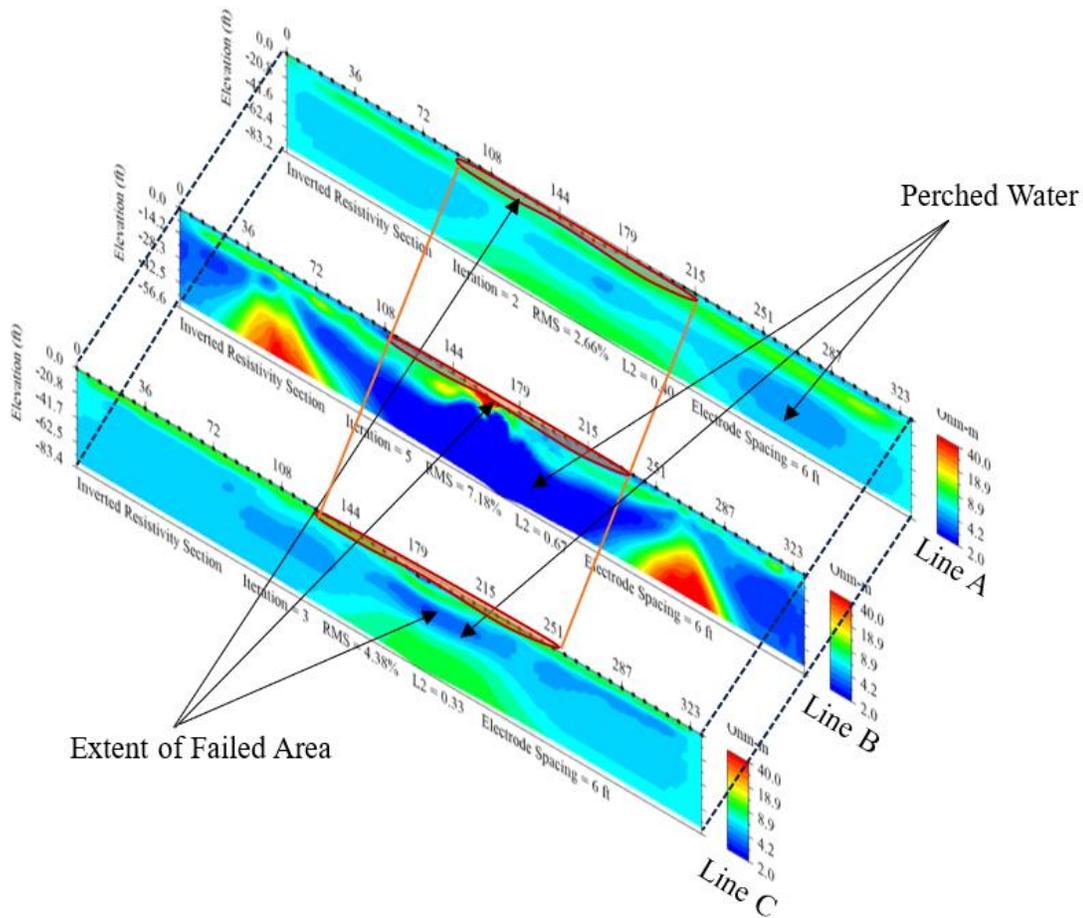
Figure 5.11 ERI Test Results of Line A, B, and C for Failed Slope along Hwy 25 at MS25/43 Interchange

The ERI profiles for Lines A, B and C at the slope along US HWY 25 are presented in Figure 5.11. Lines A and C have higher resistivity than Line B, indicating that the middle of the slope has high water accumulation that might have weakened the shear strength of the slope soil and caused the failure.

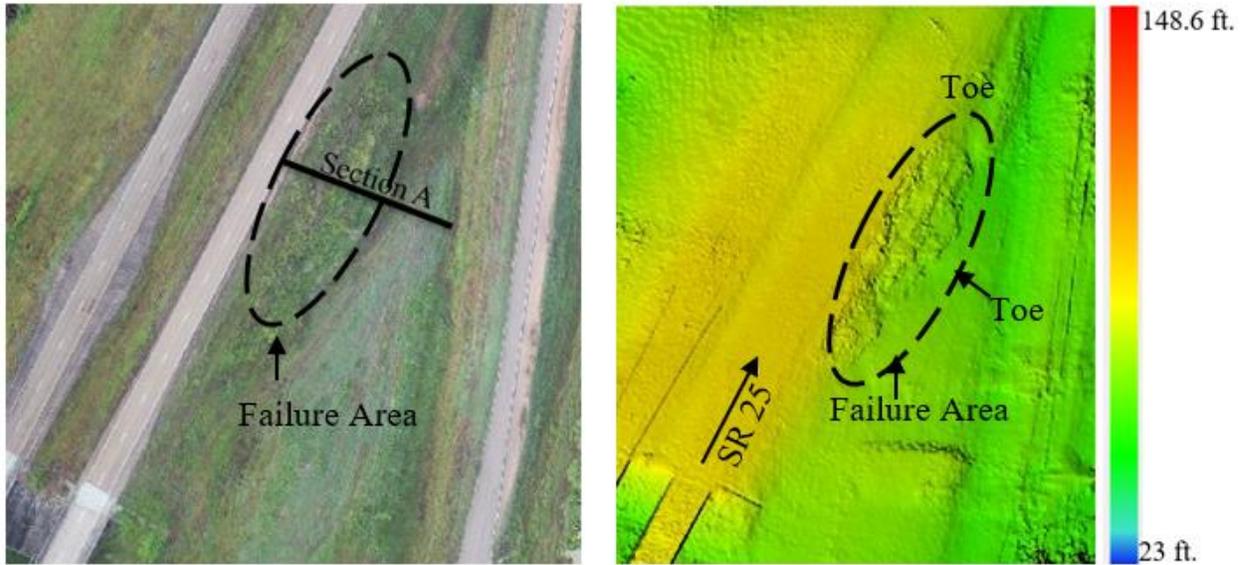
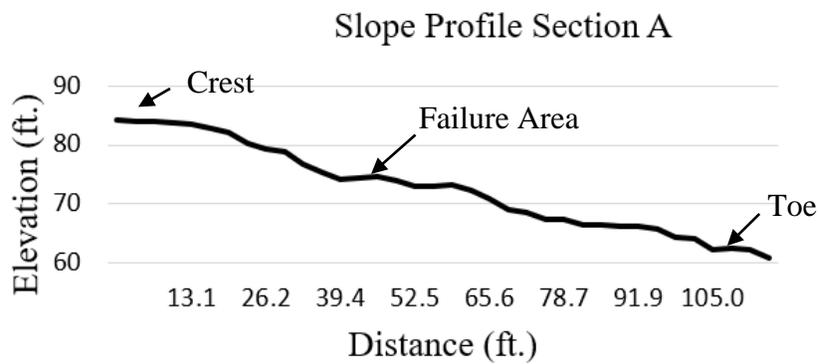
Figure 5.12 Slope along SR 25: (a) UAV Orthomosaic Image, (b) UAV DSM, (c) UAV Surface Profile

The characteristics of the failure along Highway 25 were identified using DEM. The failure profile was extracted using the DEM model, as shown in Figure 5.12. Based on the profile, the soil settlement is 3.15 ft. at 26 ft. horizontal distance from the crest, which is approximately the middle of the embankment. The failure depth, which was clearly defined by the DEM, was measured as 3.33 ft. at the toe of the embankment. The area of the soil moved was measured at 22,625.37 sq. ft.

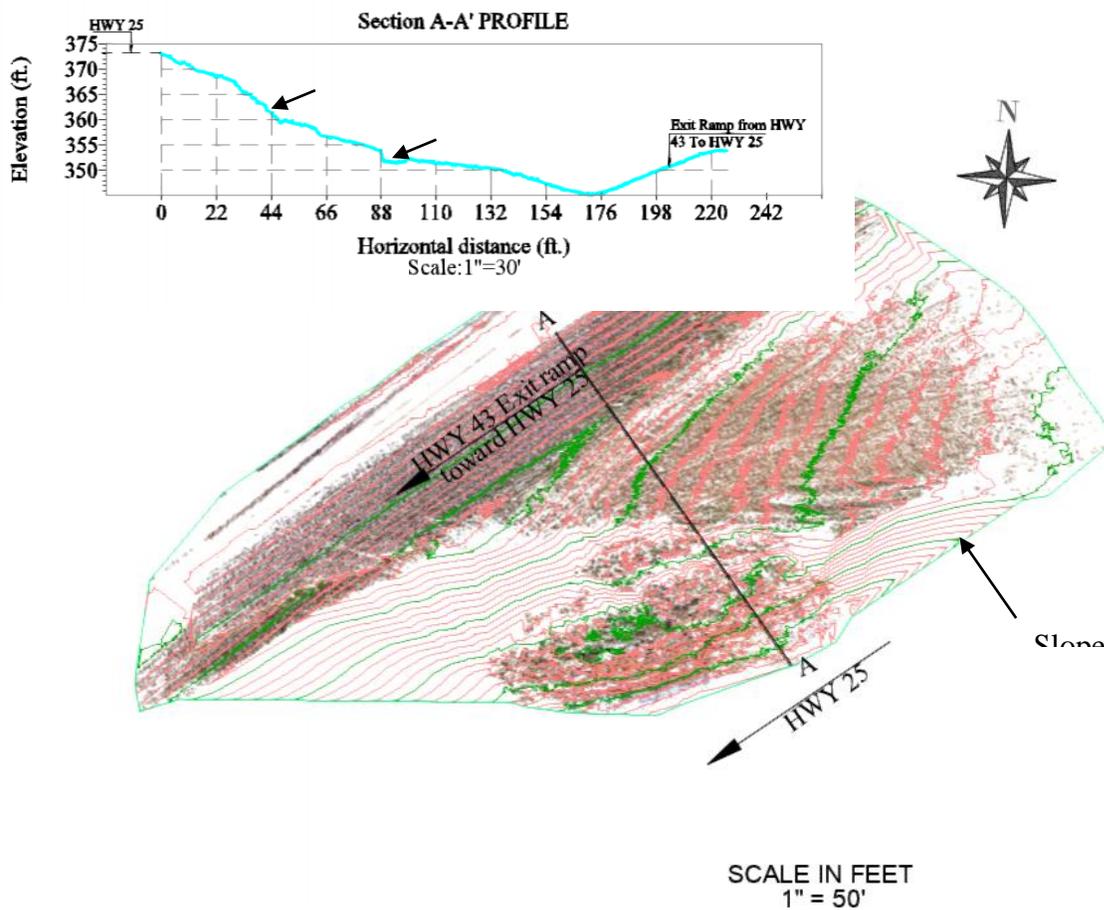
Figure 5.13 Slope along SR 25 LiDAR Results: Surface Topography and Profile

Point cloud data collected from the terrestrial LiDAR survey was processed and analyzed, and the resulting surface topography and surface profiles are presented in Figure 5.13. The LiDAR surface profile is similar to that provided by the UAV, except that it is more detailed, once again proving that LiDAR point clouds provide greater detail in surface profiles than UAVs. The failure area can also be identified in the LiDAR surface profile by the drop in elevation on the surface profile view. The subsurface resistivity on the ERI profile at this point also indicated high resistivity soil, indicating the presence of loose deformed soil and thus providing corroboration. Continuous LiDAR monitoring of the slope can detect changes and variations in slope profiles over time.

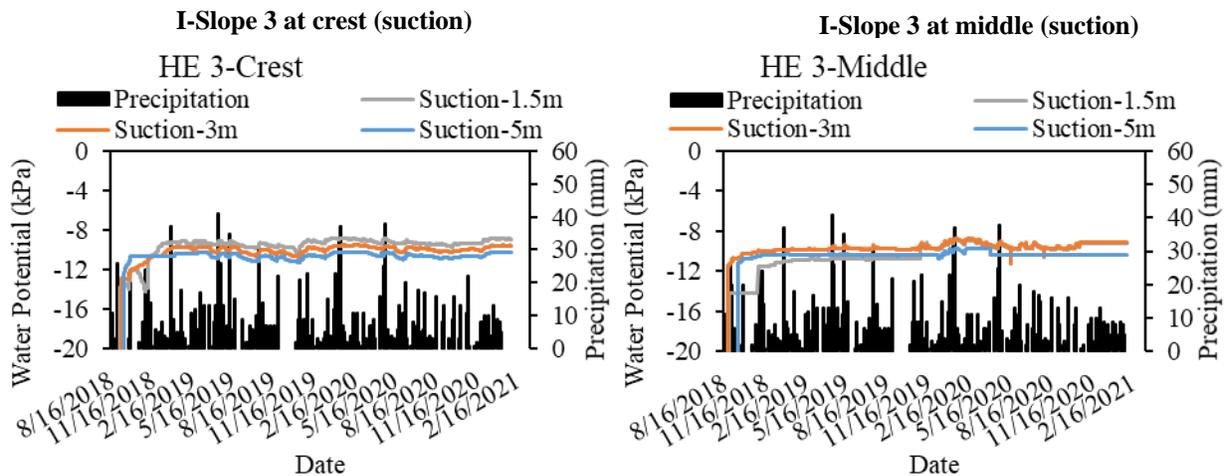
Variations in the matric suction and θ for the six I-slopes at different depths were studied based on field instrumentation data recorded for two years, between June 2019 and June 2021. The time-series variations of rainfall and suction and of rainfall and θ of I-Slope 3 are presented in Figure 5.21 and Figure 5.22, respectively. There was no notable variation in the potential of matric suction along the crest of I-slope 3, but the suction at 15 ft. depth was lower than that of soil closer to the surface. The moisture content at I-Slope 3 varied little at 5 ft. and 10 ft. depths, even with increased rainfall during some months, but considerable variations in moisture content were observed at the 15 ft. depth.

Figure 5.21 Results from Instrumentation for Suction vs. Rainfall at I-Slope 3: (a) Crest, (b) Middle.

The suction remained unchanged at all depths for most of the monitored I-slopes, including I-Slope 3. The moisture content remained at or above the saturation level at 5 ft. and 10 ft. depths but varied and remained below the saturation level at 15 ft. depth. This suggests that rainfall that runs off the crest of the slope only saturates the shallow depths of Yazoo Clay (Nobahar et al., 2020).

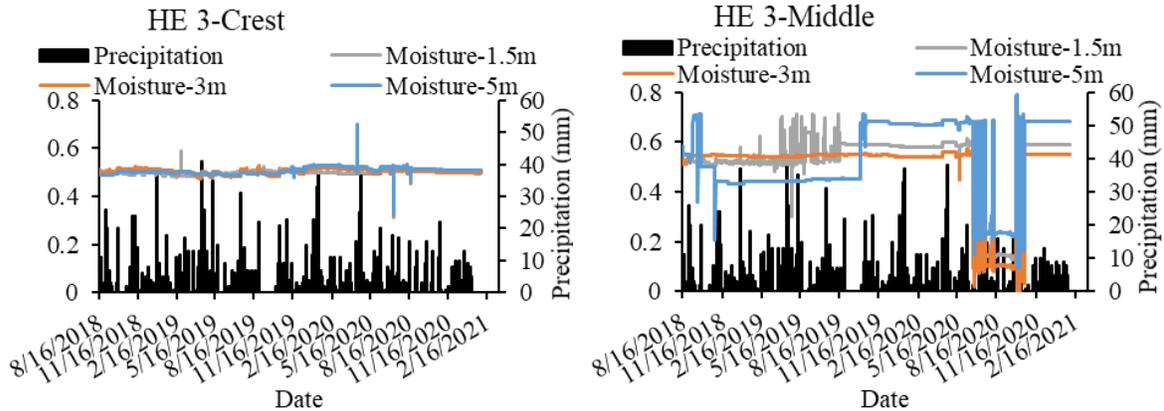
Figure 5.22 Instrumentation Results of θ vs Rainfall at I-Slope 3: (a) Crest, (b) Middle

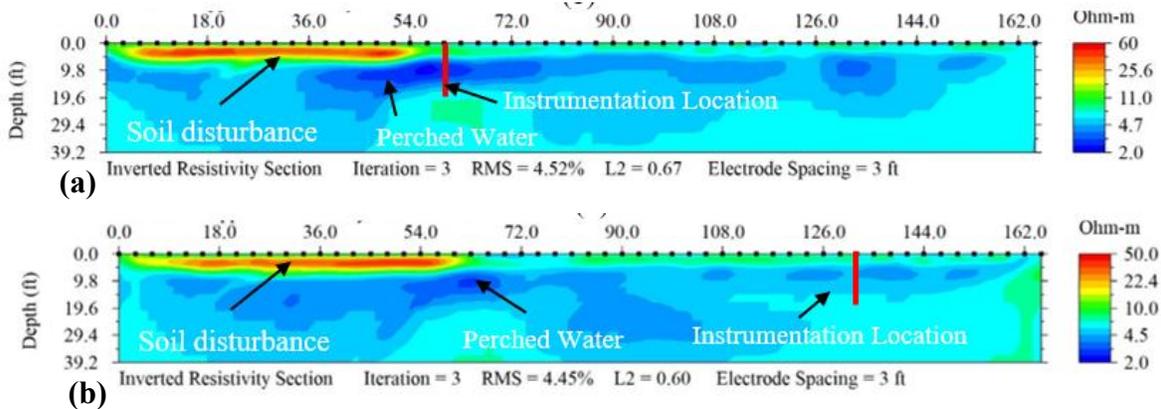
The field instrumentation locations and results from the ERI inversion for I-Slope 3 at Line A (crest) and Line B (middle) are presented in Figure 5.23. The ERI inversion images show that high resistivity areas (represented by yellow and red) are typically found closer to the surface and suggest that the soil zone up to a depth of 5 feet is unsaturated. Areas with low resistivities (represented by blue) are at greater depths, indicating the presence of moisture and fully saturated soil. Pockets of high resistivities at the surface usually indicate that the soil has been disturbed, either by failure or other reasons. Pockets of low resistivities beneath the soil usually indicate the presence of perched water zones, which often initiate slide failures in Yazoo Clay embankments (Nobahar et al., 2020; Khan et al., 2020).

Figure 5.23 ERI Results of I-Slope 3: (a) Crest, (b) Middle
