MDOT State Study 316 – Development of Advanced Landslide Investigation Protocol Using Geophysical Methods for Mississippi

FINAL REPORT

June 30, 2023

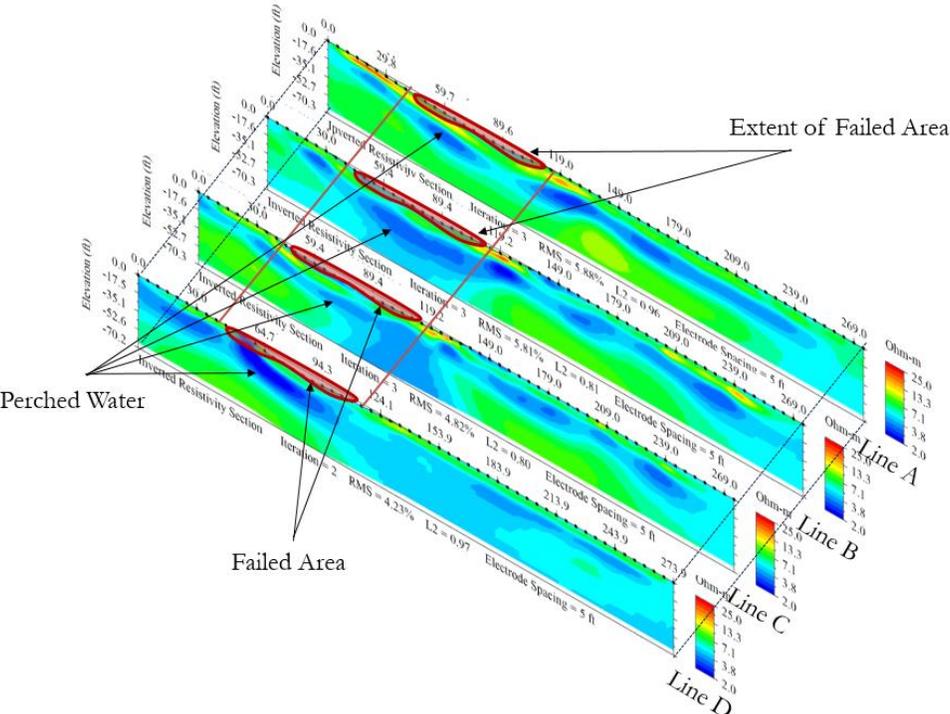
Back-analysis, using numerical modeling in PLAXIS, was performed for the failed Metrocenter slope to determine the soil's properties at failure. The ERI results are presented in Figure 5.25 and the drone results are presented in Figure 5.26. The analysis involved adjusting parameters and identifying the cohesive strength of the soil at failure by successive iterations.

Figure 5.25 Metrocenter ERI Test Results (I220 S Exit 1B)

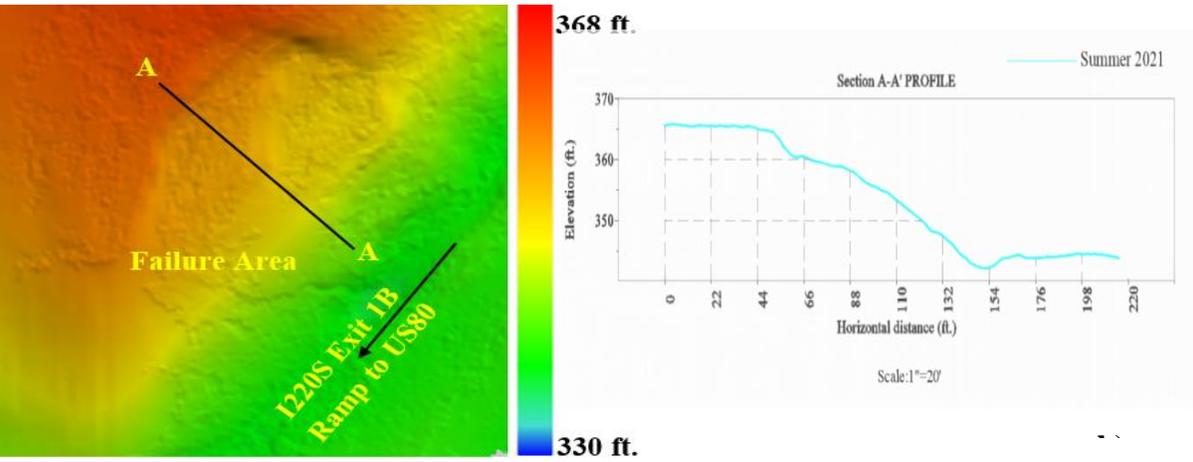
Figure 5.26 Metrocenter Drone DEM Deformation (I220S Exit 1B)

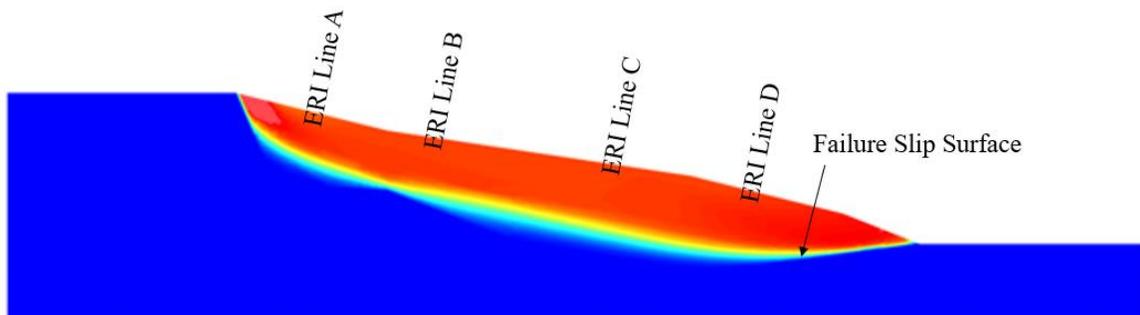
A deformation analysis of Slope 1 was conducted using 2-D FEM modeling. The integration of UAV surface profiles, ERI test results, and FEM back-analysis accurately identified the failure slip surface, matching the observed field slip surface. This methodology provides more accurate slip surface identification and extraction of soil properties compared to other post-failure analysis methods. The UAV and ERI data helped verify the post-failure surface geometry through numerical analysis.

Figure 5.28 Deformation at Failure (when $FS < 1$) with Slip Surface Field Observations
